# FACILITY CONDITION ASSESSMENT

**Shelby County Board of Education**  
160 South Hollywood Street  
Memphis, TN 38112-4892  
Michelle Stuart

Melrose Stadium  
2870 Deadrick Avenue  
Memphis, TN 38114

January 10, 2025

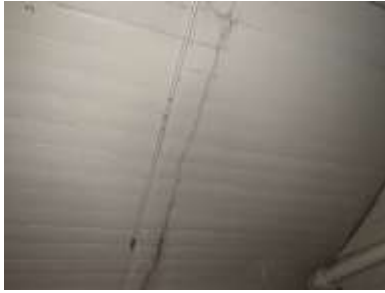
### Recommended Follow-up Study: Structural, Superstructure

Structural, Superstructure  
Locker Rooms/Press Box Melrose Stadium  
Locker room/ restroom

Cracks in the concrete superstructure with water intrusion were observed in several areas throughout the locker rooms and restrooms. - AssetCALC ID: 8781924

Uniformat Code: P2030  
Recommendation: **Evaluate/Report in 2024**

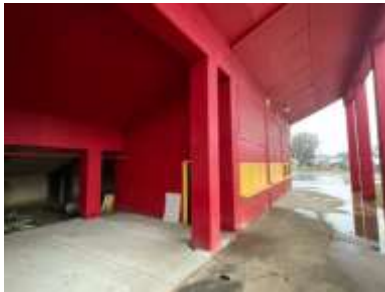
### Structural Framing in Poor condition.

Concrete Cast-in-Place  
Melrose Stadium Stadium structure

Several areas of water intrusion were observed around the concrete structural framing. A structural engineering study is recommended to determine the extent of the damage. - AssetCALC ID: 8783871

Uniformat Code: B1010  
Recommendation: **in 2024**

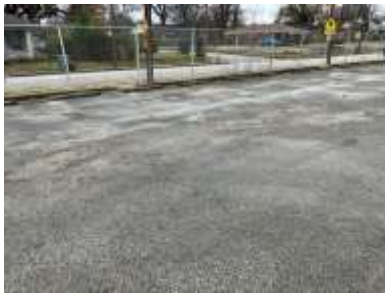
### Parking Lots in Poor condition.

Pavement, Asphalt  
Site Melrose Stadium Site

Asphalt parking lot seal and stripe was observed to be deteriorated. - AssetCALC ID: 8779632

Uniformat Code: G2020  
Recommendation: **Seal & Stripe in 2025**

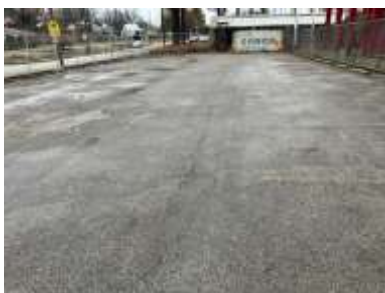
### Parking Lots in Poor condition.

Pavement, Asphalt  
Site Melrose Stadium Site

Asphalt parking lot was observed to be deteriorated. - AssetCALC ID: 8779621

Uniformat Code: G2020  
Recommendation: **Mill & Overlay in 2025**

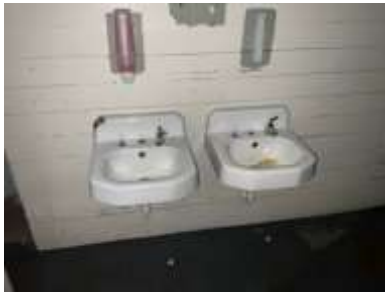
### Sink/Lavatory in Poor condition.

Wall-Hung, Enameled Steel  
Locker Rooms/Press Box Melrose Stadium  
Restrooms

Sinks were observed to show signs of damage and deterioration. - AssetCALC ID: 8779603

Uniformat Code: D2010  
Recommendation: **Replace in 2025**

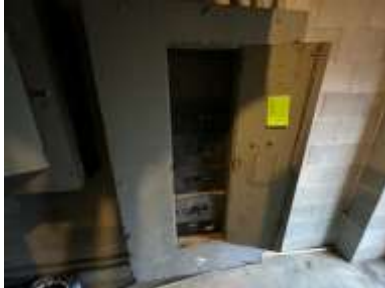
### Distribution Panel in Poor condition.

120/208 V  
Locker Rooms/Press Box Melrose Stadium  
Locker Rooms

Main distribution panel was observed to be damaged and deteriorated. - AssetCALC ID: 8779600

Uniformat Code: D5020  
Recommendation: **Replace in 2024**

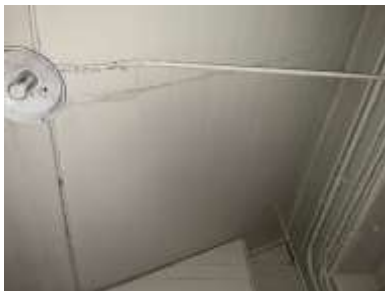
### Ceiling Finishes in Poor condition.

any flat surface  
Locker Rooms/Press Box Melrose Stadium  
Building interior

Painted concrete ceilings were observed to be deteriorated. - AssetCALC ID: 8779595

Uniformat Code: C2050  
Recommendation: **Prep & Paint in 2025**

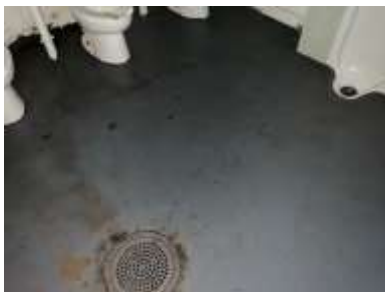
### Flooring in Poor condition.

any surface, w/ Epoxy Coating  
Locker Rooms/Press Box Melrose Stadium  
Restrooms

Epoxy coated flooring was observed to be damaged and deteriorated. - AssetCALC ID: 8779606

Uniformat Code: C2030  
Recommendation: **Prep & Paint in 2025**
