FACILITY CONDITION ASSESSMENT

Shelby County Board of Education
160 South Hollywood Street
Memphis, Tennessee 38112-4892
Michelle Stuart

Knight Road Elementary
3237 Knight Road
Memphis, Tennessee 38118

June 19, 2024

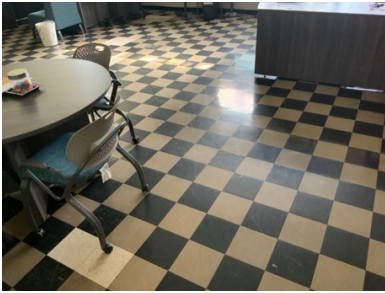
Recommended Follow-up Study: Environmental, Asbestos (ACM) and Lead Base Paint (LBP)

Environmental, Asbestos (ACM) and Lead
Base Paint (LBP)
Knight Road Elementary Throughout Building

Possible asbestos based materials and lead based paint used - AssetCALC ID: 7597266

Uniformat Code: P2030
Recommendation: **Evaluate/Report in 2024**

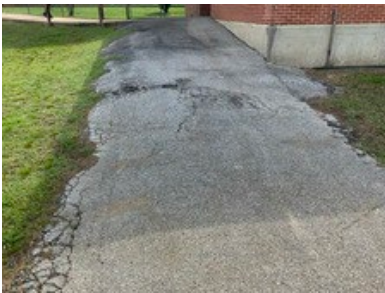
Sidewalk in Poor condition.

Asphalt
Knight Road Elementary Site

Breaking up in middle and edge - AssetCALC ID: 7597318

Uniformat Code: G2030
Recommendation: **Replace in 2026**

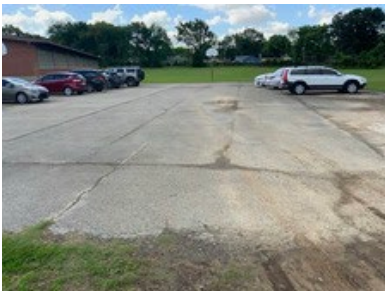
Parking Lots in Poor condition.

Pavement, Asphalt
Knight Road Elementary Site

Was playground now a parking lot Cracking and not draining - AssetCALC ID: 7597301

Uniformat Code: G2020
Recommendation: **Mill and Overlay in 2025**

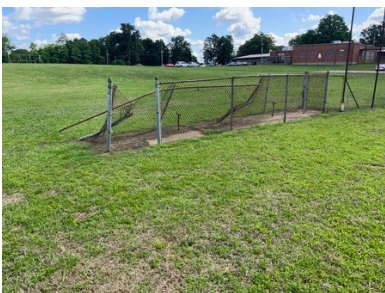
Sports Apparatus in Failed condition.

Baseball, Backstop Chain-Link
Knight Road Elementary Site

Broken up, poles knocked over, bench seat missing - AssetCALC ID: 7597299

Uniformat Code: G2050
Recommendation: **Replace in 2024**

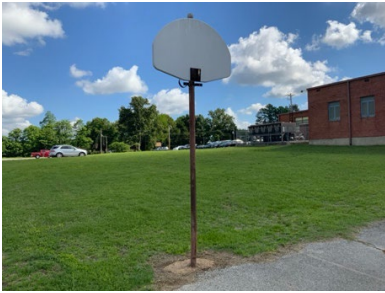
Sports Apparatus

Basketball, Backboard/Rim/Pole
Knight Road Elementary Site

No rims - AssetCALC ID: 7597278

Uniformat Code: G2050
Recommendation: **Replace in 2025**

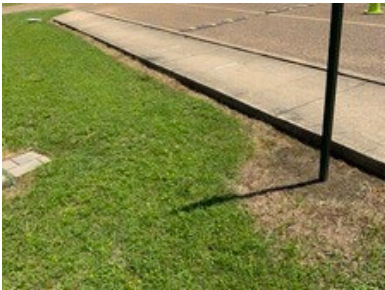
Landscaping in Poor condition.

Ground Cover
Knight Road Elementary Site

Reestablish ground cover - AssetCALC ID: 7597320

Uniformat Code: G2080
Recommendation: **Repair in 2026**

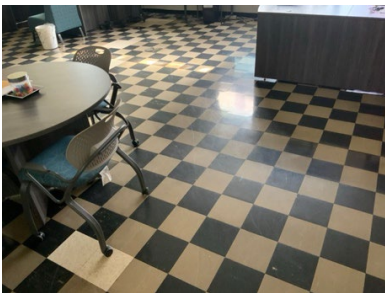
Flooring in Poor condition.

Vinyl Tile (VCT), with Asbestos Abatement
Knight Road Elementary Office

Uniformat Code: C2030
Recommendation: **Replace in 2026**

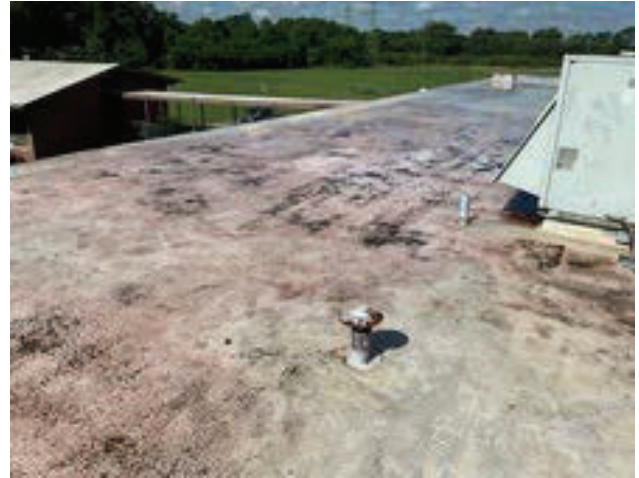
The single story masonry structure has TPO roof that has been coated. The coating is cracking on the flat roof areas. The windows in the school are single pane with steel frames that should be replaced with more energy efficient units. The IT room has damaged sheetrock ceiling and a visible hole in the metal deck that is open to the exterior. The flooring in part of the facility could contain asbestos. This should be tested with the mastic in areas that have been replaced. The paint in the building could possibly be lead based. The ceiling tiles show sagging from moisture, the painted areas have peeling and other damage. The wall finishes generally show signs of use. Floors have been patched and areas replaced.

8 - COATED ROOFING

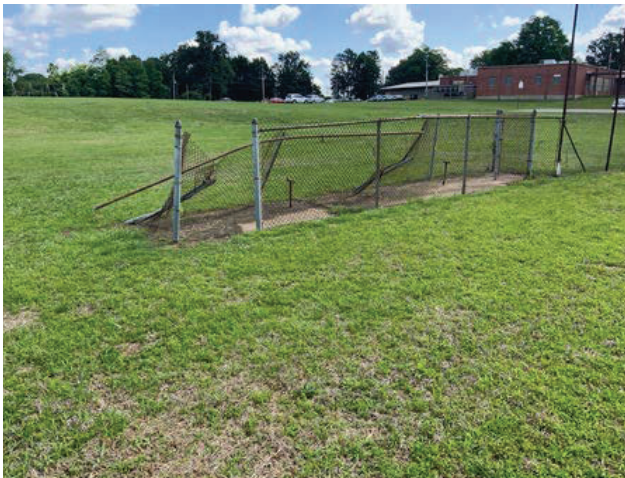
The site has older playground and sports related installations that are no longer in use by the school. Some of these are in failed condition. The backstop has damaged poles, fencing that is collapsed and the benches are gone. The basketball poles do not have rims. The playground is being used as a parking lot. The asphalt paving is cracked and breaking up. Different areas do not drain and have ponding. The grass next to the sidewalk near the building has areas that are depressed and need to be raised. There are treated timbers used for curbing that are showing signs of dry rot. The swings are not all down and in usable condition. The climbing structures are locked off and not available for use.

21 - BACKSTOP
