# FACILITY CONDITION ASSESSMENT

**Shelby County Board of Education**  
160 South Hollywood Street  
Memphis, Tennessee 38112-4892  
Michelle Stuart

Middle College High School  
750 East Parkway, South  
Memphis, Tennessee 38104

October 14, 2024

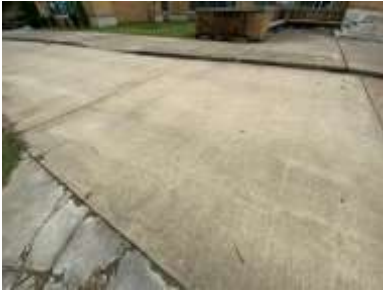
### Sidewalk in Poor condition.

Concrete, Large Areas  
Site Middle College High School Site

Significant cracking and separation. - AssetCALC ID: 8362637

Uniformat Code: G2030  
Recommendation: **Replace in 2026**

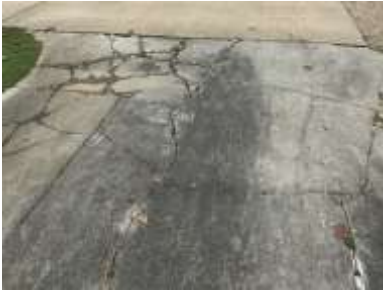
### Sidewalk in Poor condition.

Concrete, Small Areas/Sections  
Site Middle College High School Site

Significant cracking and separation. - AssetCALC ID: 8362607

Uniformat Code: G2030  
Recommendation: **Replace in 2026**

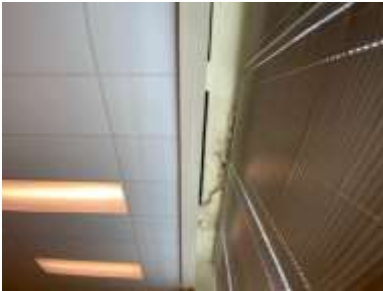
### Ceiling Finishes in Poor condition.

Gypsum Board/Plaster  
Main Building Middle College High School  
Classrooms 311-305

Uniformat Code: C2050  
Recommendation: **Replace in 2026**
