FACILITY CONDITION ASSESSMENT

Norris Achievement Academy (Old Norris ES) 1490 Norris Road Memphis, Tennessee 38106

163745.23R000-059.354

April 6, 2024

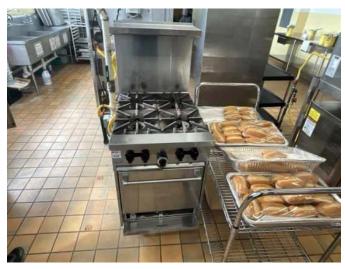
17 - FOODSERVICE EQUIPMENT

Foodservice Equipment in Failed condition.

Not working, parts missing - AssetCALC ID: 7414005

Recommendation: Replace in 2024

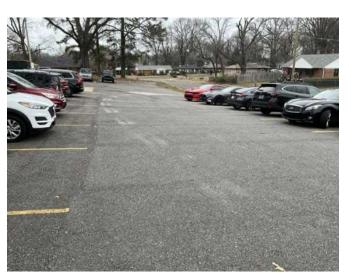
18 - PARKING LOTS

Parking Lots in Poor condition.

Extreme raveling and alligator cracking - AssetCALC ID: 7414003

Recommendation: Cut & Patch in 2024
