FACILITY CONDITION ASSESSMENT

Shelby County Board of Education
160 South Hollywood Street
Memphis, Tennessee 38112-4892
Michelle Stuart

Northeast Prep Academy
968 North Mendenhall Road
Memphis, Tennessee 38122

May 2, 2024

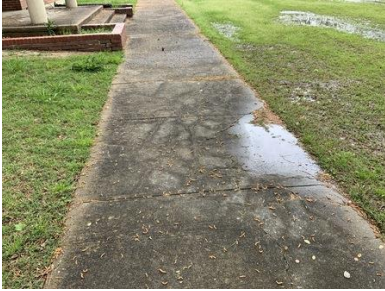
Sidewalk in Poor condition.

Concrete, Small Areas/Sections
Northeast Prep Academy Site

There are areas throughout the sidewalk within the property that is damaged and large amount of cracking has developed - AssetCALC ID: 7512338

Uniformat Code: G2030
Recommendation: **Replace in 2026**

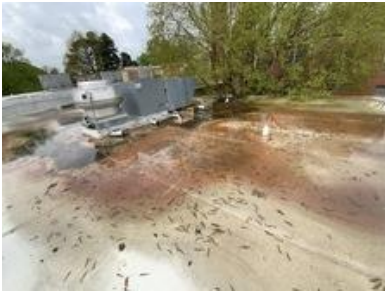
The roof drainage is in poor condition. After rain there is a large amount of standing water throughout the roof area. A professional architect must be retained to analyze the existing condition, provide recommendations and, if necessary, estimate the scope and cost of any required repairs. The cost of this study is included in the cost tables. A budgetary cost allowance to replace the roof drainage is also included. Due to the ambiguity of the required repair scope at the time of this assessment, the cost for any possible subsequent repairs is not included.

Recommended Follow-up Study: Building Envelope, Roof

Building Envelope, Roof
Northeast Prep Academy Roof

After rain, there are large amount of standing water throughout the roof area. - AssetCALC ID: 7512300

Uniformat Code: P2030
Recommendation: **Evaluate/Report in 2024**

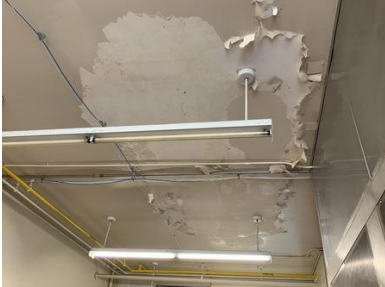
The ceilings and walls are in poor condition. The ceilings and walls surface throughout the building are cracking and peeling. A professional engineer must be retained to analyze the existing condition, provide recommendations and, if necessary, estimate the scope and cost of any required repairs. The cost of this study is included in the cost tables. A budgetary cost allowance to replace the ceilings and walls is also included. Due to the ambiguity of the required repair scope at the time of this assessment, the cost for any possible subsequent repairs is not included.

Recommended Follow-up Study: Mechanical, General Design

Mechanical, General Design
Northeast Prep Academy Throughout building

The ceilings and walls surface throughout the building are cracking and peeling. - AssetCALC ID: 7512283

Uniformat Code: P2030
Recommendation: **Evaluate/Report in 2024**

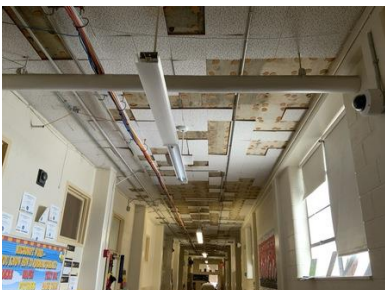
Suspended Ceilings in Poor condition.

Hard Tile, Replacement with ACT
Northeast Prep Academy Throughout building

Ceiling hard tiles throughout the building are falling and exposed. - AssetCALC ID: 7512348

Uniformat Code: C1070
Recommendation: **Replace in 2025**

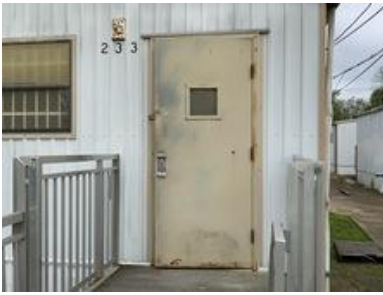
Exterior Door in Poor condition.

Is this thing portable classroom entry doors are severely rusted throughout these buildings - AssetCALC ID: 7512261

Uniformat Code: B2050
Recommendation: **Replace in 2026**

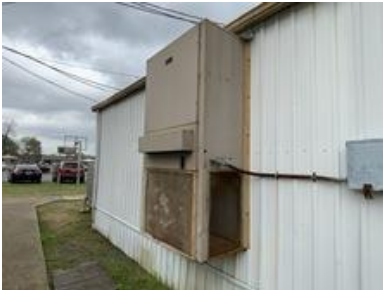
Air Conditioner in Poor condition.

Unit is rusted and in poor condition - AssetCALC ID: 7512286

Uniformat Code: D3030
Recommendation: **Replace in 2026**

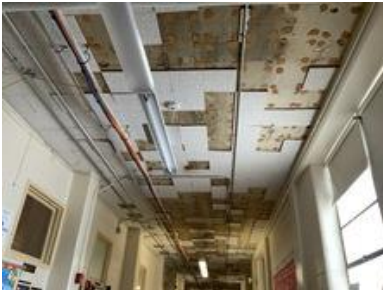
Recommended Follow-up Study: Environmental, Asbestos (ACM) and Lead Base Paint (LBP)

Uniformat Code: P2030
Recommendation: **Evaluate/Report in 2024**
