FACILITY CONDITION ASSESSMENT

**BUREAU
VERITAS**

Oakhaven Elementary
3795 Bishops Bridge
Memphis, Tennessee 38118

September 30, 2024

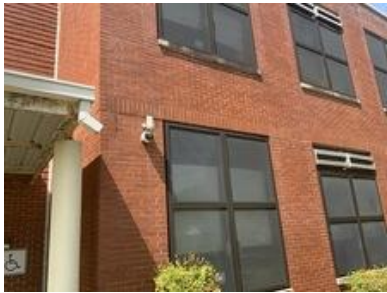
Exterior Walls in Poor condition.

Brick
Oakhaven Elementary Building Exterior

Cracking - AssetCALC ID: 8167678

Uniformat Code: B2010
Recommendation: **Repair/Repoint in 2024**

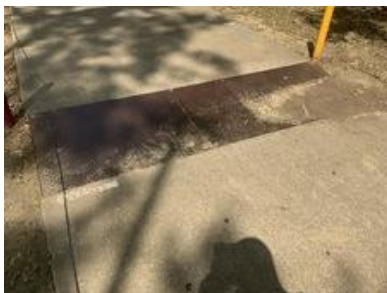
Supplemental Components in Poor condition.

Drains, Trench
Oakhaven Elementary Site

Plate is bent, not flat across area - AssetCALC ID: 8167759

Uniformat Code: D2020
Recommendation: **Replace in 2026**

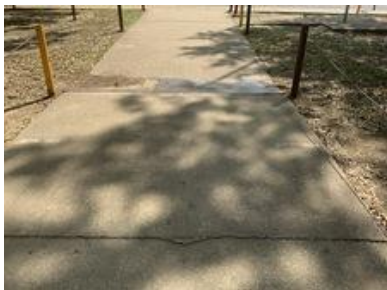
Sidewalk in Poor condition.

Concrete, Large Areas
Oakhaven Elementary Site

Heaving, uneven, trip hazard - AssetCALC ID: 8167717

Uniformat Code: G2030
Recommendation: **Replace in 2026**

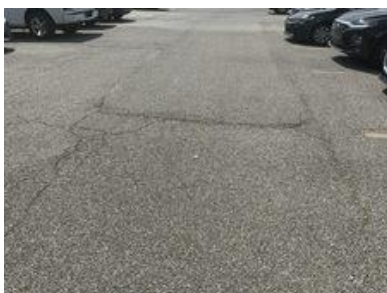
Parking Lots in Poor condition.

Pavement, Asphalt
Oakhaven Elementary Site

Wearing off - AssetCALC ID: 8167691

Uniformat Code: G2020
Recommendation: **Seal and Stripe in 2025**

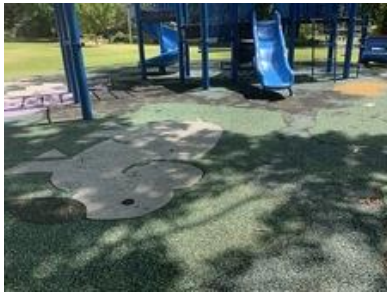
Playfield Surfaces in Poor condition.

Rubber, Poured-in-Place
Oakhaven Elementary Site

Delaminating - AssetCALC ID: 8167771

Uniformat Code: G2050
Recommendation: **Replace in 2026**

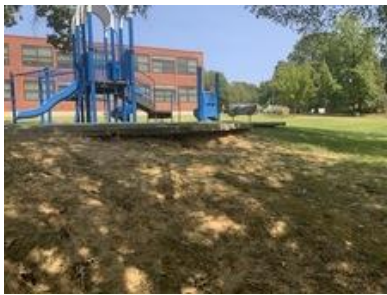
Retaining Wall in Failed condition.

Concrete Cast-in-Place
Oakhaven Elementary Site

Need to expand wall depth - AssetCALC ID: 8167663

Uniformat Code: G2060
Recommendation: **Replace in 2024**

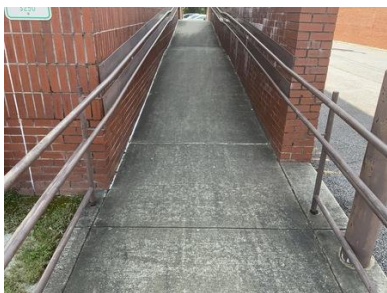
Stair/Ramp Rails in Poor condition.

Metal
Oakhaven Elementary Site

Worn, rusting - AssetCALC ID: 8167828

Uniformat Code: B1080
Recommendation: **Refinish in 2024**

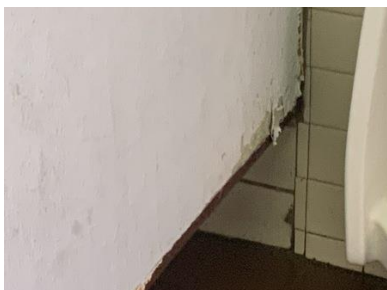
Toilet Partitions in Poor condition.

Wood
Oakhaven Elementary Restrooms

Damaged hinges and doors - AssetCALC ID: 8167698

Uniformat Code: C1090
Recommendation: **Replace in 2026**

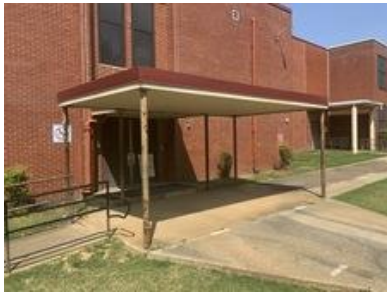
Covered Walkway in Poor condition.

Metal-Framed, Light/Medium Gauge
Oakhaven Elementary Roof

Heavy rusting and peeling paint - AssetCALC ID: 8167707

Recommendation: **Prep and Paint in 2026**

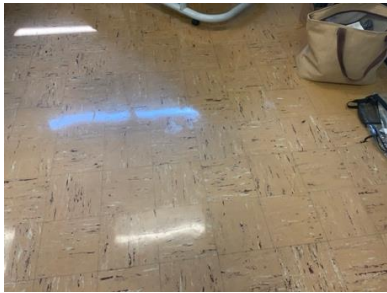
Recommended Follow-up Study: Environmental, Asbestos (ACM) and Lead Base Paint (LBP)

Environmental, Asbestos (ACM) and Lead
Base Paint (LBP)
Oakhaven Elementary Throughout

Tile is asbestos, possibly ceiling tile above ACT, pipe insulation in walls and lead based paint. - AssetCALC ID: 8168443

Recommendation: **Evaluate/Report in 2024**

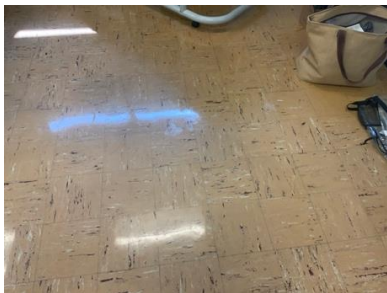
Flooring in Poor condition.

Vinyl Tile (VCT), with Asbestos Abatement
Oakhaven Elementary Classrooms General

Recommendation: **Replace in 2026**
