# FACILITY CONDITION ASSESSMENT

**Shelby County Board of Education**  
160 South Hollywood Street  
Memphis, Tennessee 38112-4892  
Michelle Stuart

Oakhaven High School  
3125 Ladbrook Road  
Memphis, Tennessee 38118

*October 1, 2024*

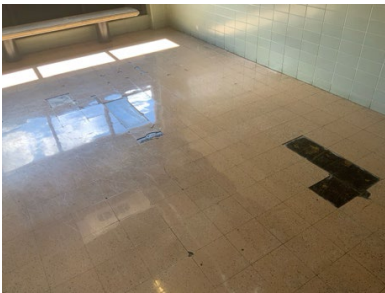
#### Recommended Follow-up Study: Environmental, Asbestos (ACM) and Lead Base Paint (LBP)

Environmental, Asbestos (ACM) and Lead Base Paint (LBP)  
Oakhaven High School Classroom Building

Determine extent of asbestos used in campus, flooring, ceiling and pipe insulation - AssetCALC ID: 8214295

Uniformat Code: P2030  
Recommendation: **Evaluate/Report in 2024**

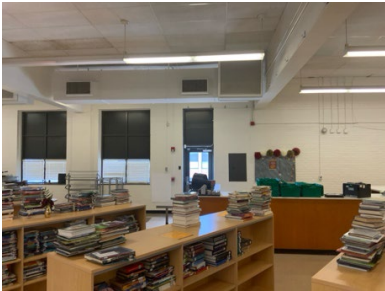
#### Electrical System in Poor condition.

Any Type, Repairs per Man-Day  
Oakhaven High School Classroom Building  
Library

Emergency exit sign blocked by ductwork - AssetCALC ID: 8206213

Uniformat Code: D5020  
Recommendation: **Repair in 2025**

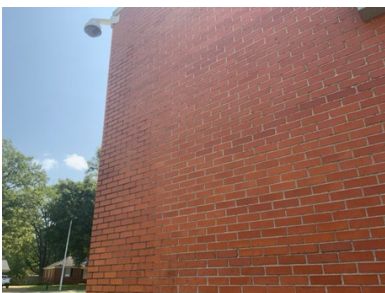
#### Exterior Walls in Poor condition.

Brick  
Oakhaven High School Auditorium Building  
Exterior

corner mortar wearing away - AssetCALC ID: 8197445

Uniformat Code: B2010  
Recommendation: **Repair/Repoint in 2024**

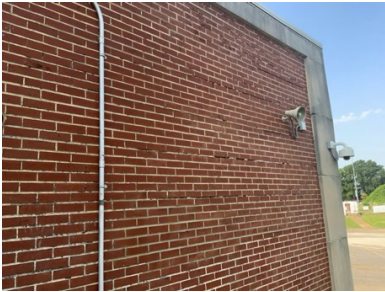
**Exterior Walls in Poor condition.**

Brick  
Oakhaven High School Gymnasium Building  
Exterior

Mortar joints are open - AssetCALC ID: 8204056

Uniformat Code: B2010  
Recommendation: **Repair/Repoint in 2025**

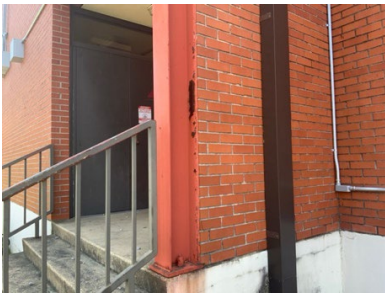
**Balcony Structure in Poor condition.**

Vertical Column Steel  
Oakhaven High School Auditorium Building  
Exterior

Flange rusted out - AssetCALC ID: 8197438

Uniformat Code: B1010  
Recommendation: **Replace in 2026**

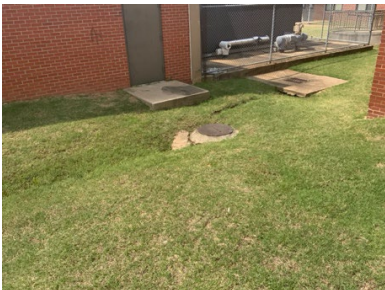
**Storm Drainage Components in Poor condition.**

Catch Basin, 6' Deep  
Oakhaven High School Site

Washed out, flowing under concrete - AssetCALC ID: 8200908

Uniformat Code: G3030  
Recommendation: **Replace/Install in 2026**

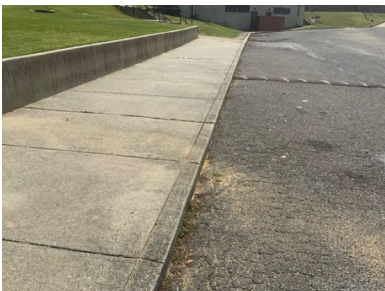
**Sidewalk in Poor condition.**

Concrete, Large Areas  
Oakhaven High School Site

Cracked breaking up - AssetCALC ID: 8200918

Uniformat Code: G2030  
Recommendation: **Replace in 2026**

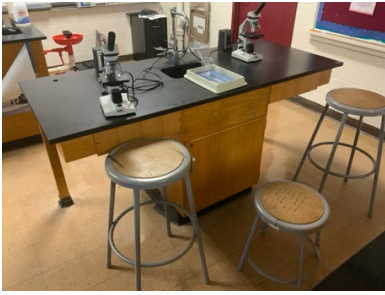
**Casework in Poor condition.**

Cabinetry, Standard  
Oakhaven High School Classroom Building  
Classrooms Science

Door openings covered over, drawers missing - AssetCALC ID: 8206218

Uniformat Code: E2010  
Recommendation: **Replace in 2026**

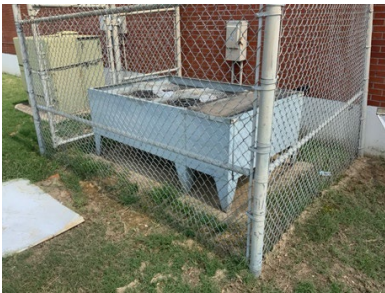
**Split System**

Condensing Unit/Heat Pump  
Oakhaven High School Auditorium Site Utility  
Areas

Off at disconnect - AssetCALC ID: 8197427

Uniformat Code: D3030  
Recommendation: **Replace in 2024**

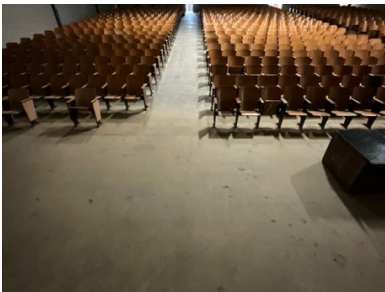
**Flooring in Failed condition.**

Carpet, Commercial Standard  
Oakhaven High School Auditorium

carpet was removed for water damage. is being replaced. - AssetCALC ID: 8187161

Uniformat Code: C2030  
Recommendation: **Replace in 2024**

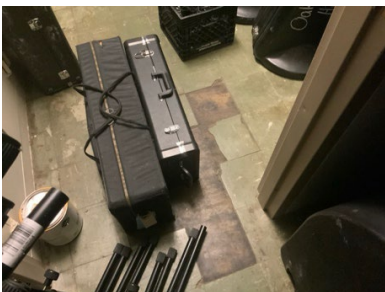
**Flooring in Poor condition.**

Vinyl Tile (VCT), with Asbestos Abatement  
Oakhaven High School Band Building  
Storeroom

Tiles lifting off floor - AssetCALC ID: 8205594

Uniformat Code: C2030  
Recommendation: **Replace in 2025**

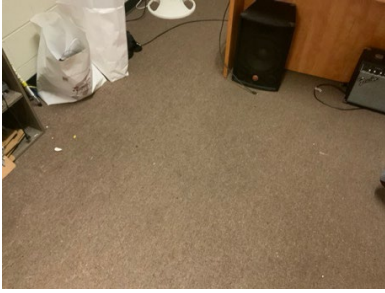
**Flooring in Poor condition.**

Carpet, Commercial Standard  
Oakhaven High School Band Building Office  
Areas

Fraying - AssetCALC ID: 8205622

Uniformat Code: C2030  
Recommendation: **Replace in 2025**

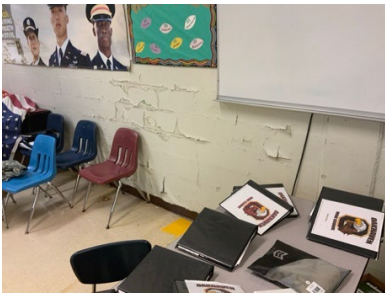
**Wall Finishes in Failed condition.**

Any Surface  
Oakhaven High School ROTC Building  
Throughout Building

Peeling paint, moisture damage likely - AssetCALC ID: 8204904

Uniformat Code: C2010  
Recommendation: **Prep and Paint in 2025**

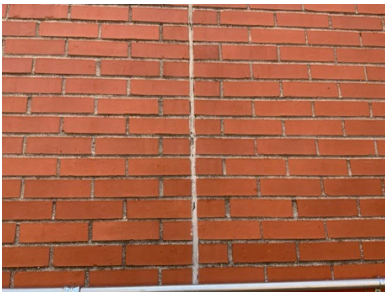
**Caulking in Poor condition.**

Cold Joints, 0" to 1/2"  
Oakhaven High School Auditorium Building  
Exterior

Cracking, holes opening up - AssetCALC ID: 8197424

Uniformat Code: B2010  
Recommendation: **Replace in 2026**

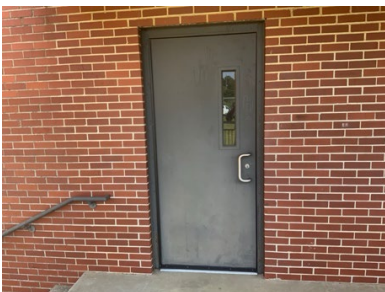
**Exterior Door in Poor condition.**

Steel, Standard  
Oakhaven High School Band Building -  
Building Exterior

Frames patched and patches rusting out - AssetCALC ID: 8205595

Uniformat Code: B2050  
Recommendation: **Replace in 2026**

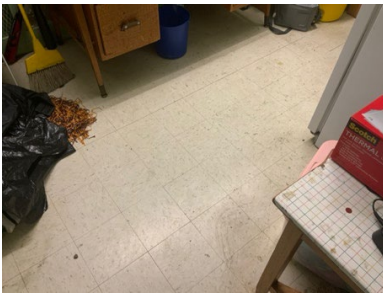
**Flooring in Poor condition.**

Vinyl Tile (VCT), with Asbestos Abatement  
Oakhaven High School ROTC Building  
Throughout Building

Some broken tiles, waxed over - AssetCALC ID: 8204893

Uniformat Code: C2030  
Recommendation: **Replace in 2026**

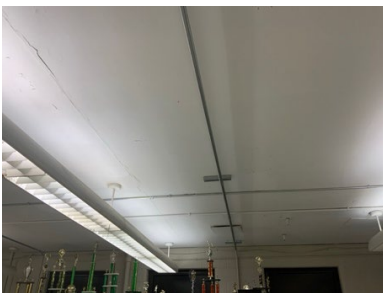
**Ceiling Finishes in Poor condition.**

Any Flat Surface  
Oakhaven High School Band Building  
Throughout Building

Paint is peeling - AssetCALC ID: 8205617

Uniformat Code: C2050  
Recommendation: **Prep and Paint in 2025**

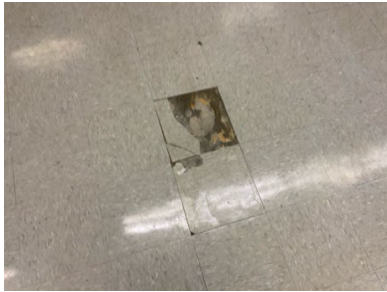
**Flooring in Poor condition.**

Vinyl Tile (VCT)  
Oakhaven High School Band Building  
Throughout Building

Some broken tiles - AssetCALC ID: 8205614

Uniformat Code: C2030  
Recommendation: **Replace in 2026**

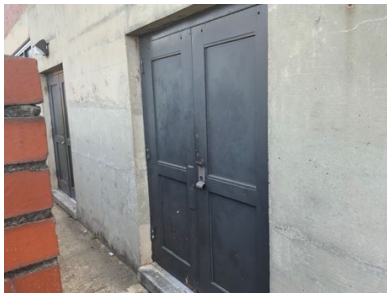
**Exterior Door in Poor condition.**

Steel, Standard  
Oakhaven High School Gymnasium Building  
Exterior

Bottoms rusting out - AssetCALC ID: 8204058

Uniformat Code: B2050  
Recommendation: **Replace in 2026**

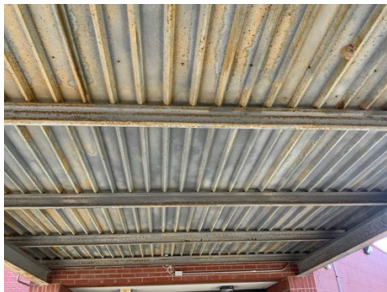
**Ceiling Finishes in Poor condition.**

exposed irregular elements  
Oakhaven High School Site Roof

Rusting, needs cleaning - AssetCALC ID: 8200921

Uniformat Code: C2050  
Recommendation: **Prep and Paint in 2026**

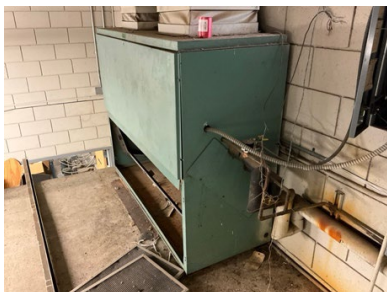
**Air Handler in Poor condition.**

Interior AHU, Easy/Moderate Access, 1201 to  
2400 CFM  
Oakhaven High School Auditorium

Condition unknown - AssetCALC ID: 8187179

Uniformat Code: D3050  
Recommendation: **Replace in 2026**
