# FACILITY CONDITION ASSESSMENT

**Shelby County Board of Education**  
160 South Hollywood Street  
Memphis, Tennessee 38112-4892  
Michelle Stuart

Oakhaven Stadium  
3125 Ladbrook Road  
Memphis, Tennessee 38118

October 1, 2024

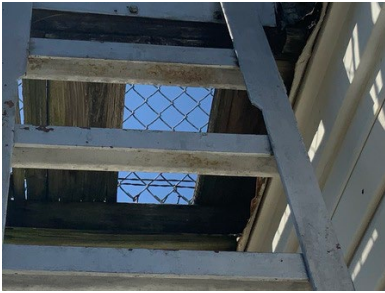
**Roofing in Poor condition.**

Modified Bitumen  
Oakhaven Stadium Press Box and Ticket  
Booth Roof

Platform missing board - AssetCALC ID: 8156729

Uniformat Code: B3010  
Recommendation: **Replace in 2025**

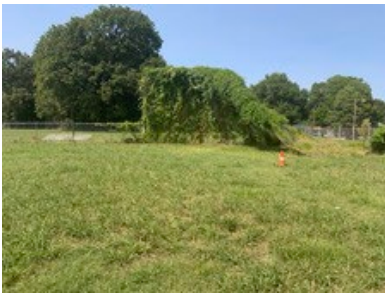
**Sports Apparatus in Failed condition.**

Baseball, Backstop Chain-Link  
Oakhaven Stadium Site

Falling over, weed covered - AssetCALC ID: 8156742

Uniformat Code: G2050  
Recommendation: **Replace in 2024**

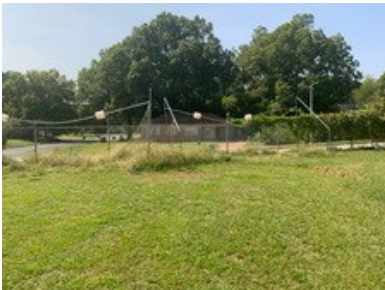
**Sports Apparatus in Failed condition.**

Soccer, Movable Practice Goal  
Oakhaven Stadium Site

Inverted, bent, appear out of service - AssetCALC ID: 8156736

Uniformat Code: G2050  
Recommendation: **Replace in 2024**

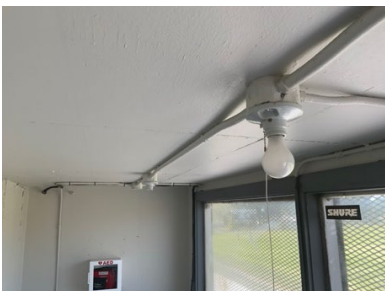
**Interior Lighting System in Poor condition.**

Full Upgrade, Low Density and Standard  
Fixtures  
Oakhaven Stadium Press Box and Ticket  
Booth – Press Box

Missing bulbs Not LED - AssetCALC ID: 8156725

Uniformat Code: D5040  
Recommendation: **Replace in 2026**

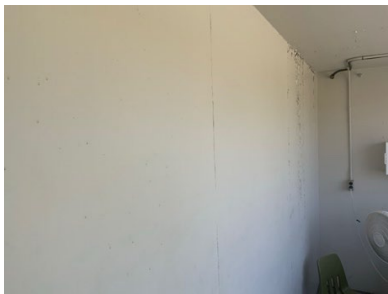
Wall Finishes in Poor condition.

Any Surface  
Oakhaven Stadium Press Box and Ticket Booth – Press Box

Water damage to paint - AssetCALC ID: 8156749

Uniformat Code: C2010  
Recommendation: **Prep and Paint in 2026**

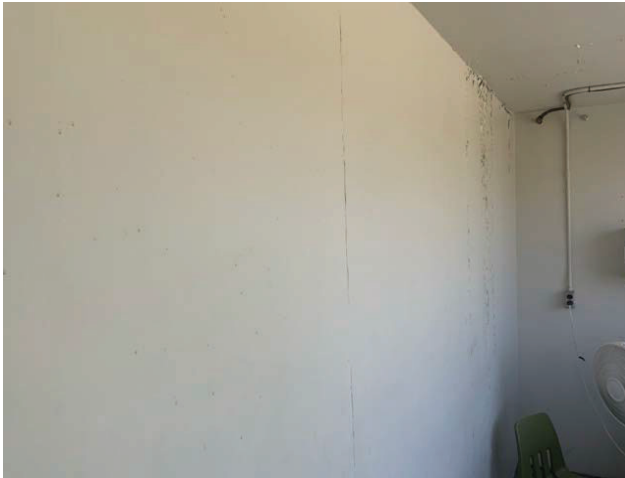
7 - WALL FINISHES

The stadium consists of the Press Box and a Ticket Booth. The Press Box interior has water damage on the rear wall. The floorboards at the top of the ladder are missing a board. The windows are large pieces of plexiglass that are losing the clear appearance and starting to cloud over.

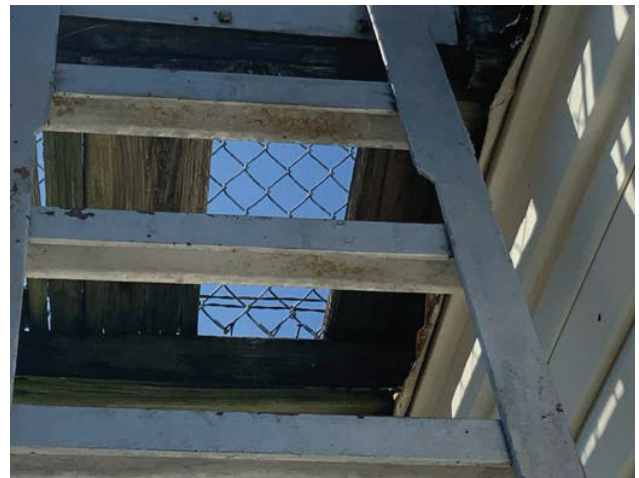
10 - ROOFING MISSING BOARD

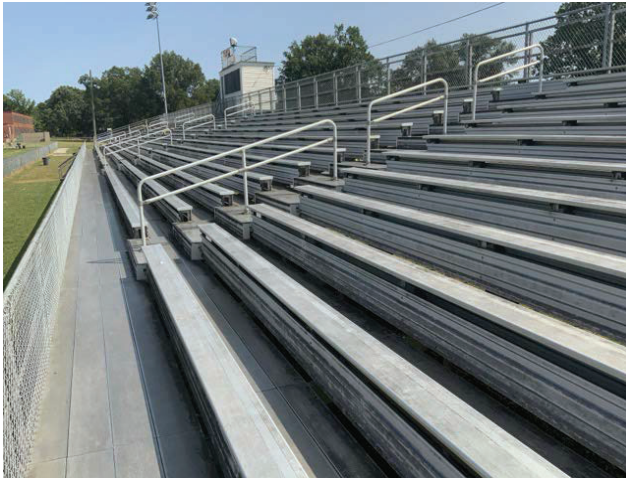
13 - BLEACHERS

The main bleachers are not ADA accessible, there is not ramp or wheelchair seating areas. The bleachers are also partially open to the area beneath the bleachers. The baseball backstop is partially collapsed and covered with weeds; the portable soccer goals are stored against the fence with torn netting. The practice football goal post is bent. The small bleachers have damaged seats and footrests. They are not set-up for viewing. The stadium lights and sound system have been upgraded. The field is full of weeds.

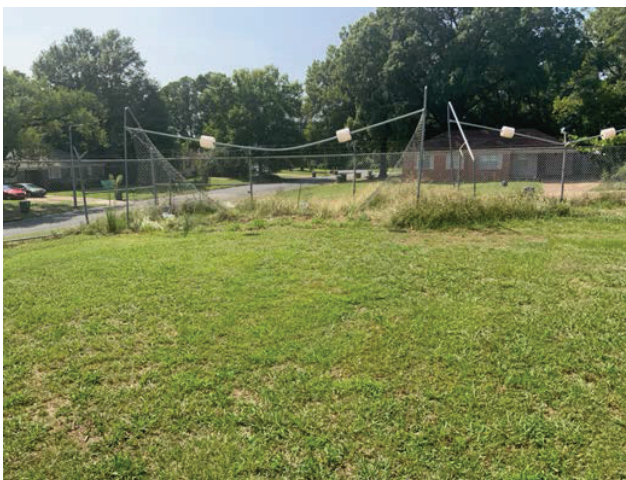
17 - SOCCER GOALS

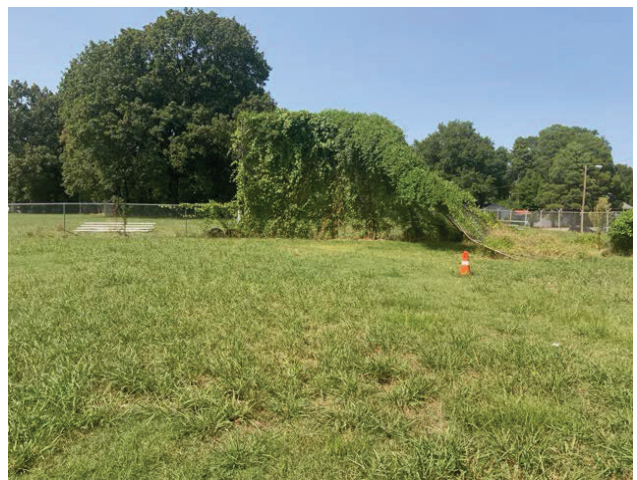
18 - BASEBALL BACKSTOP
