# FACILITY CONDITION ASSESSMENT

**Shelby County Board of Education**  
160 South Hollywood Street  
Memphis, Tennessee 38112-4892  
Michelle Stuart

Oakshire Elementary  
1765 Holmes Road  
Memphis, Tennessee 38116

*August 20, 2024*

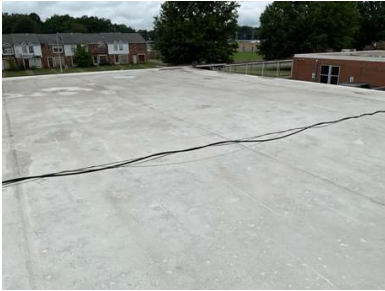
### Roofing in Poor condition.

Single-Ply Membrane, TPO/PVC  
Oakshire Elementary Roof

Abundance of ponding and cracking observed on roof - AssetCALC ID: 7916972

Uniformat Code: B3010  
Recommendation: **Replace in 2024**

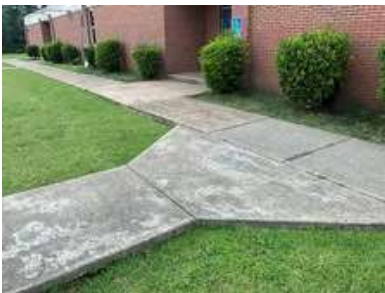
### Sidewalk in Poor condition.

Concrete, Large Areas  
Oakshire Elementary Site

Lots of heaving in the concrete walkways, lots of cracked and damage observed - AssetCALC ID: 7917006

Uniformat Code: G2030  
Recommendation: **Replace in 2025**

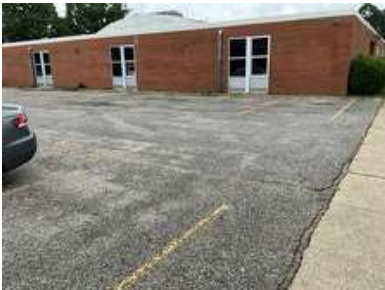
### Parking Lots in Poor condition.

Pavement, Asphalt  
Oakshire Elementary Site

Faded and worn observed. - AssetCALC ID: 7917001

Uniformat Code: G2020  
Recommendation: **Seal and Stripe in 2024**

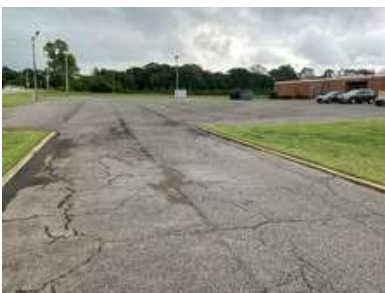
### Parking Lots in Poor condition.

Pavement, Asphalt  
Oakshire Elementary Site

Severe alligator cracking and ponding observed. - AssetCALC ID: 7916994

Uniformat Code: G2020  
Recommendation: **Mill and Overlay in 2024**

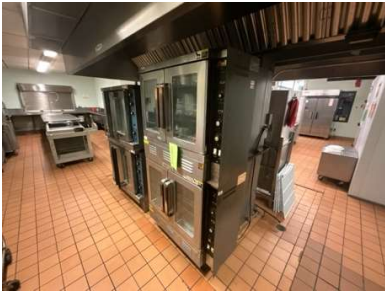
### Foodservice Equipment in Poor condition.

Broiler  
Oakshire Elementary Kitchen

Out of order - AssetCALC ID: 7917018

Uniformat Code: E1030  
Recommendation: **Replace in 2024**

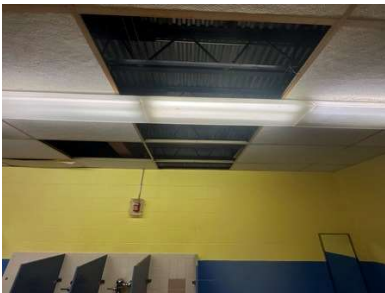
### Suspended Ceilings in Poor condition.

Acoustical Tile (ACT)  
Oakshire Elementary Throughout Building

Several missing tiles throughout the building existing tiles are water stain, broken, and war - AssetCALC ID: 7917014

Uniformat Code: C1070  
Recommendation: **Replace in 2025**

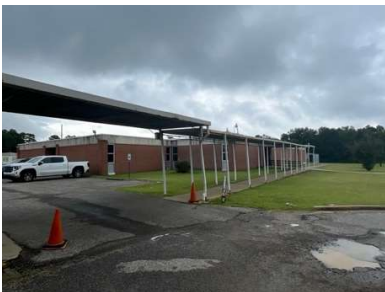
### Shed/Gazebo/Shade Structure in Poor condition.

Wood or Metal-Framed, Basic/Minimal  
Oakshire Elementary Building Exterior

Lots of rest observed, as well as bent post - AssetCALC ID: 7916996

Uniformat Code: F1020  
Recommendation: **Replace in 2025**

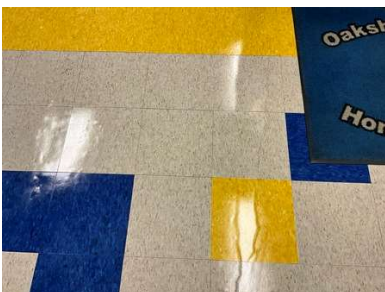
### Flooring in Poor condition.

Vinyl Tile (VCT)  
Oakshire Elementary Throughout Building

Abundant cracking observed - AssetCALC ID: 7916991

Uniformat Code: C2030  
Recommendation: **Replace in 2025**

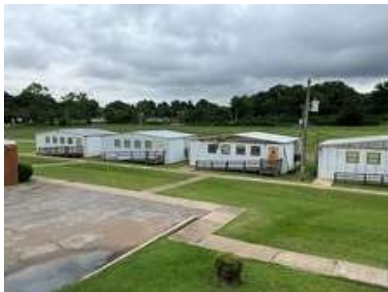
**Ancillary Building in Poor condition.**

Classroom/Office Module, Basic/Portable  
Oakshire Elementary Site General

Uniformat Code: F1020  
Recommendation: **Replace in 2025**
