FACILITY CONDITION ASSESSMENT

163745.23R000-030.354

March 6, 2024

Peabody Elementary School
2086 Young Avenue
Memphis, Tennessee 38104

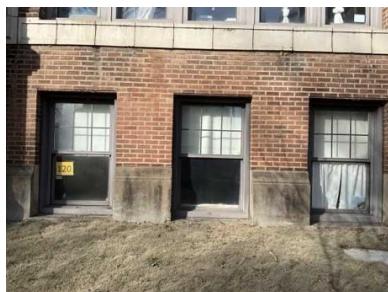
Window in Poor condition.

Aluminum Double-Glazed, 16-25 SF
Peabody Elementary School Building Exterior

Seals failed condensate and mold on interior of glazing - AssetCALC ID: 7388822

Uniformat Code: B2020
Recommendation: **Replace in 2026**

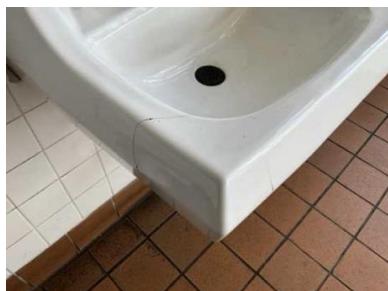
Sink/Lavatory in Poor condition.

Wall-Hung, Vitreous China
Peabody Elementary School Throughout building

Significantly worn hardware. Aged units - AssetCALC ID: 7342022

Uniformat Code: D2010
Recommendation: **Replace in 2026**

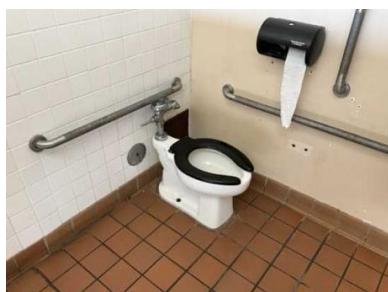
Toilet in Poor condition.

Child-Sized
Peabody Elementary School Restrooms

Stained, worn, poor pressure at fixture. - AssetCALC ID: 7342028

Uniformat Code: D2010
Recommendation: **Replace in 2026**

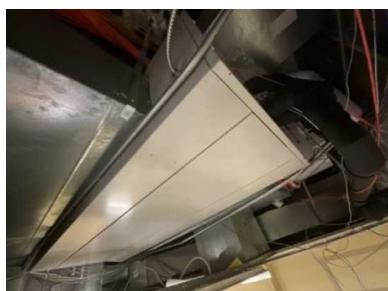
HVAC System in Failed condition.

Full System Renovation/Upgrade, Medium Complexity
Peabody Elementary School

Faulty above ceiling unit ventilators and hydronic distribution system. - AssetCALC ID: 7391589

Uniformat Code: D3050
Recommendation: **Replace in 2025**

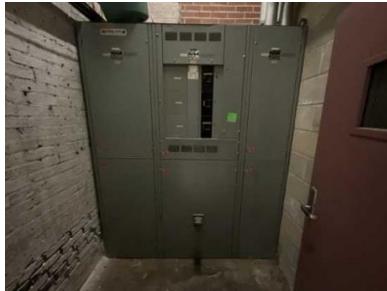
Electrical System in Poor condition.

Full System Renovation/Upgrade, Medium Density/Complexity
Peabody Elementary School

Undersized and outdated. Circuit breakers trip often. - AssetCALC ID: 7391591

Uniformat Code: D5020
Recommendation: **Replace in 2026**

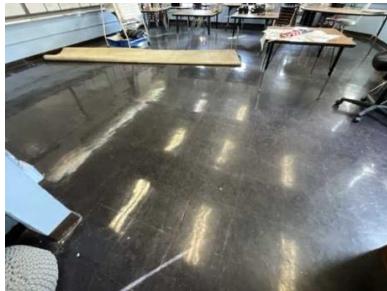
Flooring in Poor condition.

Vinyl Tile (VCT)
Peabody Elementary School Throughout building

Water damaged, Color faded. Detaching from subfloor. - AssetCALC ID: 7342603

Uniformat Code: C2030
Recommendation: **Replace in 2026**

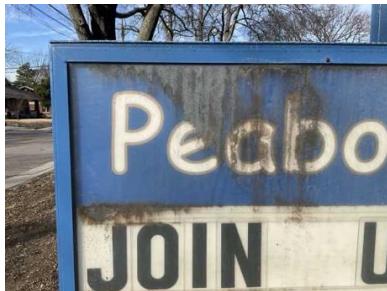
Signage in Poor condition.

Property, Monument
Peabody Elementary School Site

Paint worn, damaged, dented, growth. Replace with digital monument or brick monument - AssetCALC ID: 7388816

Uniformat Code: G2060
Recommendation: **Replace/Install in 2026**

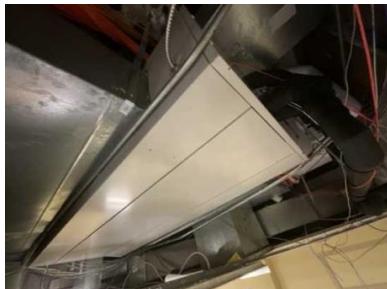
Unit Ventilator in Poor condition.

approx/nominal 4 Ton
Peabody Elementary School Classrooms

Units began leaking after installing resulting in mold issue closing down school. - AssetCALC ID: 7342040

Uniformat Code: D3030
Recommendation: **Replace in 2026**

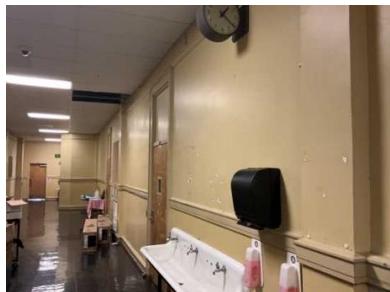
Wall Finishes in Poor condition.

any surface
Peabody Elementary School Throughout building

Damage to the wall caused by general used and abrasion over time. - AssetCALC ID: 7342614

Uniformat Code: C2010
Recommendation: **Prep and Paint in 2026**

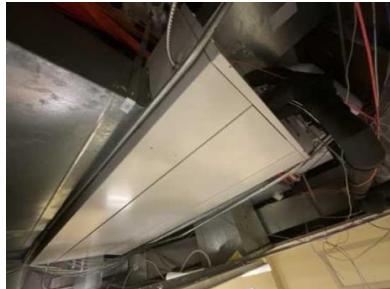
Recommended Follow-up Study: Environmental, Analysis of Suspect Fungal Growth

Environmental, Analysis of Suspect Fungal Growth
Peabody Elementary School Throughout

An overall failure in the HVAC system has caused multiple leaks throughout and resulting building wide mold growth. - AssetCALC ID: 7395944

Uniformat Code: P2030
Recommendation: **Evaluate/Report in 2024**

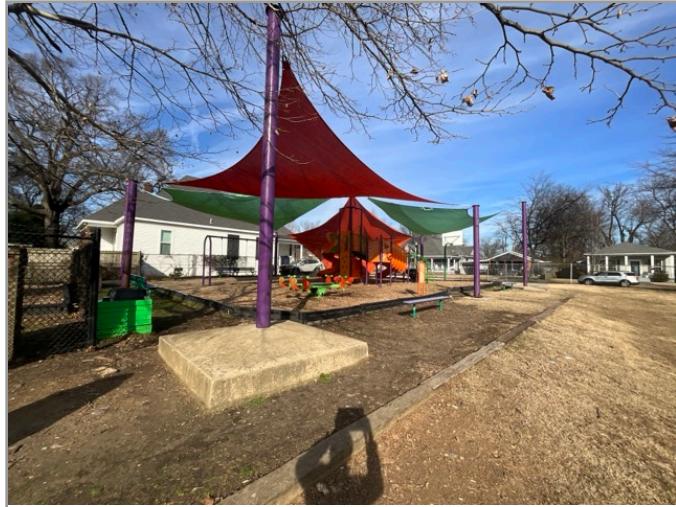
OVERVIEW OF PLAYGROUND

Question		Yes	No	NA	Comments
1	Is there an accessible route to the play area / s?		✗		No wheel chair access
2	Has the play area been reviewed for accessibility ?	✗			
3	Are publicly accessible swimming pools equipped with an entrance lift ?			✗
