FACILITY CONDITION ASSESSMENT

Shelby County Board of Education
160 South Hollywood Street
Memphis, Tennessee 38112-4892
Michelle Stuart

Raleigh Bartlett Meadows Elementary
5195 Twin Woods Avenue
Memphis, Tennessee 38134

February 16, 2024

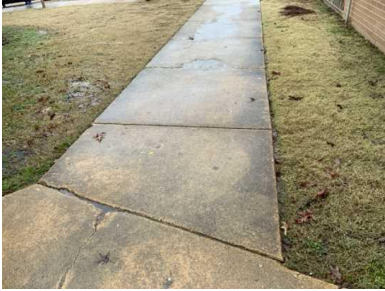
**Sidewalk in Poor condition.**

Concrete, Large Areas
Raleigh Bartlett Meadows Elementary Site

Sidewalk is uneven and has large cracks - AssetCALC ID: 7327337

Uniformat Code: G2030
Recommendation: **Replace in 2024**

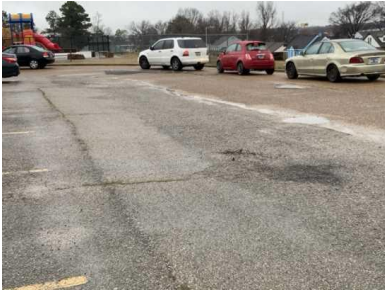
**Parking Lots in Poor condition.**

Pavement, Asphalt
Raleigh Bartlett Meadows Elementary Site

Pavement has potholes, crumbled pavement and severe alligator cracks - AssetCALC ID: 7327395

Uniformat Code: G2020
Recommendation: **Mill and Overlay in 2024**

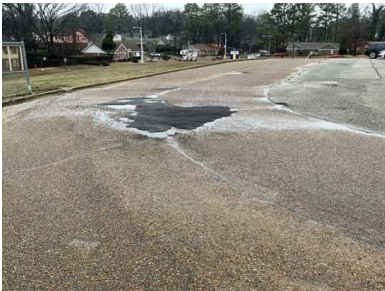
**Parking Lots in Poor condition.**

Pavement, Asphalt
Raleigh Bartlett Meadows Elementary Site

Stripe after paving - AssetCALC ID: 7340450

Uniformat Code: G2020
Recommendation: **Seal and Stripe in 2024**

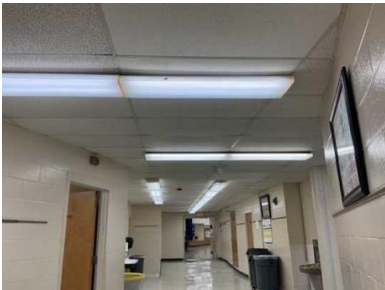
The ceilings in the school are suspended tiles. There are many tiles that are stained or damaged due to past leaks. There is the presence of mold in several areas of the ceilings. The portable classrooms are in a similar outdated appearance. Access to all the portable classrooms is limited and not ADA compliant.

**Suspended Ceilings in Poor condition.**

Acoustical Tile (ACT)
Raleigh Bartlett Meadows Elementary
Throughout building

Mold, damaged and old. - AssetCALC ID: 7340438

Uniformat Code: C1070
Recommendation: **Replace in 2024**

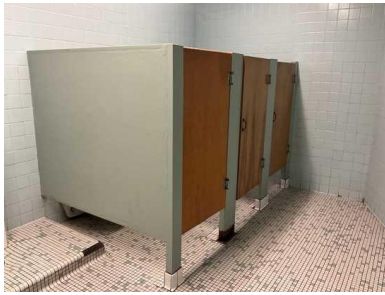
Toilet Partitions in Poor condition.

Wood
Raleigh Bartlett Meadows Elementary
Restrooms

Partitions are peeling and warped - AssetCALC ID: 7340459

Uniformat Code: C1090
Recommendation: **Replace in 2024**

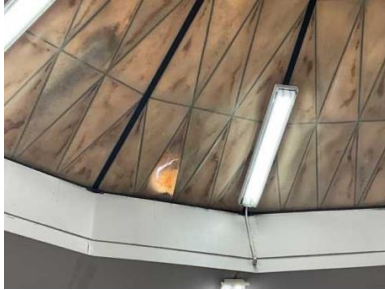
Ceiling Finishes in Poor condition.

Plastic Fiberglass-Reinforced
Raleigh Bartlett Meadows Elementary
Classrooms

Water damage. - AssetCALC ID: 7340453

Uniformat Code: C2050
Recommendation: **Replace in 2024**

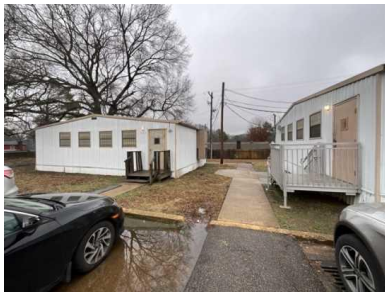
Ancillary Building in Poor condition.

Classroom/Office Module, Basic/Portable
Raleigh Bartlett Meadows Elementary
Portables

Units are in poor condition, access is limited, heating units are unreliable - AssetCALC ID: 7340451

Uniformat Code: F1020
Recommendation: **Replace in 2025**

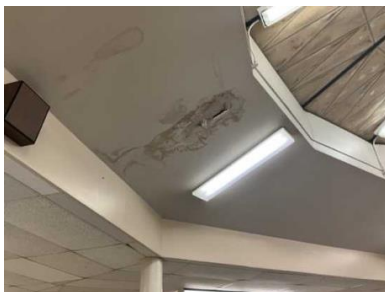
Recommended Follow-up Study: Environmental, Analysis of Suspect Fungal Growth

Environmental, Analysis of Suspect Fungal
Growth
Raleigh Bartlett Meadows Elementary
Throughout building

Roof leaks. - AssetCALC ID: 7340441

Uniformat Code: P2030
Recommendation: **Evaluate/Report in 2024**

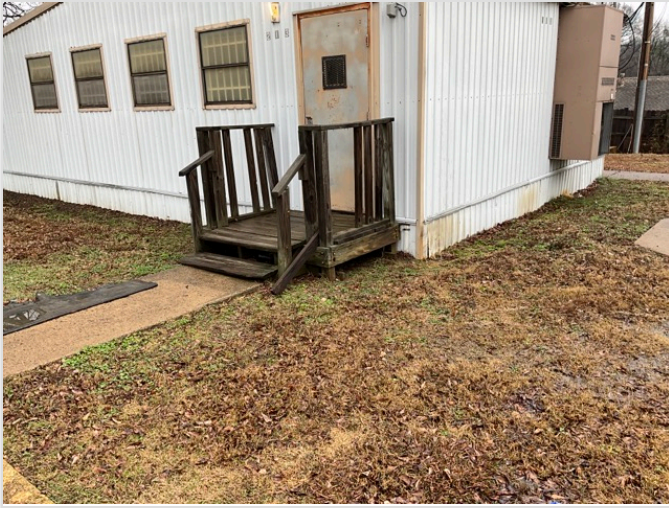
NON COMPLIANT ENTRY.
