# FACILITY CONDITION ASSESSMENT

**Shelby County Board of Education**  
160 South Hollywood Street  
Memphis, TN 38112-4892  
Michelle Stuart

Raleigh Egypt High School  
3970 Voltaire Avenue  
Memphis, TN 38128

*May 2, 2024*

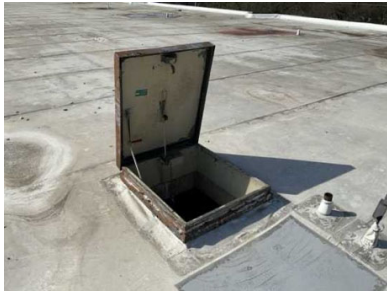
#### Roof Hatch in Failed condition.

Hatch to original roof. Broken hatch safety mechanism - AssetCALC ID: 7443918

Uniformat Code: B3060  
Recommendation: **Replace in 2024**

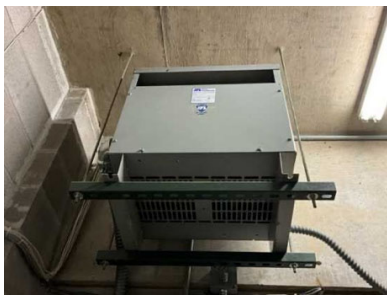
#### Secondary Transformer in Poor condition.

Electrical room - AssetCALC ID: 7455340

Uniformat Code: D5020  
Recommendation: **Replace in 2026**

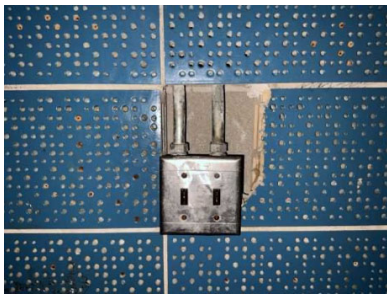
#### Wall Finishes in Poor condition.

Damage in certain bathrooms - AssetCALC ID: 7455333

Uniformat Code: C2010  
Recommendation: **Replace in 2024**

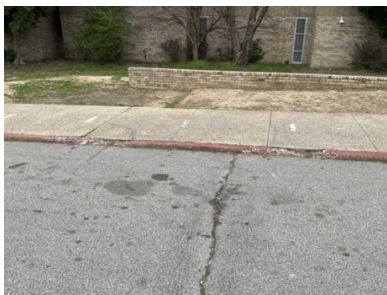
#### Parking Lots in Poor condition.

Significantly deteriorating concrete creating trip hazards - AssetCALC ID: 7443943

Uniformat Code: G2020  
Recommendation: **Repair in 2024**

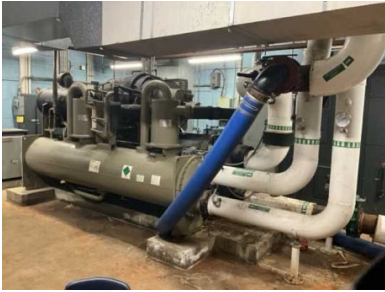
**Chiller in Poor condition.**

Not in use. Temporary chiller utilized. Scheduled to be replaced - AssetCALC ID: 7443952

Uniformat Code: D3030  
Recommendation: **Replace in 2024**

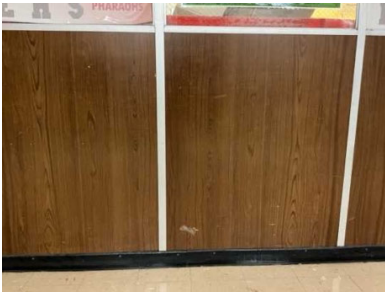
**Wall Finishes in Poor condition.**

Punctures in surface, original to construction - AssetCALC ID: 7455351

Uniformat Code: C2010  
Recommendation: **Replace in 2026**

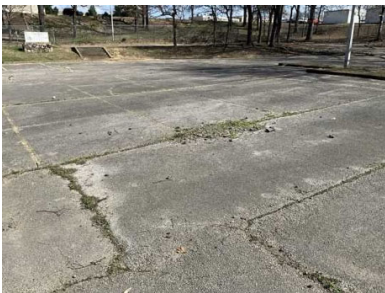
**Parking Lots in Failed condition.**

Closed off and derelict - AssetCALC ID: 7443929

Uniformat Code: G2020  
Recommendation: **Mill & Overlay in 2024**

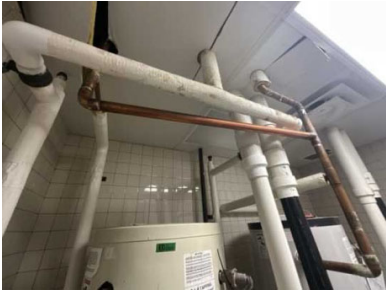
**Plumbing System in Poor condition.**

Old Fixtures, Clogs - AssetCALC ID: 7483684

Uniformat Code: D2010  
Recommendation: **Replace in 2026**

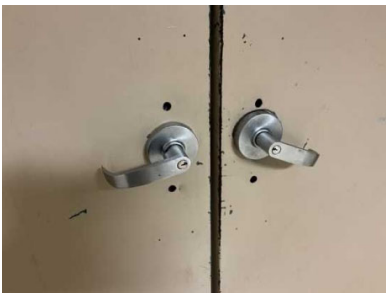
**Door Hardware in Poor condition.**

Door hardware is broken and corroded throughout the school. - AssetCALC ID: 7455343

Uniformat Code: C1030  
Recommendation: **Replace in 2026**

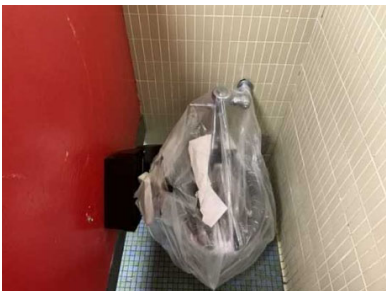
**Failed Toilet in Failed condition.**

No Longer functional clogged. - AssetCALC ID: 7443938

Uniformat Code: D2010  
Recommendation: **Replace in 2024**

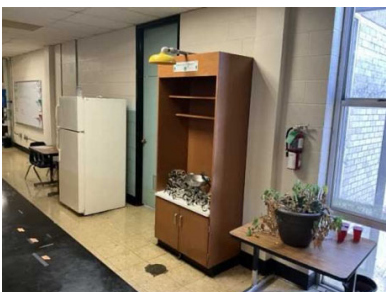
**Emergency Plumbing Fixtures in Failed condition.**

Disabled - AssetCALC ID: 7443923

Uniformat Code: D2010  
Recommendation: **Replace in 2024**

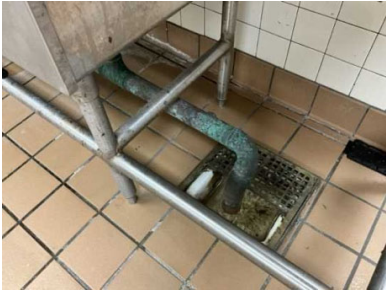
**Sink/Lavatory in Poor condition.**

In need of repair, corrosion at interior metal components - AssetCALC ID: 7443902

Uniformat Code: D2010  
Recommendation: **Replace in 2026**

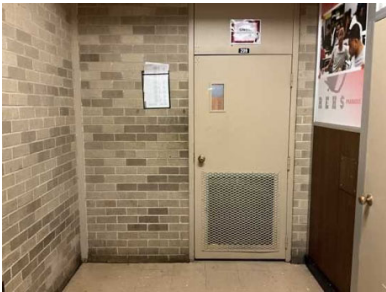
**Interior Door in Poor condition.**

All doors throughout building are in poor condition - AssetCALC ID: 7455371

Uniformat Code: C1030  
Recommendation: **Replace in 2026**

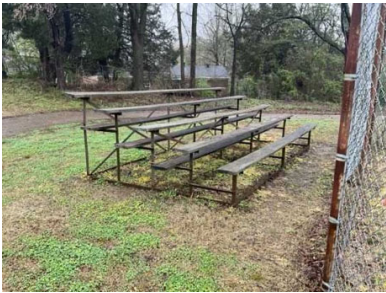
**Outdoor Spectator Seating in Poor condition.**

Rusted and bent supports coupled with deteriorating wood planks - AssetCALC ID: 7483654

Uniformat Code: G2050  
Recommendation: **Replace in 2026**

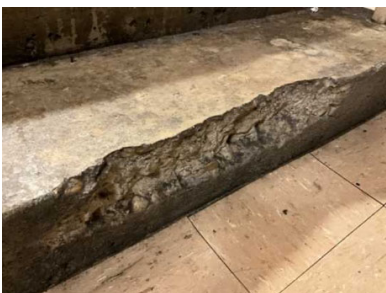
**Stair Treads in Failed condition.**

Finish has completely come off concrete stairs exposed. Need new rubber threads - AssetCALC ID: 7455364

Uniformat Code: B1080  
Recommendation: **Replace in 2024**

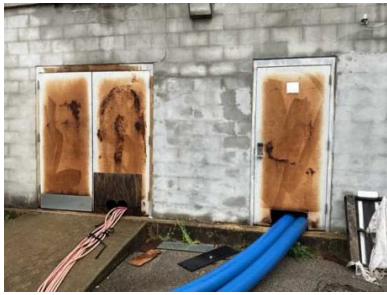
**Exterior Door in Failed condition.**

Main building, Consider sealing and installing opening for utility lines - AssetCALC ID: 7483655

Uniformat Code: B2050  
Recommendation: **Replace in 2024**

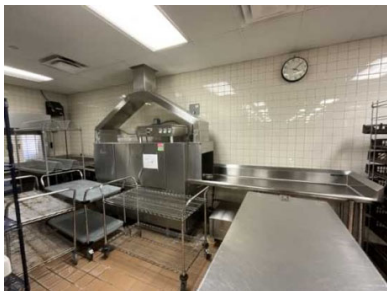
**Foodservice Equipment in Failed condition.**

Looks like it's no longer in use - AssetCALC ID: 7455352

Uniformat Code: E1030  
Recommendation: **Replace in 2024**

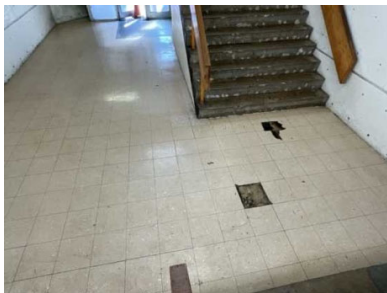
**Flooring in Poor condition.**

Stairwell - AssetCALC ID: 7455350

Uniformat Code: C2030  
Recommendation: **Replace in 2024**

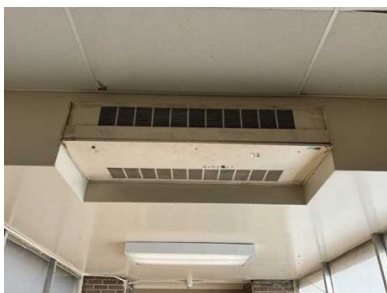
**Unit Ventilator in Poor condition.**

At the time of the assessment an HVAC tech was performing repair on all units which are significantly aged, worn, and in decline. - AssetCALC ID: 7443963

Uniformat Code: D3030  
Recommendation: **Replace in 2025**

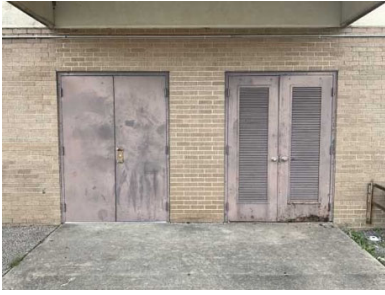
**Exterior Door in Poor condition.**

Gymnasium; corroded - AssetCALC ID: 7483662

Uniformat Code: B2050  
Recommendation: **Replace in 2026**

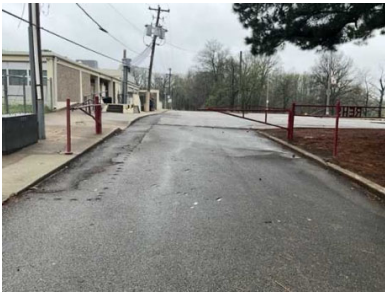
**Fences & Gates in Poor condition.**

Bollard tie down has detached - AssetCALC ID: 7483656

Uniformat Code: G2060  
Recommendation: **Replace in 2026**

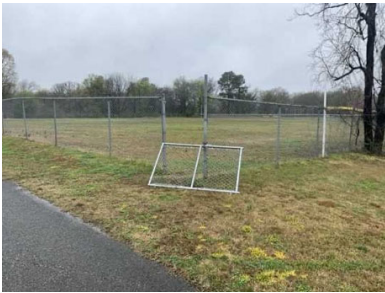
**Fences & Gates in Poor condition.**

Breaks in fence, bent and malformed posts and nets - AssetCALC ID: 7483651

Uniformat Code: G2060  
Recommendation: **Replace in 2026**

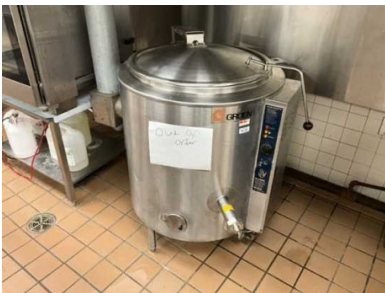
**Foodservice Equipment in Poor condition.**

Needs repair - AssetCALC ID: 7443941

Uniformat Code: E1030  
Recommendation: **Replace in 2026**

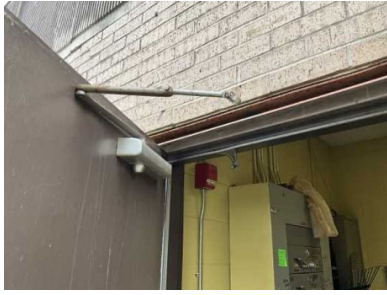
**Exterior Door in Poor condition.**

Rusted, frames detaching from brick - AssetCALC ID: 7443908

Uniformat Code: B2050  
Recommendation: **Replace in 2026**

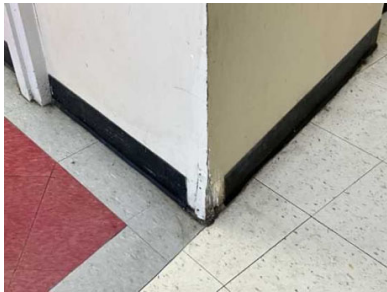
**Wall Finishes in Poor condition.**

Uniformat Code: C2010  
Recommendation: **Prep & Paint in 2026**

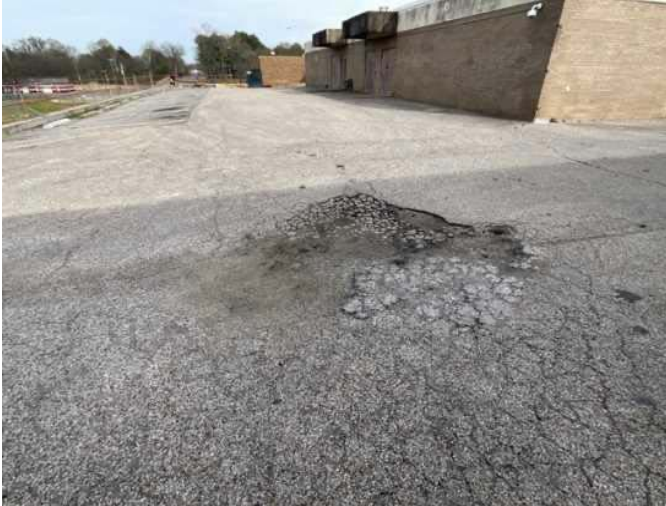
19 - TYPICAL PAVEMENT DAMAGE
