# FACILITY CONDITION ASSESSMENT

**Shelby County Board of Education**  
160 South Hollywood Street  
Memphis, Tennessee 38112-4892  
Michelle Stuart

Raleigh Egypt Middle School  
4215 Alice Ann Drive  
Memphis, Tennessee 38128

*September 30, 2024*

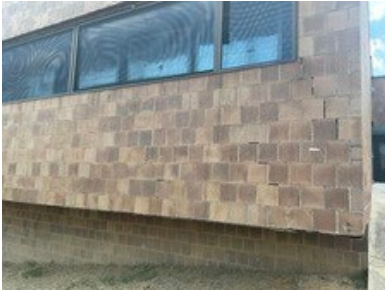
**Exterior Walls in Poor condition.**

Brick  
Raleigh Egypt Middle School Main Building  
Exterior

In various areas throughout the exterior wall the brick joints has broken or missing mortar - AssetCALC ID: 8129733

Uniformat Code: B2010  
Recommendation: **Repair/Repoint in 2024**

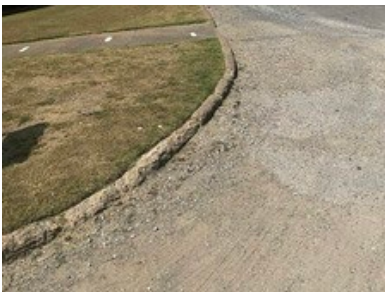
**Parking Lots in Poor condition.**

Curb and Gutter, Concrete  
Raleigh Egypt Middle School Main Building Site

Sections of the curbs are heavily deteriorated - AssetCALC ID: 8129735

Uniformat Code: G2020  
Recommendation: **Replace in 2025**

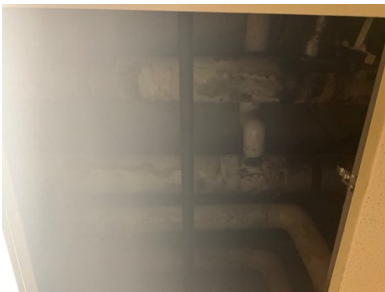
**Piping and Valves in Poor condition.**

Fiberglass Insulation, HVAC Chilled Water  
Raleigh Egypt Middle School Main Building  
Throughout Building

Condensation from pipes is leaking on to suspended ceiling tiles - AssetCALC ID: 8129746

Uniformat Code: D3050  
Recommendation: **Replace in 2025**

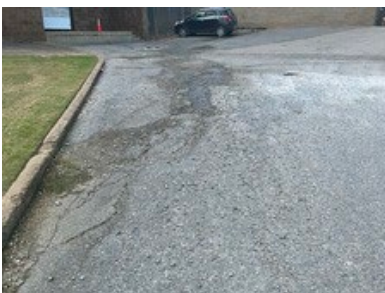
**Parking Lots in Poor condition.**

Pavement, Asphalt  
Raleigh Egypt Middle School Main Building Site

The parking lot has heavy weathering and pothole throughout its surface - AssetCALC ID: 8129739

Uniformat Code: G2020  
Recommendation: **Mill and Overlay in 2025**

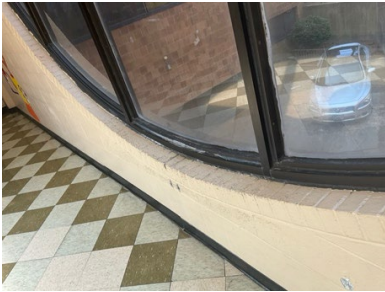
**Caulking in Poor condition.**

Window Edge/Trim, per LF  
Raleigh Egypt Middle School Annex Building  
Breezeway

Windows in breezeway leaks when it rains. - AssetCALC ID: 8129916

Uniformat Code: B2010  
Recommendation: **Replace in 2024**

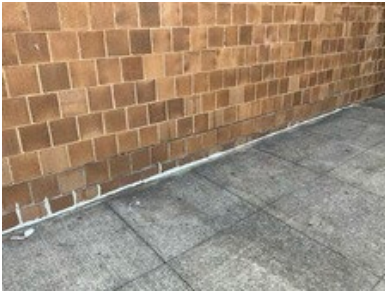
The exterior wall is in poor condition. A section if the exterior wall is bulging and missing mortar. A professional engineer must be retained to analyze the existing condition, provide recommendations and, if necessary, estimate the scope and cost of any required repairs. Due to the ambiguity of the required repair scope at the time of this assessment, the cost for any possible subsequent repairs is not included.

**Recommended Follow-up Study: Structural, General Design**

Structural, General Design  
Raleigh Egypt Middle School Main Building  
Exterior

The bottom wall is building and missing mortar. I'm not sure it's a structural defect and a general repair - AssetCALC ID: 8129760

Uniformat Code: P2030  
Recommendation: **Design in 2024**

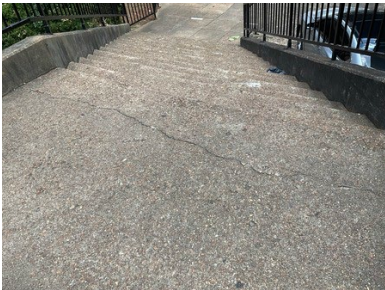
**Stairs in Poor condition.**

Concrete/Masonry, Exterior  
Raleigh Egypt Middle School Main Building  
Exterior

Some stairs are broken and cracked in isolated areas - AssetCALC ID: 8129747

Uniformat Code: B1080  
Recommendation: **Repair in 2024**

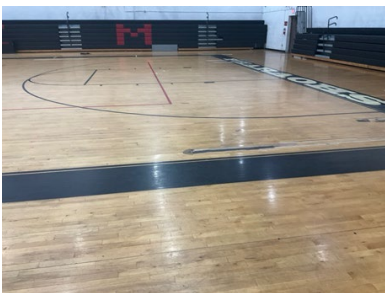
**Flooring in Poor condition.**

Maple Sports Floor  
Raleigh Egypt Middle School Main Building  
Gymnasium

The gym floor has worn areas throughout it's surface. - AssetCALC ID: 8129696

Uniformat Code: C2030  
Recommendation: **Replace in 2025**

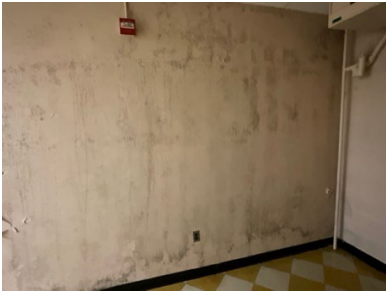
The interior wall is in poor condition. The wall in and around stairwell C has suspected mold growth. A professional consultant must be retained to analyze the existing condition, provide recommendations and, if necessary, estimate the scope and cost of any required repairs. The cost of this study is included in the cost tables. A budgetary cost allowance to repair for mold remediation is also included.

**Recommended Follow-up Study:  
Environmental, Remediation of  
Suspect Fungal Growth**

Environmental, Remediation of Suspect Fungal Growth  
Raleigh Egypt Middle School Main Building  
Stairwell 2C

The stairwell and walls has fungal growth - AssetCALC ID: 8129743

Uniformat Code: P2030  
Recommendation: **Remove in 2024**

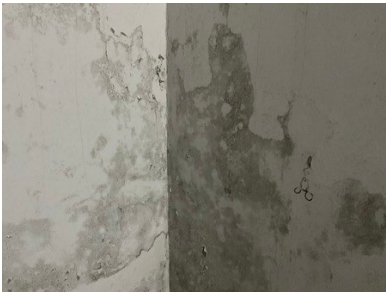
**Recommended Follow-up Study:  
Environmental, Analysis of  
Suspect Fungal Growth**

Environmental, Analysis of Suspect Fungal Growth  
Raleigh Egypt Middle School Main Building  
Stairwell 2C

It was reported that mildew or mold caused by poor air quality - AssetCALC ID: 8129725

Uniformat Code: P2030  
Recommendation: **Evaluate/Report in 2024**
