# FACILITY CONDITION ASSESSMENT

**Shelby County Board of Education**  
160 South Hollywood Street  
Memphis, Tennessee 38112-4892  
Michelle Stuart

Richland Elementary  
5440 Rich Road  
Memphis, Tennessee 38120

November 1, 2024

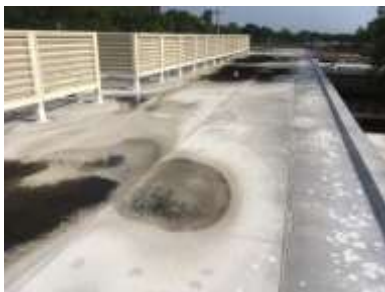
### Recommended Follow-up Study: Civil, Site Drainage

The site drainage system is in poor condition. Typical rain events lead to ponding, while heavy rain events leading to flooding within the school. A professional engineer must be retained to analyze the existing condition, provide recommendations and, if necessary, estimate the scope and cost of any required repairs. The cost of this study is included in the cost tables.

Ongoing flooding and ponding - AssetCALC ID: 8023790

Uniformat Code: P2030  
Recommendation: **Evaluate/Report in 2024**

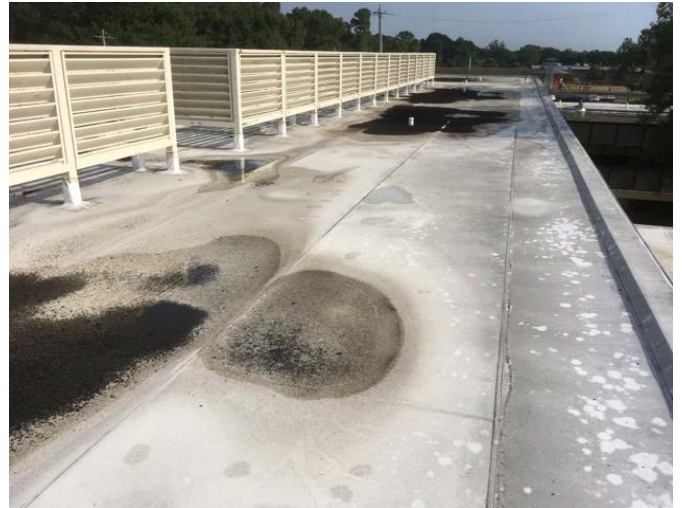
Excessive ponding on the roof has led to multiple areas of vegetation growth and ongoing roof leaks. It is recommended to hire a registered architect to ascertain the existing conditions and explore options for remediation. Due to the ambiguity of the required repair scopes at the time of this assessment, the cost for any possible subsequent repairs is not included.

8 - ROOFING, PONDING ISSUE
