# FACILITY CONDITION ASSESSMENT

**Shelby County Board of Education**  
160 South Hollywood Street  
Memphis, Tennessee 38112-4892  
Michelle Stuart

Riverview Elementary and Middle School  
241 Majuba Avenue  
Memphis, Tennessee 38109

*September 30, 2024*

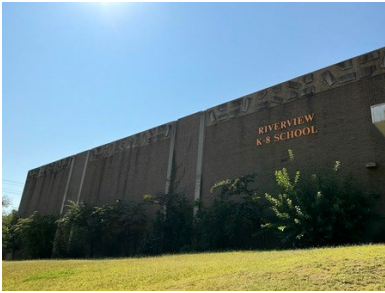
#### Exterior Walls in Poor condition.

Brick  
Riverview Elementary and Middle School  
Building Exterior

Needs to be cleaned, repoint, and sealed - AssetCALC ID: 8121829

Uniformat Code: B2010  
Recommendation: **Repair/Repoint in 2024**

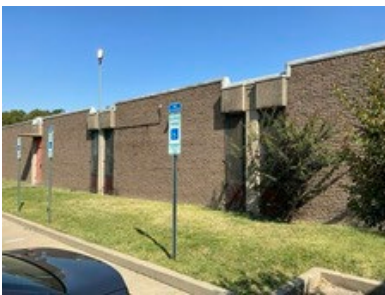
#### Glazing in Poor condition.

Any Type, by SF  
Riverview Elementary and Middle School  
Building Exterior

Beyond useful life with failed seals and broken panes - AssetCALC ID: 8121822

Uniformat Code: B2020  
Recommendation: **Replace in 2026**

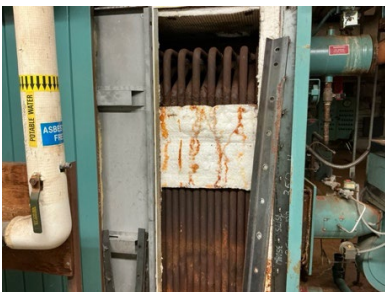
#### Boiler in Failed condition.

Gas, HVAC  
Riverview Elementary and Middle School Boiler  
Room

Unit is not functional and currently out of commission - AssetCALC ID: 8121810

Uniformat Code: D3020  
Recommendation: **Replace in 2024**

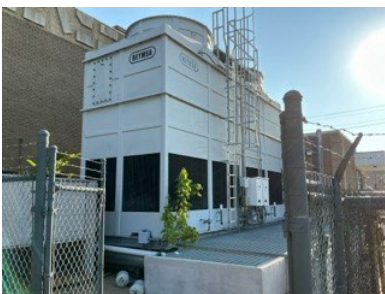
#### Cooling Tower in Failed condition.

(Typical) Open Circuit  
Riverview Elementary Middle School Rear  
elevation

Has not been functional in some years per POC - AssetCALC ID: 8121854

Uniformat Code: D3030  
Recommendation: **Replace in 2024**

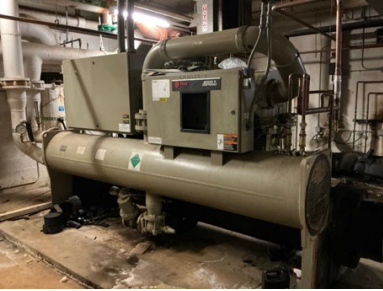
**Chiller in Poor condition.**

Water-Cooled  
Riverview Elementary and Middle School  
Mechanical Room

This unit is one of two and reported to not be functioning, and appears dismantled. - AssetCALC ID: 8121815

Uniformat Code: D3030  
Recommendation: **Replace in 2024**

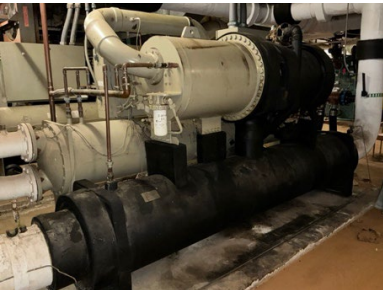
**Chiller in Poor condition.**

Water-Cooled  
Riverview Elementary and Middle School Boiler  
Room

This unit is one of two and reported to not be functioning, and appears dismantled. - AssetCALC ID: 8121838

Uniformat Code: D3030  
Recommendation: **Replace in 2026**

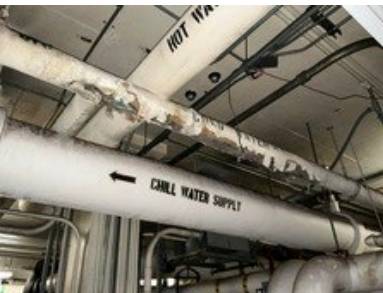
**HVAC System in Poor condition.**

Hydronic Piping, 2-Pipe  
Riverview Elementary and Middle School Boiler  
Room

Numerous leaks reported on extremely corroded and uninsulated pipe - AssetCALC ID: 8121847

Uniformat Code: D3050  
Recommendation: **Replace in 2026**

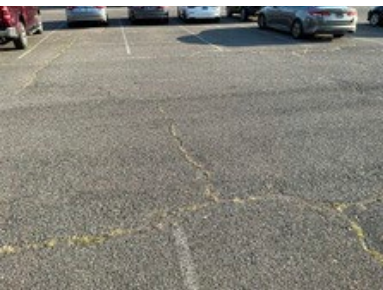
**Parking Lots in Poor condition.**

Pavement, Asphalt  
Riverview Elementary and Middle School Site

Faded beyond usefulness - AssetCALC ID: 8121816

Uniformat Code: G2020  
Recommendation: **Seal and Stripe in 2025**

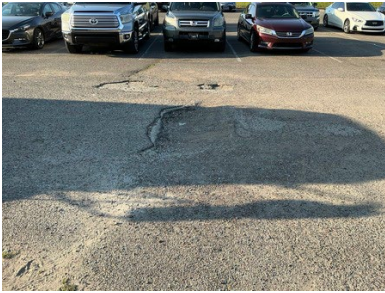
**Parking Lots in Poor condition.**

Pavement, Asphalt  
Riverview Elementary and Middle School Site

Cracking throughout, failed patchwork - AssetCALC ID: 8121820

Uniformat Code: G2020  
Recommendation: **Mill and Overlay in 2025**

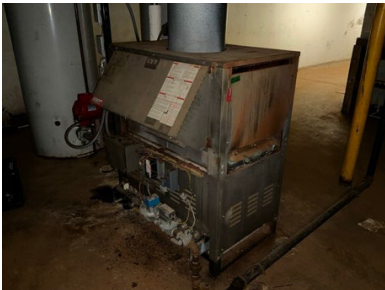
**Boiler in Poor condition.**

Gas, Domestic  
Riverview Elementary and Middle School Boiler Room

Rusted components and not warm to the touch suggests it isn't functional - AssetCALC ID: 8121832

Uniformat Code: D2010  
Recommendation: **Replace in 2026**

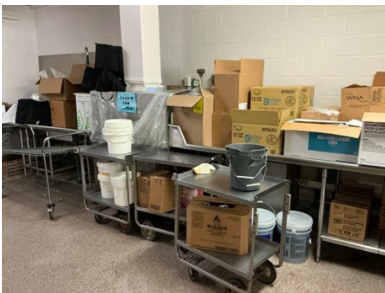
**Foodservice Equipment in Failed condition.**

Dishwasher Commercial  
Riverview Elementary and Middle School Kitchen

Uniformat Code: E1030  
Recommendation: **Replace in 2024**

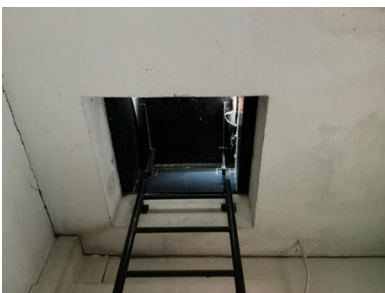
**Roof Hatch in Failed condition.**

Metal  
Riverview Elementary and Middle School Roof

Will not close properly and mechanism is missing - AssetCALC ID: 8121824

Uniformat Code: B3060  
Recommendation: **Replace in 2024**

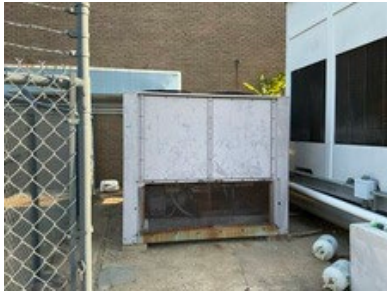
**Split System in Poor condition.**

Condensing Unit/Heat Pump  
Riverview Elementary and Middle School Rear  
Elevation

May not be functional and conjunction with the cooling tower that is also not functioning - AssetCALC ID: 8121845

Uniformat Code: D3030  
Recommendation: **Replace in 2025**

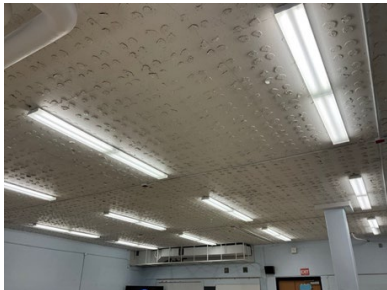
The ceilings within the building have had hard tile removed from the ceilings and remnants of the adhesive materials remain. There are areas throughout where this is exposed and not covered with paint. A professional consultant must be retained to analyze the existing condition, provide recommendations and, if necessary, estimate the scope and cost of any required repairs.

**Recommended Follow-up Study:  
Environmental, Asbestos (ACM)  
and Lead Base Paint (LBP)**

Environmental, Asbestos (ACM) and Lead  
Base Paint (LBP)  
Riverview Elementary and Middle School PreK

Uniformat Code: P2030  
Recommendation: **Evaluate/Report in 2024**
