FACILITY CONDITION ASSESSMENT

Robert R. Church Elementary
4100 Millbranch Road
Memphis, Tennessee 38116

163745.23R000-166.354

September 30, 2024

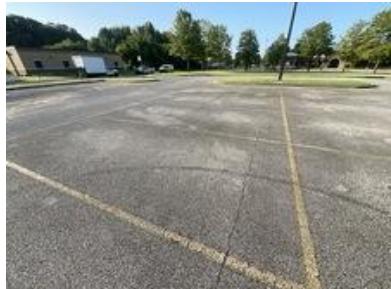
Pavement, Asphalt
Robert R. Church Elementary Site

Much of the site is primarily open grassy fields with asphalt parking lots surrounding the building. The parking lots are worn with significant loss to striping and topcoat with webbing and damage to the asphalt. The grounds are illuminated via pole and building mounted lighting.

Parking Lots in Poor condition.

Faded - AssetCALC ID: 7956425

Uniformat Code: G2020
Recommendation: **Seal and Stripe in 2025**

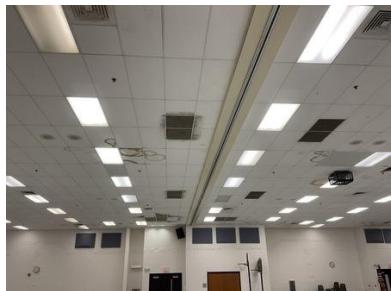
Acoustical Tile (ACT)
Robert R. Church Elementary Throughout Building

Suspended Ceilings in Poor condition.

Stained - AssetCALC ID: 7956427

Uniformat Code: C1070
Recommendation: **Replace in 2025**
