FACILITY CONDITION ASSESSMENT

Shelby County Board of Education 160 South Hollywood Street Memphis, Tennessee 38112-4892 Michelle Stuart

Rozelle Elementary School 993 Roland Street Memphis, Tennessee 38114

March 8, 2024

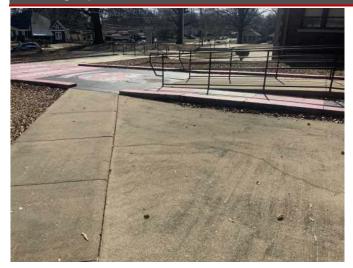
19 - SIDEWALK

The Backstop fence is missing pieces, appears not in use. The retaining wall is rotten and falling apart. The north stairwell has roots growing into it, it appears not required. The sidewalk is starting to crack. There are areas that require raising of the soil near the sidewalks.

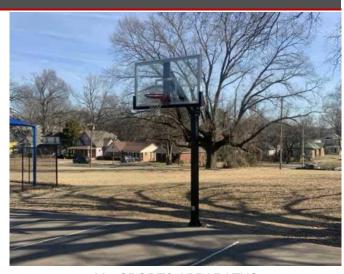
20 - SPORTS APPARATUS

Sports Apparatus in Poor condition.

Not in use, fence sections missing, loose - AssetCALC ID: 7409871

Recommendation: Replace in 2024

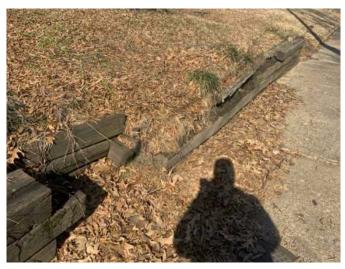
23 - RETAINING WALL

Retaining Wall in Poor condition.

Recommendation: Replace in 2026
