# FACILITY CONDITION ASSESSMENT

**Shelby County Board of Education**  
160 South Hollywood Street  
Memphis, Tennessee 38112-4892  
Michelle Stuart

Scenic Hills Elementary  
3450 Scenic Highway  
Memphis, Tennessee 38128

*April 15, 2024*

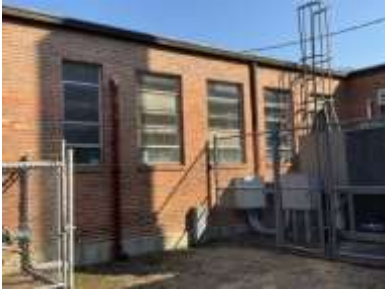
### Window in Poor condition.

Aluminum Single-Glazed, 16-25 SF  
Scenic Hills Elementary Building Exterior

Many windows are failing. Modernize windows throughout. - AssetCALC ID: 7376798

Uniformat Code: B2020  
Recommendation: **Replace in 2026**

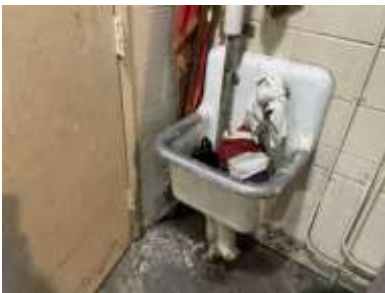
### Sink/Lavatory in Poor condition.

Wall-Hung, Vitreous China  
Scenic Hills Elementary Mechanical room

Advanced wear on surfaces - AssetCALC ID: 7385014

Uniformat Code: D2010  
Recommendation: **Replace in 2026**

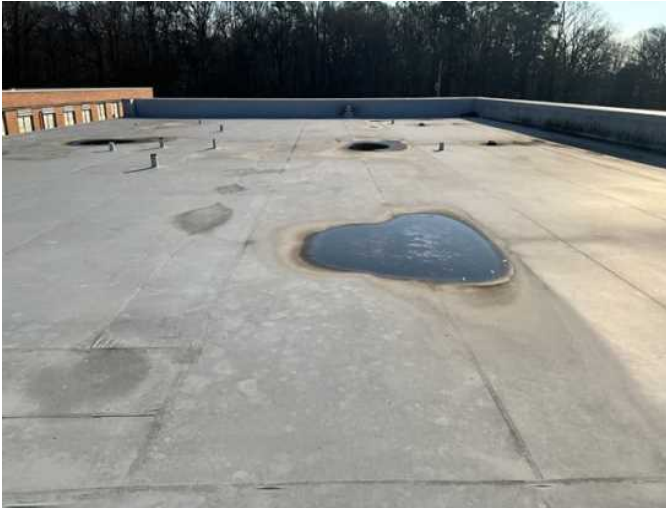
7 - ROOF

The flat EPDM roof appears to have been installed in 2000 and is near the end of its useful life. Interior finishes are mainly VCT floors, painted gypsum wall, painted CMU walls, and a suspended ceiling tile system. Exterior walls are brick with some areas needing repair and repointing. Exterior windows appear original and glass panes in many locations have been replaced with plexiglass, which has deteriorated over time.

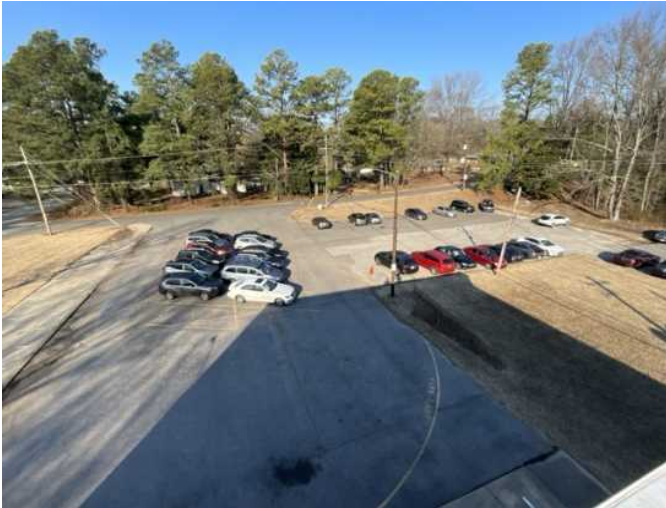
13 - PARKING LOT

The site has a small portion of moderate slope from north to south. Asphalt pavement is very worn. There is a basketball court on the site with hoops damaged and the upper playground baseball field has fallen into disrepair.
