FACILITY CONDITION ASSESSMENT

Sharpe Elementary
3431 Sharpe Avenue
Memphis, Tennessee 38111

DATE OF REPORT:
April 22, 2024

ON SITE DATE:
January 30, 2024

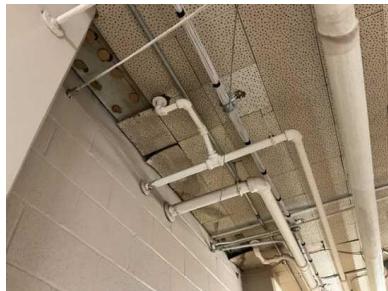
Suspended Ceilings in Failed condition.

Hard Tile, Replacement with ACT
Sharpe Elementary School

Asbestos adhesive used. Drop tile needed to contain asbestos - AssetCALC ID: 7335528

Recommendation: **Replace in 2024**

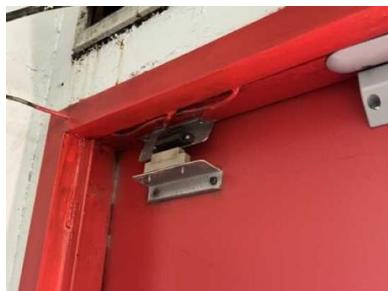
Exterior Door in Poor condition.

Steel, Standard
Sharpe Elementary School Building Exterior

The closer is broken and security sensor is not working - AssetCALC ID: 7341586

Recommendation: **Replace in 2024**

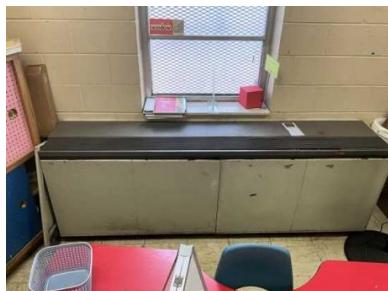
Unit Ventilator in Poor condition.

approx/nominal 3 Ton
Sharpe Elementary School Addition
Classrooms

Several issues across all units. Broken dampers and enclosures. Children can open unit enclosures. - AssetCALC ID: 7335539

Recommendation: **Replace in 2024**

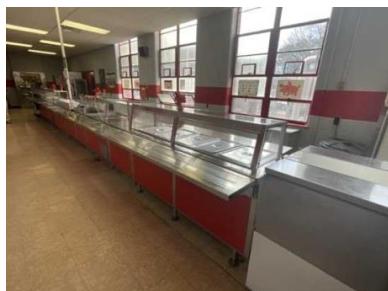
Commercial Kitchen in Poor condition.

Service Line
Sharpe Elementary School Kitchen

Steamer tables leaking gas. - AssetCALC ID: 7335544

Recommendation: **Replace in 2024**

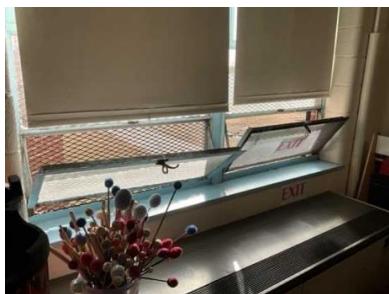
Window in Poor condition.

Steel, 28-40 SF
Sharpe Elementary School Building Exterior

Window seals & frames are failing. Windows are no longer operable. Original to building, replace. -
AssetCALC ID: 7335551

Uniformat Code: B2020
Recommendation: **Replace in 2025**

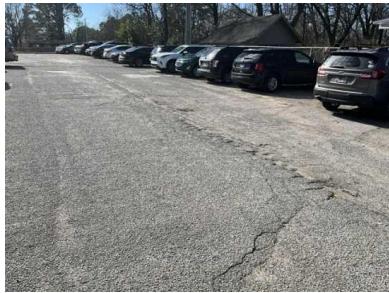
Parking Lots in Poor condition.

Pavement, Asphalt
Sharpe Elementary School Site

Potholes, cracking, asphalt has extensive & significant wear, loose & worn aggregate. - AssetCALC ID: 7335529

Uniformat Code: G2020
Recommendation: **Mill and Overlay in 2025**

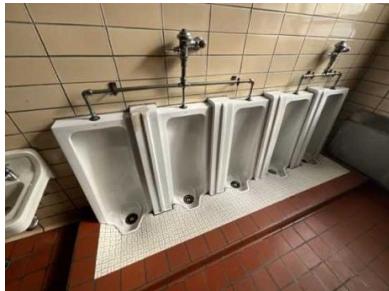
Urinal in Poor condition.

Standard
Sharpe Elementary School Second floor
Restroom

Very inefficient urinals all flush simultaneously when one is used. Original 1955 urinals. Porcelain chipping. -
AssetCALC ID: 7335520

Uniformat Code: D2010
Recommendation: **Replace in 2025**

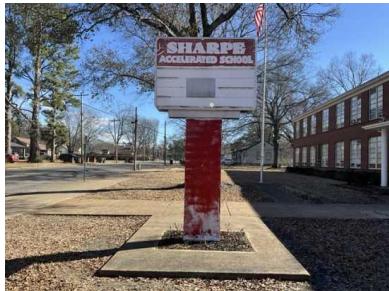
Signage in Failed condition.

Property, Monument
Sharpe Elementary School Site

Bullet holes, faded paint, can no longer post letters on sign. - AssetCALC ID: 7335535

Uniformat Code: G2060
Recommendation: **Replace/Install in 2024**

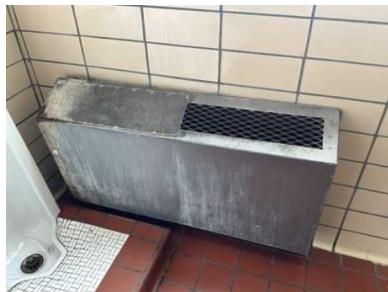
Radiator in Failed condition.

Hydronic, Baseboard (per LF)
Sharpe Elementary School Restrooms

Damaged unit - AssetCALC ID: 7335567

Uniformat Code: D3020
Recommendation: **Replace in 2024**

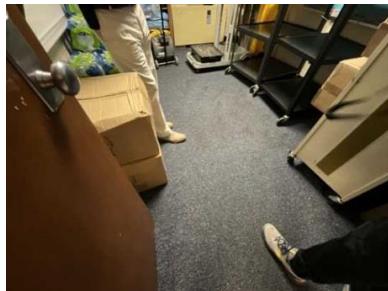
Flooring in Failed condition.

Carpet, Commercial Standard
Sharpe Elementary School Additional

Possible mold from prior flooding. - AssetCALC ID: 7341577

Uniformat Code: C2030
Recommendation: **Replace in 2024**

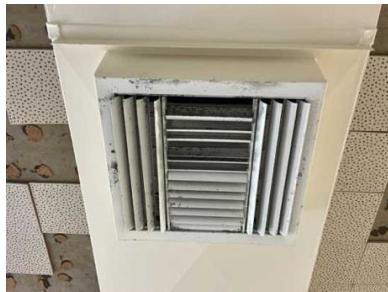
HVAC System in Poor condition.

Ductwork, Medium Density
Sharpe Elementary School Throughout building

Black dust and possible mold seen at supply/return grilles. - AssetCALC ID: 7335536

Uniformat Code: D3050
Recommendation: **Replace in 2025**

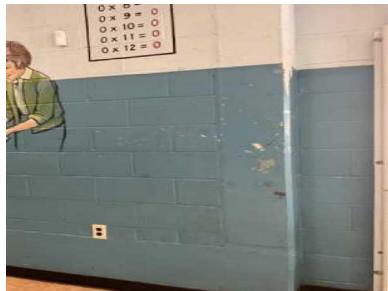
Wall Finishes in Poor condition.

any surface
Sharpe Elementary School Cafeteria

Needs new paint - AssetCALC ID: 7341570

Uniformat Code: C2010
Recommendation: **Prep and Paint in 2026**

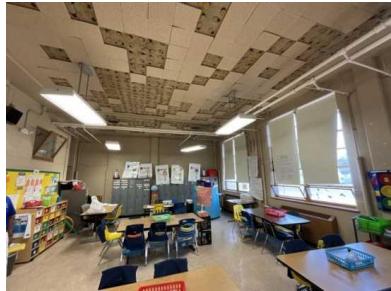
Recommended Follow-up Study: Environmental, Asbestos (ACM) and Lead Base Paint (LBP)

Environmental, Asbestos (ACM) & Lead Base
Paint (LBP)
Sharpe Elementary School Throughout

Uniformat Code: P2030
Recommendation: **Evaluate/Report in 2024**
