# FACILITY CONDITION ASSESSMENT

**Shelby County Board of Education**  
160 South Hollywood Street  
Memphis, Tennessee 38112-4892  
Michelle Stuart

Sheffield High School  
4315 Sheffield Avenue  
Memphis, Tennessee 38118

October 17, 2024

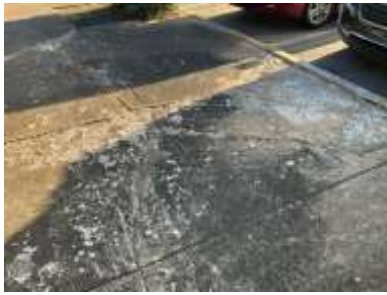
### Sidewalk in Poor condition.

Concrete, Small Areas/Sections  
Site Sheffield High School Site

Sections of the sidewalks are cracked and heavily deteriorated - AssetCALC ID: 8351437

Uniformat Code: G2030  
Recommendation: **Replace in 2026**

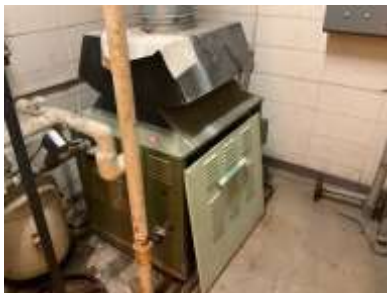
### Boiler in Failed condition.

Gas, Domestic  
Gymnasium B Sheffield High School Utility  
Rooms/Areas

The unit is not in service - AssetCALC ID: 8351606

Uniformat Code: D2010  
Recommendation: **Replace in 2024**

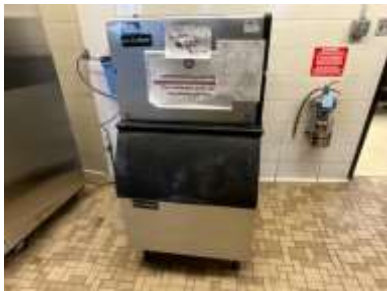
### Foodservice Equipment in Failed condition.

Icemaker, Freestanding  
Main Building Sheffield High School Kitchen

The ice machine is out of service - AssetCALC ID: 8324855

Uniformat Code: E1030  
Recommendation: **Replace in 2024**

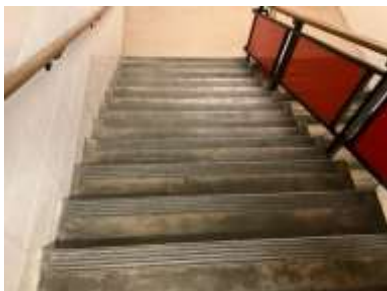
### Stairs in Poor condition.

Concrete/Masonry, Interior  
Main Building Sheffield High School  
Throughout Building

Stairs are chipped throughout the building - AssetCALC ID: 8324872

Uniformat Code: B1080  
Recommendation: **Repair in 2024**

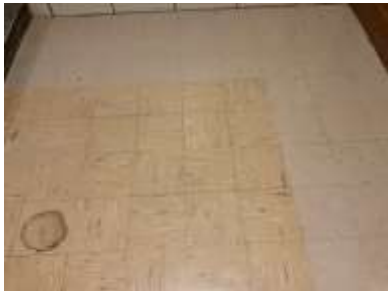
**Recommended Follow-up Study:  
Environmental, Asbestos (ACM)  
and Lead Base Paint (LBP)**

Environmental, Asbestos (ACM) and Lead  
Base Paint (LBP)  
Main Building Sheffield High School  
Throughout Building

Unifomat Code: P2030  
Recommendation: **Evaluate/Report in 2024**
