FACILITY CONDITION ASSESSMENT

Shelby Oaks Elementary
6053 Summer Avenue
Memphis, Tennessee 38134

September 30, 2024

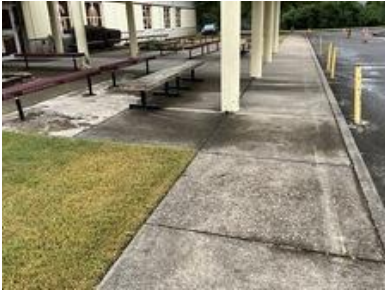
Sidewalk in Poor condition.

Concrete, Large Areas
Shelby Oaks Elementary Site

Observe cracks, pocking heaving - AssetCALC ID: 8029317

Uniformat Code: G2030
Recommendation: **Replace in 2026**

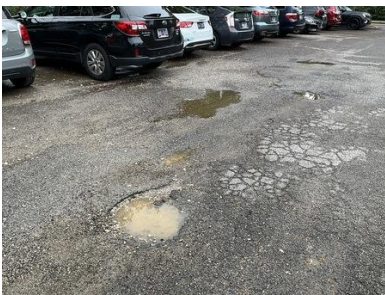
Parking Lots in Poor condition.

Pavement, Asphalt
Shelby Oaks Elementary Site

Alligator cracking, ponding observed - AssetCALC ID: 8029362

Uniformat Code: G2020
Recommendation: **Mill and Overlay in 2025**

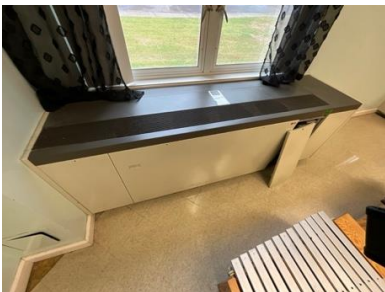
Unit Ventilator in Poor condition.

approx/nominal 2 Ton
Shelby Oaks Elementary Classroom 137

Uniformat Code: D3030
Recommendation: **Replace in 2024**
