FACILITY CONDITION ASSESSMENT

Sherwood Elementary School
1156 Robin Hood Lane
Memphis, Tennessee 38111

163745.23R000-055.354

January 12, 2024

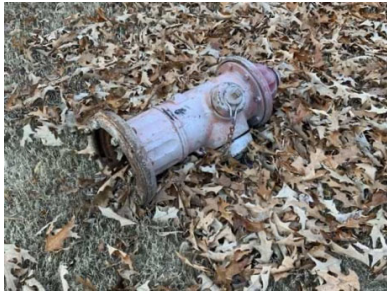
Hydrant in Failed condition.

Fire
Sherwood Elementary School Site

Broken off - AssetCALC ID: 7172700

Uniformat Code: G3010
Recommendation: **Replace/Install in 2023**

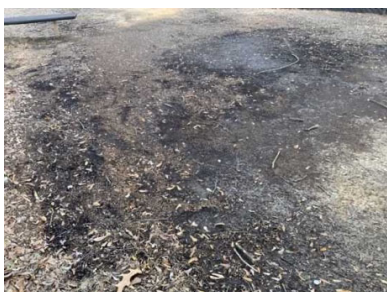
Playfield Surfaces in Failed condition.

Chips Wood, 6" Depth
Sherwood Elementary School Site

Mostly bare dirt, roots exposed - AssetCALC ID: 7172752

Uniformat Code: G2050
Recommendation: **Replace in 2023**

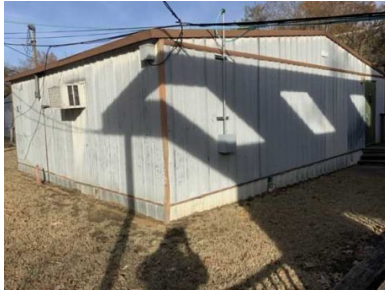
Ancillary Building in Poor condition.

Classroom/Office Module, Basic/Portable
Sherwood Elementary School Site

Scheduled to be removed over December break - AssetCALC ID: 7172776

Uniformat Code: F1020
Recommendation: **Replace in 2023**

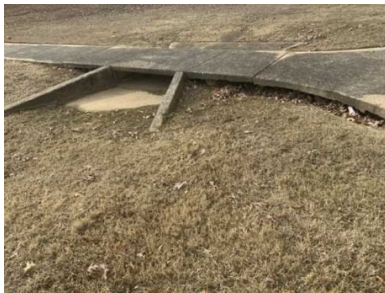
Landscaping in Poor condition.

Turf/Sod
Sherwood Elementary School Site

Uniformat Code: G2080
Recommendation: **Replace/Install in 2025**

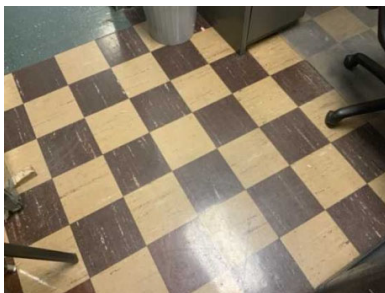
Recommended Follow-up Study: Environmental, Asbestos (ACM) and Lead Base Paint (LBP)

Environmental, Asbestos (ACM) and Lead
Base Paint (LBP)
Sherwood Elementary School Throughout
building

Possible asbestos tile, mastic and lead paint - AssetCALC ID: 7172658

Uniformat Code: P2030
Recommendation: **Evaluate/Report in 2023**

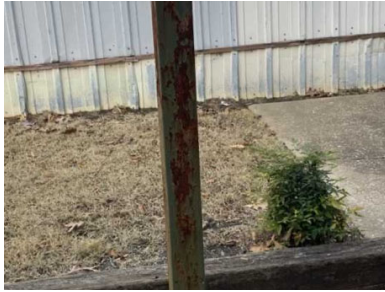
Balcony Structure in Poor condition.

Vertical Column Steel
Sherwood Elementary School Building exterior

Rusting flaking of paint and metal - AssetCALC ID: 7172756

Uniformat Code: B1010
Recommendation: **Replace in 2025**

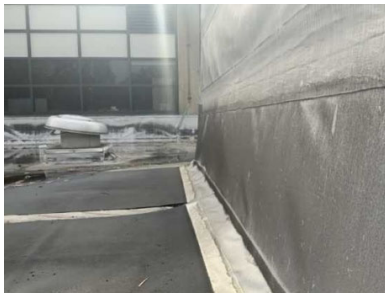
Roofing in Poor condition.

Single-Ply Membrane, TPO/PVC
Sherwood Elementary School Roof

Age related - AssetCALC ID: 7172782

Uniformat Code: B3010
Recommendation: **Replace in 2025**

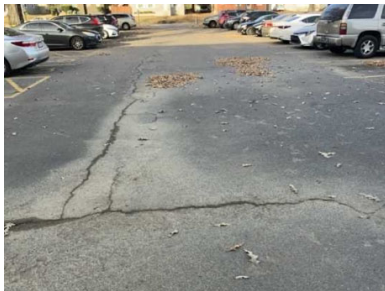
Parking Lots in Poor condition.

Pavement, Asphalt
Sherwood Elementary School Site

Some cracking, broken out area in circle - AssetCALC ID: 7172689

Uniformat Code: G2020
Recommendation: **Mill and Overlay in 2025**

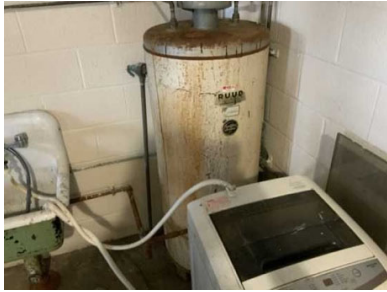
Water Heater in Poor condition.

Gas, Residential
Sherwood Elementary School Boiler room

Rusting out jacket, very old - AssetCALC ID: 7172765

Uniformat Code: D2010
Recommendation: **Replace in 2025**

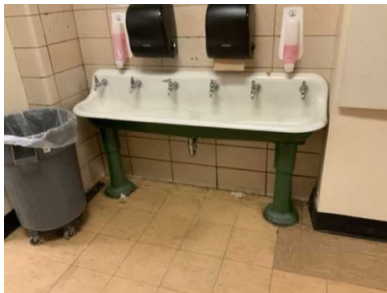
Sink/Lavatory in Poor condition.

Trough Style, Solid Surface
Sherwood Elementary School Hallway

Cast iron, faucets leaking - AssetCALC ID: 7172781

Uniformat Code: D2010
Recommendation: **Replace in 2025**

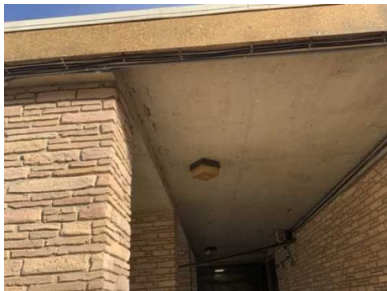
Soffit in Poor condition.

Stucco
Sherwood Elementary School Roof

Cracked, broken out pieces - AssetCALC ID: 7172717

Uniformat Code: B3080
Recommendation: **Replace in 2025**

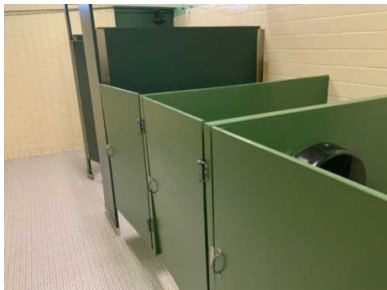
Toilet Partitions in Poor condition.

Wood
Sherwood Elementary School Restrooms

Wooden, plastic partitions broken in areas, ADA some pushed inside so no swing - AssetCALC ID: 7172736

Uniformat Code: C1090
Recommendation: **Replace in 2025**

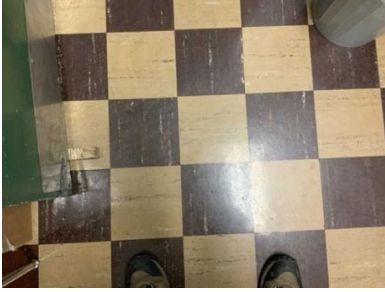
**Flooring in Poor condition.**

Vinyl Tile (VCT), with Asbestos Abatement
Sherwood Elementary School Office

Possible asbestos, worn - AssetCALC ID: 7172684

Uniformat Code: C2030
Recommendation: **Replace in 2025**
