# FACILITY CONDITION ASSESSMENT

**Shelby County Board of Education**  
160 South Hollywood Street  
Memphis, Tennessee 38112-4892  
Michelle Stuart

Sherwood Middle School  
3480 Rhodes Avenue  
Memphis, Tennessee 38111

*January 18, 2024*

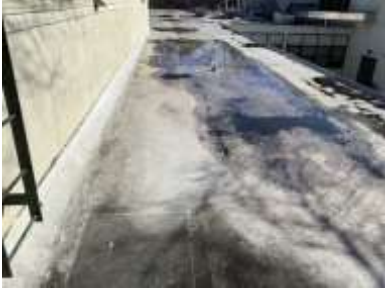
### Roofing in Poor condition.

any type, Repairs per Man-Day  
Sherwood Middle School Roof

Excessive ponding was observed on the second level roof. - AssetCALC ID: 7179656

Uniformat Code: B3010  
Recommendation: **Repair in 2023**

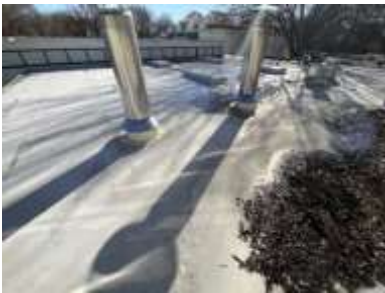
### Roofing in Poor condition.

Single-Ply Membrane, TPO/PVC  
Sherwood Middle School Roof

The TPO was observed to have significant ponding, cracking and leaks throughout the building. - AssetCALC ID: 7178059

Uniformat Code: B3010  
Recommendation: **Replace in 2024**

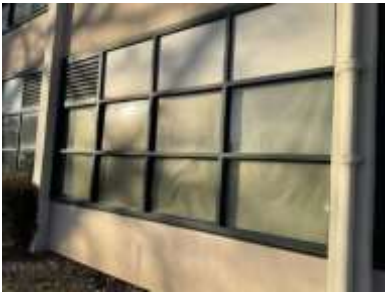
### Glazing in Poor condition.

any type by SF  
Sherwood Middle School Throughout building

Exterior windows were observed to be in poor condition. - AssetCALC ID: 7178153

Uniformat Code: B2020  
Recommendation: **Replace in 2024**

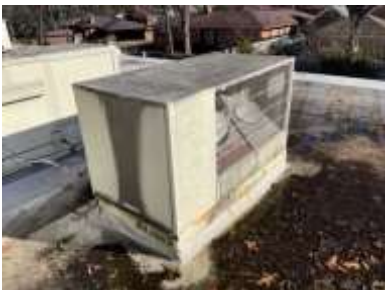
### Exhaust Fan in Poor condition.

Propeller, 0.75 HP Motor  
Sherwood Middle School Roof

Barely in operational conditions. - AssetCALC ID: 7178173

Uniformat Code: D3060  
Recommendation: **Replace in 2025**

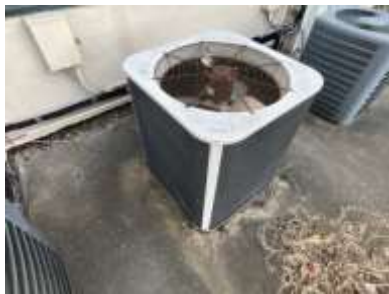
**Split System in Poor condition.**

Condensing Unit/Heat Pump  
Sherwood Middle School Building exterior

Significant rusting and outdated components were observed. - AssetCALC ID: 7178084

Uniformat Code: D3030  
Recommendation: **Replace in 2024**
