# FACILITY CONDITION ASSESSMENT

Springdale Elementary  
880 North Hollywood Street  
Memphis, Tennessee 38108

*163745.23R000-182.354*

*May 10, 2024*

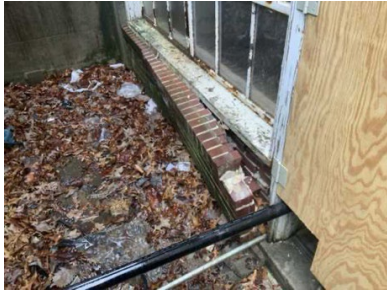
### Exterior Walls in Failed condition.

Likely damaged as part of temporary boiler connection - AssetCALC ID: 7369934

Uniformat Code: B2010  
Recommendation: **Repair/Repoint in 2024**

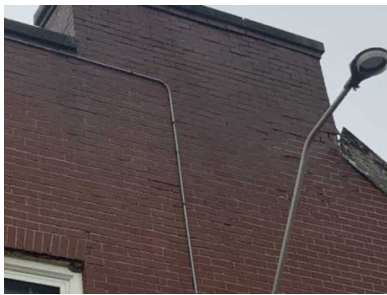
### Exterior Walls in Poor condition.

Water damaged in areas - AssetCALC ID: 7369875

Uniformat Code: B2010  
Recommendation: **Repair/Repoint in 2024**

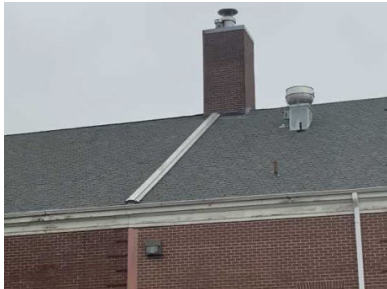
### Roofing in Poor condition.

Roof has leaks Plywood deck boards failed in areas - AssetCALC ID: 7369927

Uniformat Code: B3010  
Recommendation: **Replace in 2026**

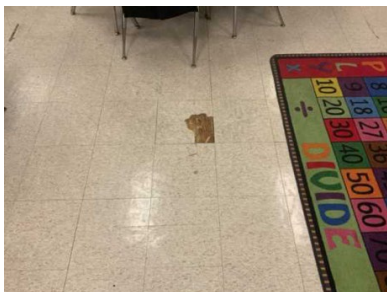
### Structural Flooring/Decking in Poor condition.

There are high spots in the sub flooring, causing tiles to crack and break. Visible in west side classrooms - AssetCALC ID: 7369940

Uniformat Code: B1010  
Recommendation: **Refinish in 2026**

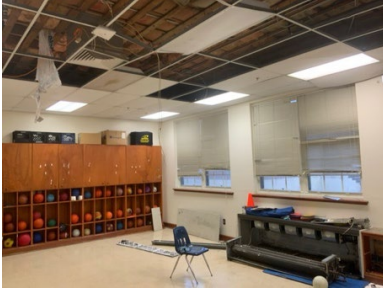
## Roofing in Poor condition.

Roof leaks - AssetCALC ID: 7369928

Uniformat Code: B3010  
Recommendation: **Replace in 2026**

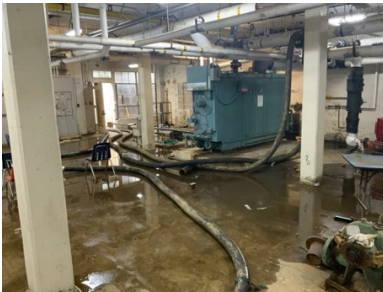
## Boiler in Failed condition.

Being replaced - AssetCALC ID: 7541341

Uniformat Code: D3020  
Recommendation: **Replace in 2024**

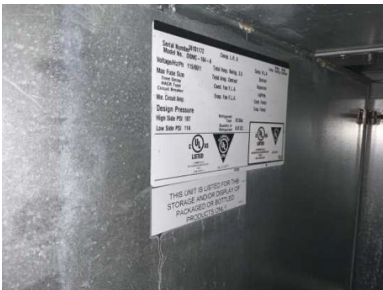
## Foodservice Equipment

Out of service - AssetCALC ID: 7369954

Uniformat Code: E1030  
Recommendation: **Replace in 2024**

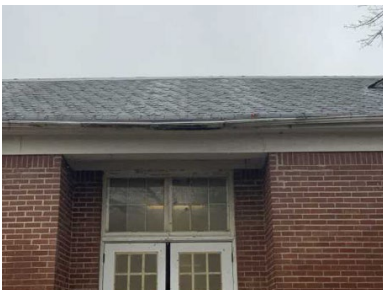
## Recommended Follow-up Study: Building Envelope, Roof

Dry rotten wood, failed gutters, missing fascia and soffits. Water leaking into walls and building - AssetCALC ID: 7371670

The Roof system is in failed condition. There are areas of dry rotted wood on the soffit and fascia, areas with both missing and water leaking into the walls of the building. A professional engineer must be retained to analyze the existing condition, provide recommendations and, if necessary, estimate the scope and cost of any required repairs. The cost of this study is included in the cost tables. Due to the ambiguity of the required repair scope at the time of this assessment, the cost for any possible subsequent repairs is not included.

Uniformat Code: P2030  
Recommendation: **Evaluate/Report in 2024**

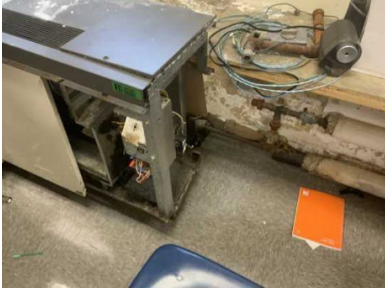
### Unit Ventilator in Failed condition.

Disconnect pulled away from wall - AssetCALC ID: 7369861

Uniformat Code: D3030  
Recommendation: **Replace in 2024**

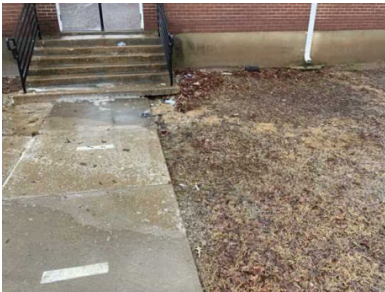
### Landscaping in Poor condition.

Washout or depressions holding water at sidewalks - AssetCALC ID: 7369857

Uniformat Code: G2080  
Recommendation: **Repair in 2024**

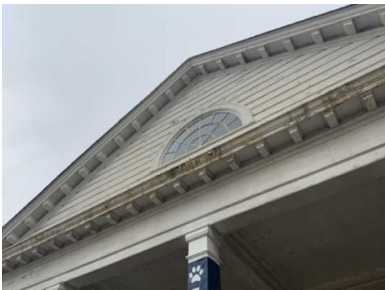
### Soffit in Failed condition.

Wood is dry rotting around whole facility Gutters, soffit and fascia are completely deteriorated in areas on north and east sides - AssetCALC ID: 7369938

Uniformat Code: B3080  
Recommendation: **Replace in 2025**

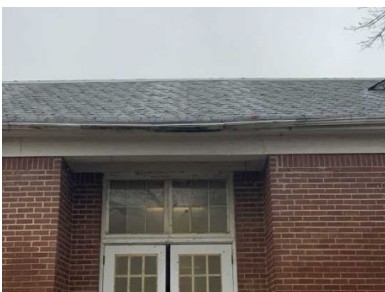
### Roof Appurtenances in Failed condition.

Falling down in areas, don't drain - AssetCALC ID: 7369919

Uniformat Code: B3020  
Recommendation: **Replace in 2025**

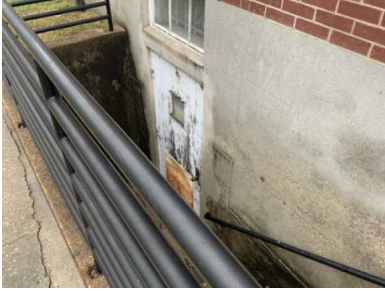
### Exterior Door in Poor condition.

Door to boiler room removed. Door peeling - AssetCALC ID: 7369979

Uniformat Code: B2050  
Recommendation: **Replace in 2026**

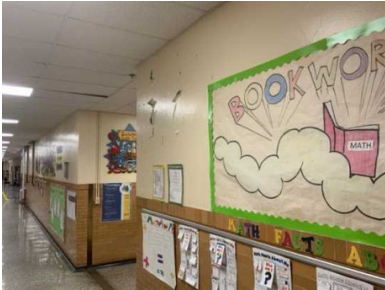
### Wall Finishes in Poor condition.

Wall repair required, paint peeling in hallway - AssetCALC ID: 7369956

Uniformat Code: C2010  
Recommendation: **Prep and Paint in 2026**

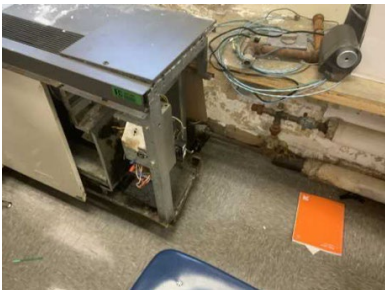
### Recommended Follow-up Study: Environmental, Asbestos (ACM) and Lead Base Paint (LBP)

Possible asbestos containing floor tile, possible lead based paint and possible asbestos insulation - AssetCALC ID: 7371815

There are areas of facility that could possibly contain asbestos containing floor tiles, mastic, pipe insulation and lead paint. A professional engineer must be retained to analyze the existing condition, provide recommendations and, if necessary, estimate the scope and cost of any required repairs. The cost of this study is included in the cost tables. Due to the ambiguity of the required repair scope at the time of this assessment, the cost for any possible subsequent repairs is not included.

Uniformat Code: P2030  
Recommendation: **Evaluate/Report in 2024**

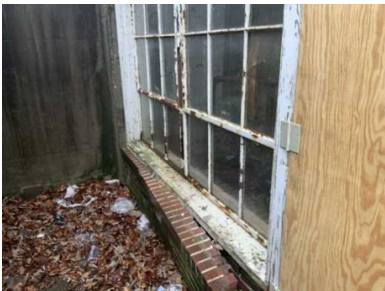
### Window in Failed condition.

Single pane, rusting out, could reduce size with wall repair - AssetCALC ID: 7369864

Uniformat Code: B2020  
Recommendation: **Replace in 2025**

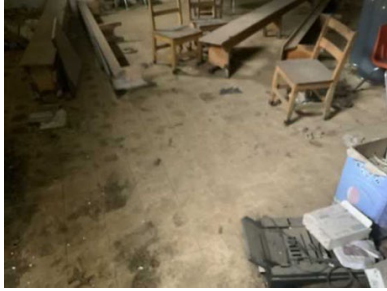
## Flooring in Poor condition.

Unifomat Code: C2030  
Recommendation: **Replace in 2026**

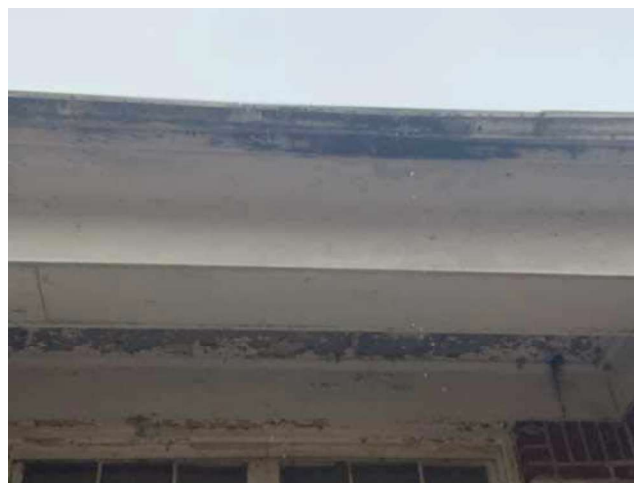
12 - DAMAGED SOFFIT AND FASCIA

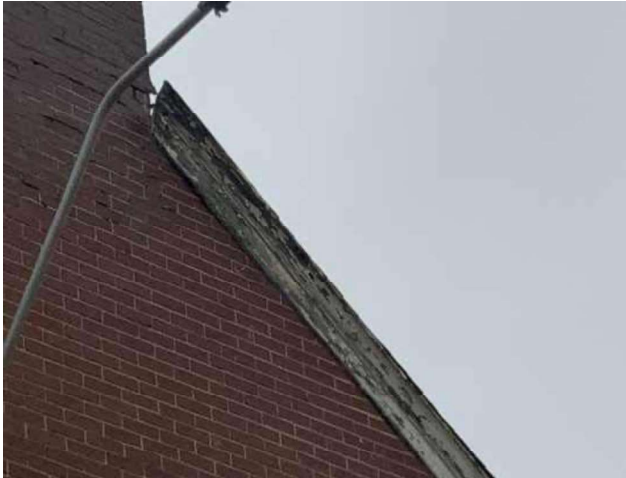
13 - DRY ROT

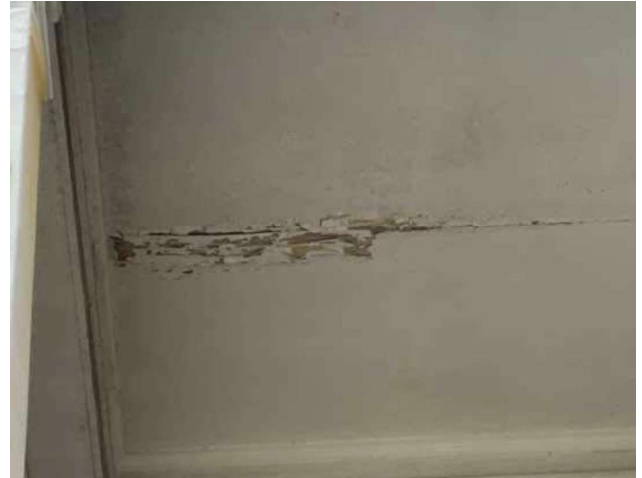
14 - DAMAGED SOFFIT

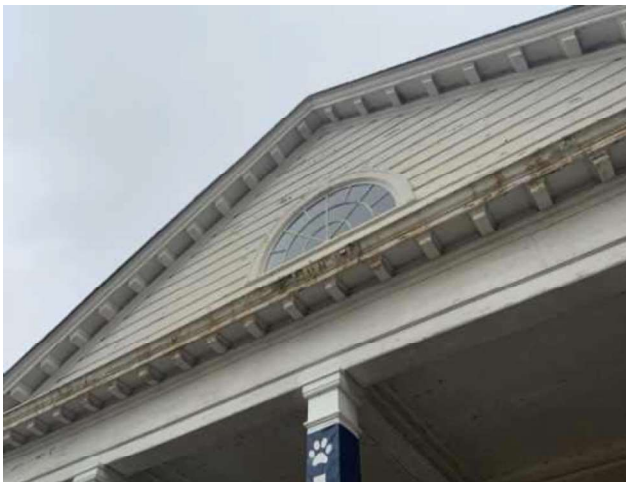
15 - DAMAGED FASCIA

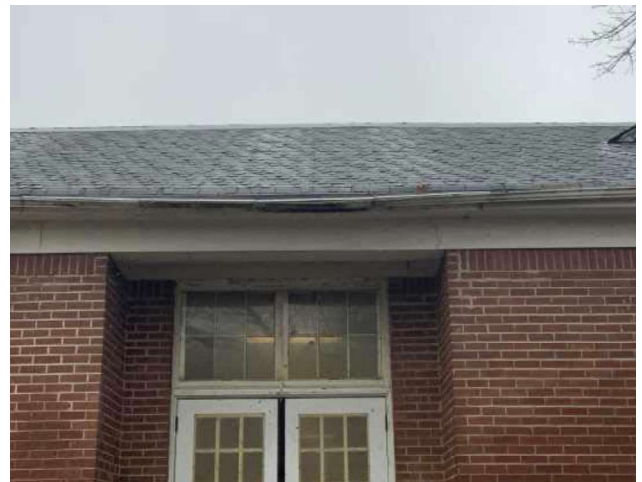
16 - DAMAGED SOFFIT AND FASCIA

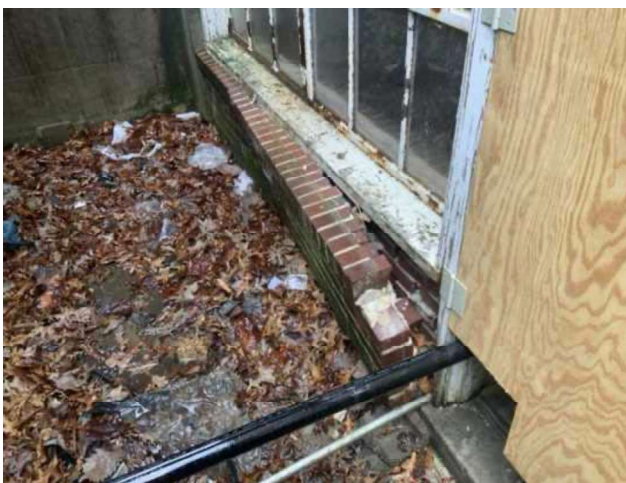
17 - DAMAGED BRICK VENEER

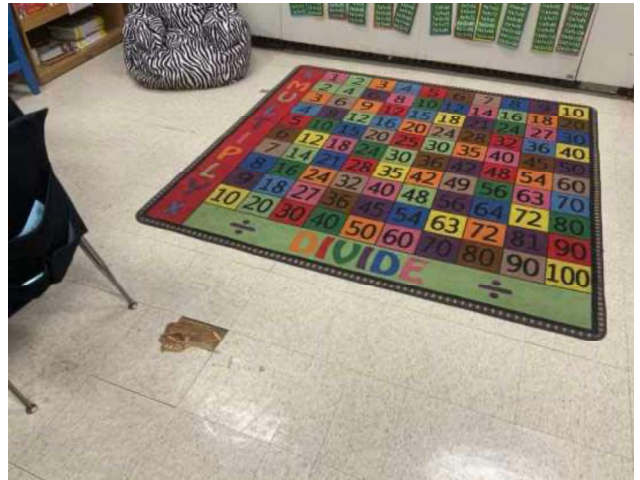
28 - SUB-FLOOR FAILURE IN CLASSROOMS
