FACILITY CONDITION ASSESSMENT

Shelby County Board of Education
160 South Hollywood Street
Memphis, Tennessee 38112-4892
Michelle Stuart

Treadwell Middle School
920 North Highland Street
Memphis, Tennessee 38122

October 23, 2024

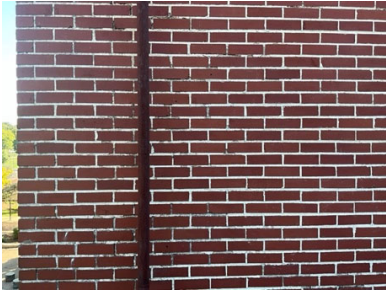
Exterior Walls in Poor condition.

Brick
Main Building Treadwell Middle School Building
Exterior

There is cracked and missing mortar in isolated areas throughout the exterior wall surface. - AssetCALC ID: 8451001

Uniformat Code: B2010
Recommendation: **Repair/Repoint in 2024**

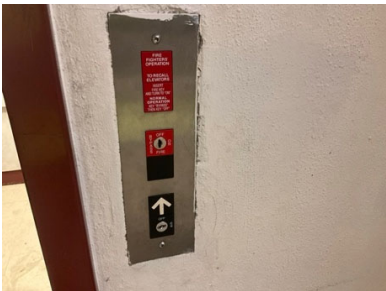
Elevator Controls in Failed condition.

Automatic, 1 Car
Main Building Treadwell Middle School
Elevator

1st floor Key control is broken. Have to go the 3rd floor to bring the elevator down - AssetCALC ID: 8451034

Uniformat Code: D1010
Recommendation: **Replace in 2024**

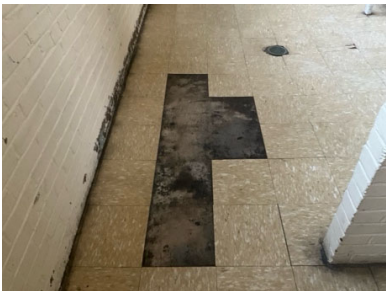
Interior Construction in Poor condition.

any type, Repairs per Man-Day
Gymnasium Treadwell Middle School
Throughout Building

Cost allowance for the replacement of broken and missing VCT tiles. - AssetCALC ID: 8451493

Uniformat Code: C1010
Recommendation: **Repair in 2024**

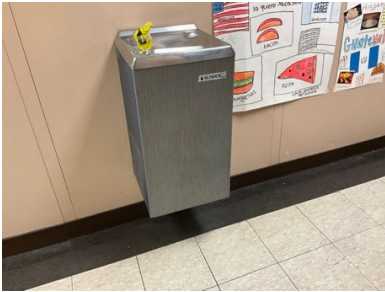
Drinking Fountain in Failed condition.

Wall-Mounted, Single-Level
Northeast Regional Office Treadwell Middle School Throughout Building

The fountain is not in service - AssetCALC ID: 8451527

Uniformat Code: D2010
Recommendation: **Replace in 2024**

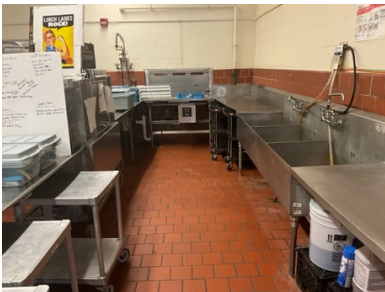
Foodservice Equipment in Failed condition.

Dishwasher Commercial
Cafeteria Treadwell Middle School Kitchen

The unit is not in service - AssetCALC ID: 8451397

Uniformat Code: E1030
Recommendation: **Replace in 2024**

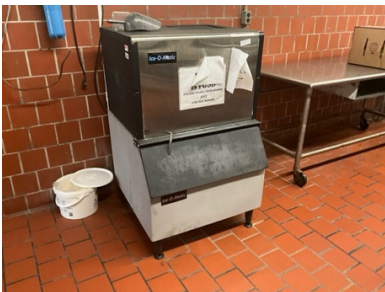
Foodservice Equipment in Failed condition.

Icemaker, Freestanding
Cafeteria Treadwell Middle School Kitchen

The unit is out of service - AssetCALC ID: 8451422

Uniformat Code: E1030
Recommendation: **Replace in 2024**

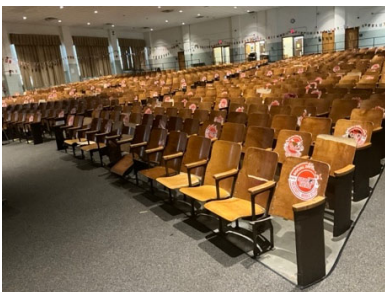
Fixed Seating in Poor condition.

Auditorium/Theater, Metal Cushioned Standard
Main Building Treadwell Middle School Auditorium

There are broken seats throughout the auditorium - AssetCALC ID: 8451026

Uniformat Code: E2010
Recommendation: **Replace in 2026**
