FACILITY CONDITION ASSESSMENT

Trezevant CTC
3224 Range Line Road
Memphis, Tennessee 38127

163745.23R000-186.354

May 2, 2024

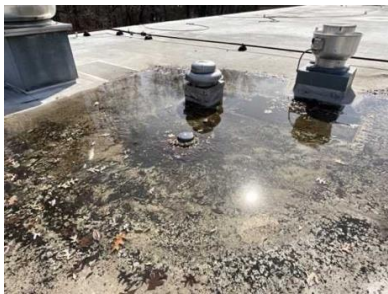
Roofing

any type, Repairs per Man-Day
Trezevant CTC Roof

Drains are clogged in multiple areas. Unclog drains as needed. - AssetCALC ID: 7412842

Uniformat Code: B3010
Recommendation: **Repair in 2024**

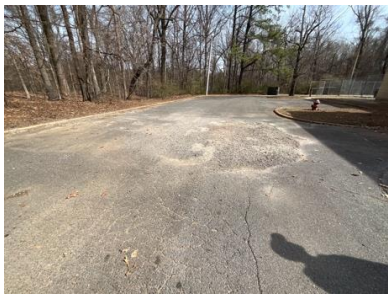
Parking Lots in Failed condition.

Pavement, Asphalt
Trezevant CTC Site

Potholes and asphalt cracks throughout. - AssetCALC ID: 7412830

Uniformat Code: G2020
Recommendation: **Cut and Patch in 2024**
