FACILITY CONDITION ASSESSMENT

Shelby County Board of Education
160 South Hollywood Street
Memphis, Tennessee 38112-4892
Michelle Stuart

Trezevant High School
3350 North Trezevant Street
Memphis, Tennessee 38127

October 22, 2024

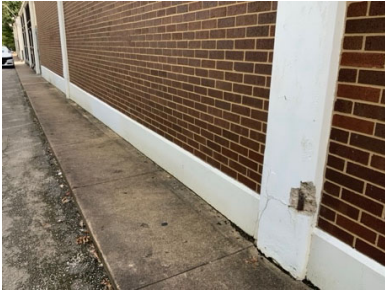
Exterior Walls in Poor condition.

any painted surface, 1-2 Story Building
Main Building Trezevant High School Building
Exterior

Much of these painted surfaces are weathered, worn and peeling. - AssetCALC ID: 8335831

Recommendation: **Prep and Paint in 2026**

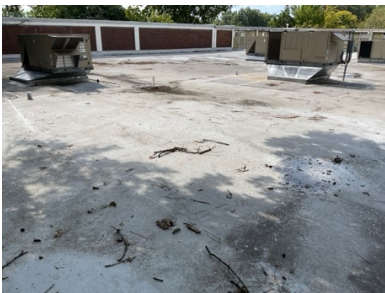
Roofing in Poor condition.

Single-Ply Membrane, TPO/PVC
Main Building Trezevant High School Roof

Excessive roof leaks reported throughout. At the time of assessment there was standing water as deep as 6 inches - AssetCALC ID: 8366203

Recommendation: **Replace in 2024**

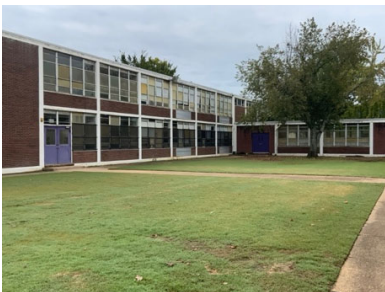
Glazing in Poor condition.

any type by SF
Main Building Trezevant High School Building
Exterior

Glazing is failing or missing. - AssetCALC ID: 8335824

Recommendation: **Replace in 2026**

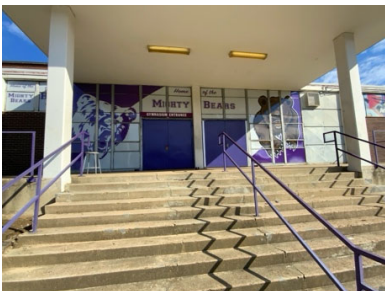
Storefront in Poor condition.

Glazing and Framing
Main Building Trezevant High School Building
Exterior

A significant amount of the storefront glazing is dried, cracking or missing. - AssetCALC ID: 8335821

Recommendation: **Replace in 2026**

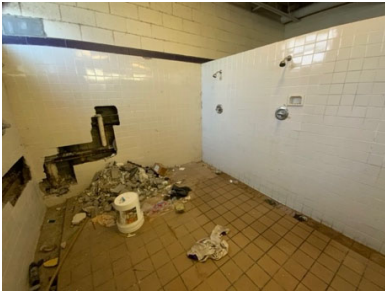
Wall Finishes in Poor condition.

Ceramic Tile
Field House Trezevant High School Locker Rooms

Wall tile is damaged through out building. It appears a repair or renovation is in progress. - AssetCALC ID: 8335841

Uniformat Code: C2010
Recommendation: **Replace in 2026**

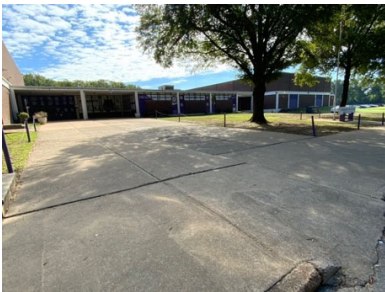
Sidewalk in Poor condition.

Concrete, Large Areas
Site Trezevant High School Site

Significant cracking and lifting of concrete areas. - AssetCALC ID: 8335874

Uniformat Code: G2030
Recommendation: **Replace in 2024**

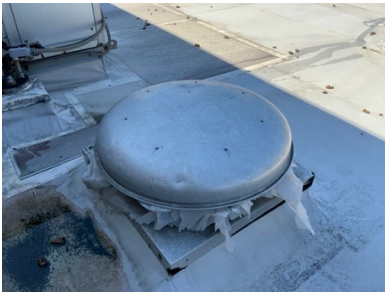
Exhaust Fan in Poor condition.

Roof or Wall-Mounted, 16" Damper
Field House Trezevant High School Roof

Not functioning, reason unknown. - AssetCALC ID: 8335866

Uniformat Code: D3060
Recommendation: **Replace in 2024**

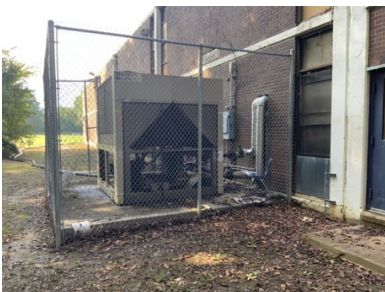
Chiller in Poor condition.

Air-Cooled
Main Building Trezevant High School Building Exterior

Unit is non-functional and in the process of being replaced. A new unit has been ordered. - AssetCALC ID: 8335826

Uniformat Code: D3030
Recommendation: **Replace in 2024**

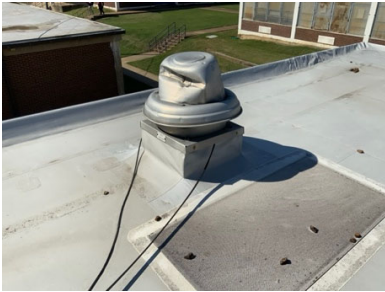
Exhaust Fan in Poor condition.

Roof or Wall-Mounted, 12" Damper
Field House Trezevant High School Roof

Fan housing damaged - AssetCALC ID: 8335868

Uniformat Code: D3060
Recommendation: **Replace in 2026**

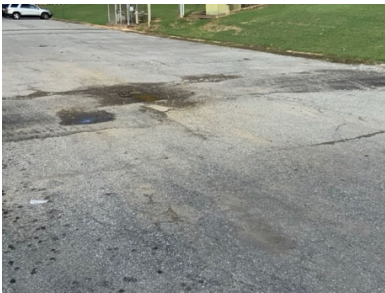
Parking Lots in Poor condition.

Pavement, Asphalt
Site Trezevant High School Site

Cracking, lifting, potholes throughout asphalt. - AssetCALC ID: 8335870

Uniformat Code: G2020
Recommendation: **Mill and Overlay in 2026**

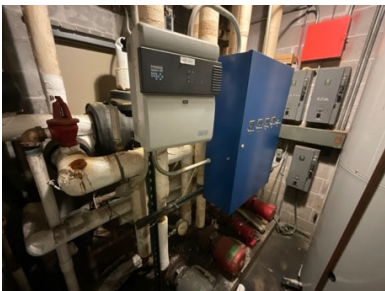
Pump Station in Poor condition.

Triplex Mounted
Main Building Trezevant High School Utility
Rooms/Areas

Aged significantly and well beyond its useful life - AssetCALC ID: 8366192

Uniformat Code: D2010
Recommendation: **Replace in 2024**

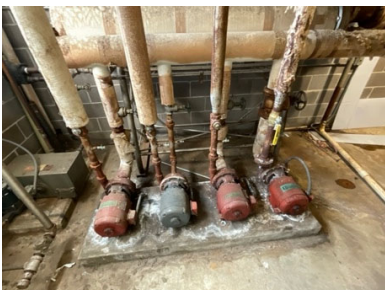
Pump Station in Poor condition.

Triplex Mounted
Main Building Trezevant High School Utility
Rooms/Areas

Aged significantly and well beyond its useful life - AssetCALC ID: 8366216

Uniformat Code: D2010
Recommendation: **Replace in 2024**

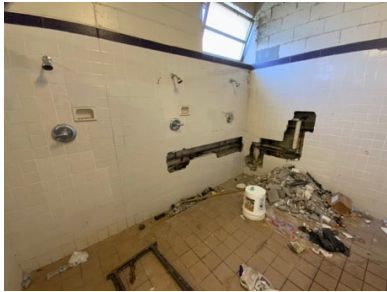
Shower in Poor condition.

Valve & Showerhead
Field House Trezevant High School Locker Rooms

Showers are non functional. Area appears to be under renovation. - AssetCALC ID: 8335848

Uniformat Code: D2010
Recommendation: **Replace in 2026**

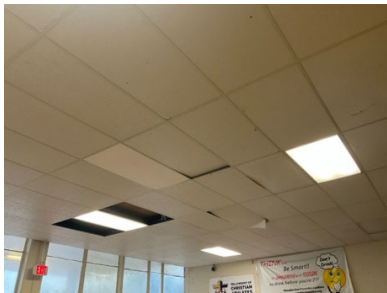
Suspended Ceilings in Poor condition.

Acoustical Tile (ACT)
Main Building Trezevant High School Throughout Building

Tile is stained from water leaks and warped throughout - AssetCALC ID: 8366211

Uniformat Code: C1070
Recommendation: **Replace in 2024**

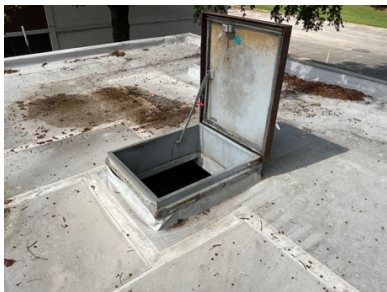
Roof Hatch in Poor condition.

Metal
Main Building Trezevant High School Roof

Roof hatch is aged and rusted, the latch is poorly functioning - AssetCALC ID: 8366148

Uniformat Code: B3060
Recommendation: **Replace in 2024**

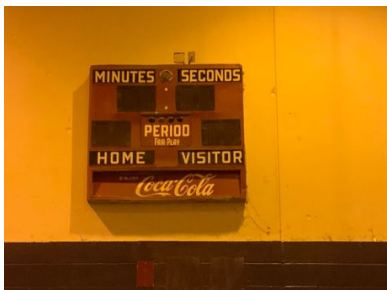
Gym Scoreboard in Poor condition.

Electronic Basic
Field House Trezevant High School Gymnasium

Scoreboard does not work, no scheduled repair. - AssetCALC ID: 8335834

Uniformat Code: E1070
Recommendation: **Replace in 2024**

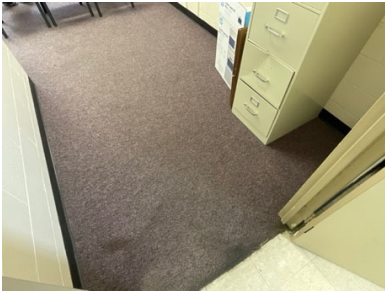
Flooring in Poor condition.

Carpet, Commercial Standard
Main Building Trezevant High School Office
Areas

Carpet is stained and ripped in areas - AssetCALC ID: 8366101

Uniformat Code: C2030
Recommendation: **Replace in 2024**

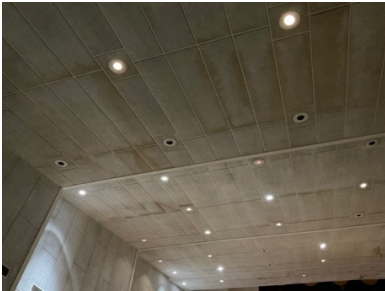
Suspended Ceilings in Poor condition.

Fiberglass Paneling
Main Building Trezevant High School
Auditorium

Tile is stained from water leaks and warped throughout - AssetCALC ID: 8366182

Uniformat Code: C1070
Recommendation: **Replace in 2024**

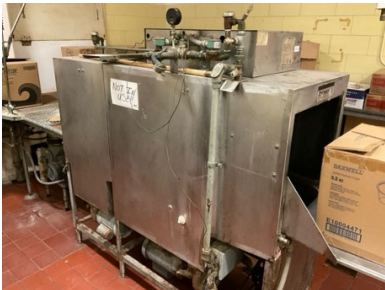
Foodservice Equipment in Poor condition.

Dishwasher Commercial
Main Building Trezevant High School
Commercial Kitchen

Non operational, needs repair or replacement - AssetCALC ID: 8366167

Uniformat Code: E1030
Recommendation: **Replace in 2024**

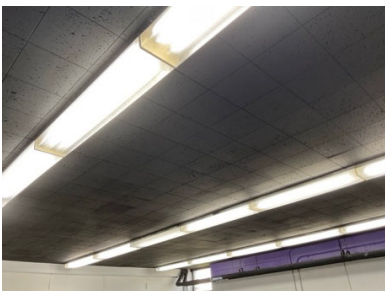
Suspended Ceilings in Poor condition.

Hard Tile, Replacement w/ ACT
Main Building Trezevant High School
Throughout Building

Tile is stained from water leaks and warped throughout - AssetCALC ID: 8366102

Uniformat Code: C1070
Recommendation: **Replace in 2024**

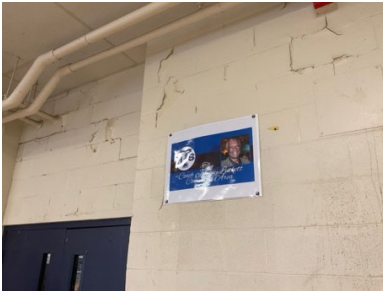
Wall Finishes in Poor condition.

any surface
Main Building Trezevant High School
Throughout Building

Wall paint has deteriorated and chipped throughout - AssetCALC ID: 8366162

Uniformat Code: C2010
Recommendation: **Prep and Paint in 2024**

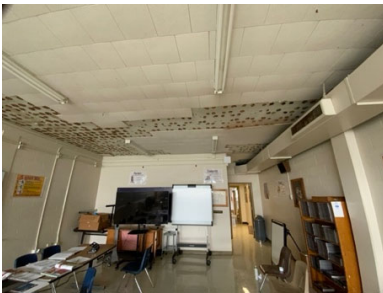
Suspended Ceilings in Poor condition.

Hard Tile, Replacement w/ ACT
ROTC Building Trezevant High School
Classrooms General

Tiles missing, falling and damaged. - AssetCALC ID: 8349134

Uniformat Code: C1070
Recommendation: **Replace in 2026**

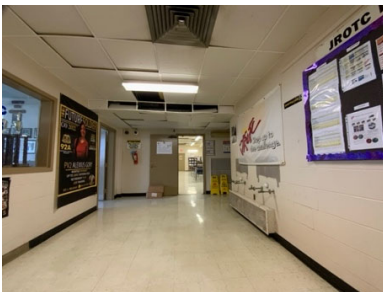
Suspended Ceilings in Poor condition.

Acoustical Tile (ACT)
ROTC Building Trezevant High School Office
Areas

Tiles broken and missing, parts of grid missing. - AssetCALC ID: 8349144

Uniformat Code: C1070
Recommendation: **Replace in 2026**

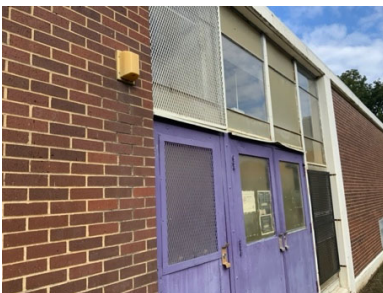
Exterior Light in Poor condition.

any type, w/ LED Replacement
Main Building Trezevant High School Building
Exterior

Light housing is weathered, lenses are discolored and appear to be brittle. - AssetCALC ID: 8335820

Uniformat Code: D5040
Recommendation: **Replace in 2026**

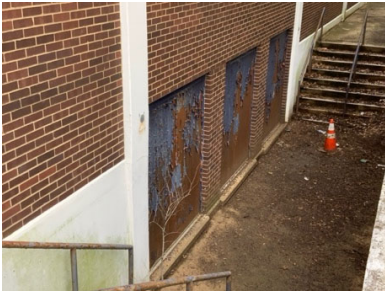
**Exterior Door in Poor condition.**

Steel, Standard
Main Building Trezevant High School Building
Exterior

Significant corrosion, a majority of the door paint has peeled away. - AssetCALC ID: 8335819

Uniformat Code: B2050
Recommendation: **Replace in 2026**

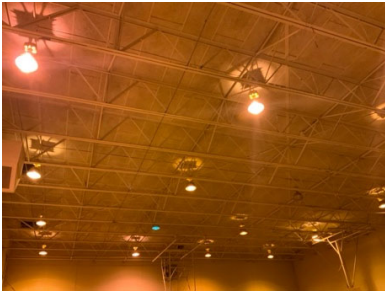
**Ceiling Finishes in Poor condition.**

any flat surface
Field House Trezevant High School
Throughout Building

Last paint unknown, needs to be refreshed - AssetCALC ID: 8335844

Uniformat Code: C2050
Recommendation: **Prep and Paint in 2026**

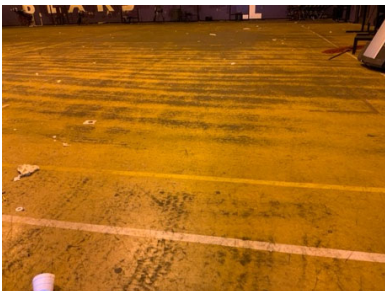
**Flooring in Poor condition.**

any surface, w/ Paint or Sealant
Field House Trezevant High School
Throughout Building

Floor seal is worn down to bare concrete. - AssetCALC ID: 8335850

Uniformat Code: C2030
Recommendation: **Prep and Paint in 2026**

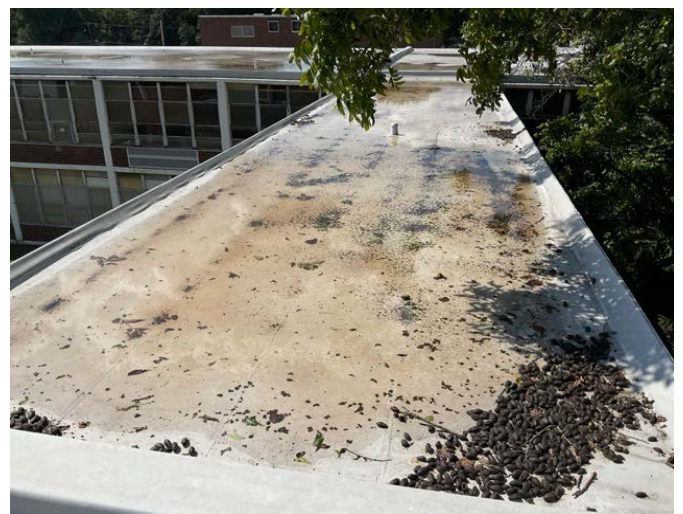
6 - ROOF PONDING
