FACILITY CONDITION ASSESSMENT

October 1, 2024

Vollentine Elementary
1682 Vollintine Avenue
Memphis, Tennessee 38107

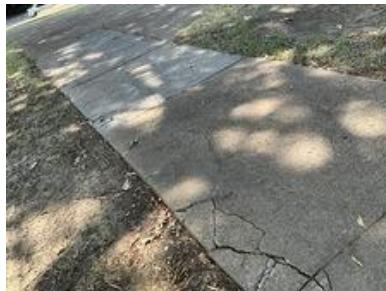
Sidewalk in Poor condition.

Concrete, Large Areas
Vollentine Elementary Site

Several areas observed to be cracked damaged as well as upheaval and trip hazards - AssetCALC ID: 8031864

Uniformat Code: G2030
Recommendation: **Replace in 2026**

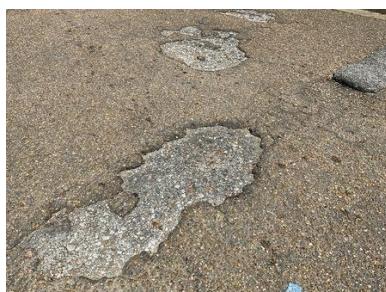
Parking Lots in Poor condition.

Pavement, Asphalt
Vollentine Elementary Site

Severe alligator, cracking ponding observed - AssetCALC ID: 8031853

Uniformat Code: G2020
Recommendation: **Mill and Overlay in 2024**

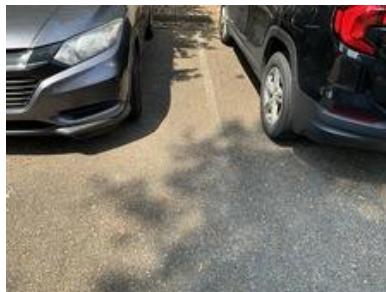
Parking Lots in Poor condition.

Pavement, Asphalt
Vollentine Elementary Site

Barely visible striping - AssetCALC ID: 8031848

Uniformat Code: G2020
Recommendation: **Seal and Stripe in 2024**

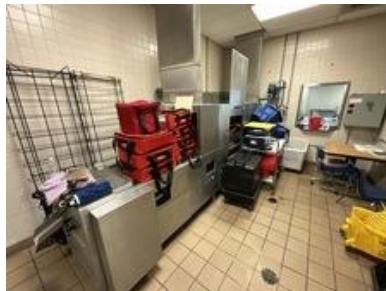
Foodservice Equipment in Poor condition.

Dishwasher Commercial
Vollentine Elementary Kitchen

Posted out of order - AssetCALC ID: 8031873

Uniformat Code: E1030
Recommendation: **Replace in 2024**

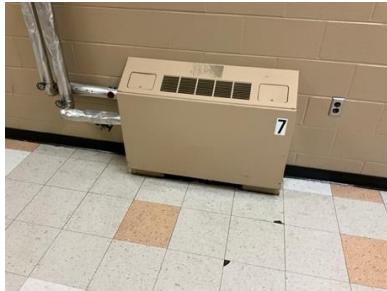
Unit Heater in Poor condition.

Electric
Vollentine Elementary Throughout Building

Down units - AssetCALC ID: 8029631

Uniformat Code: D3020
Recommendation: **Replace in 2024**

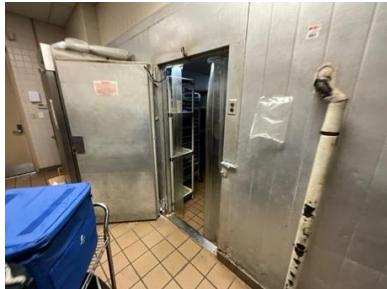
Foodservice Equipment in Poor condition.

Walk-In, Refrigerator
Vollentine Elementary Kitchen

Door broken off of hinges - AssetCALC ID: 8031859

Uniformat Code: E1030
Recommendation: **Replace in 2025**
