FACILITY CONDITION ASSESSMENT

Wells Station Elementary
1610 Wells Station Road
Memphis, Tennessee 38108

BV PROJECT #:
163745.23R000-189.354

DATE OF REPORT:
October 1, 2024

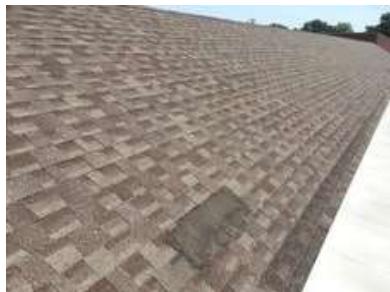
Roofing in Poor condition.

Asphalt Shingle, 30-Year Premium Wells Station Elementary Roof

Ongoing leak issues - AssetCALC ID: 8026027

Uniformat Code: B3010
Recommendation: **Replace in 2025**

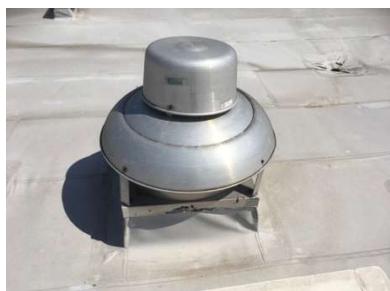
Exhaust Fan in Poor condition.

Centrifugal, 16" Damper Wells Station Elementary Roof

Broken shroud, not operating - AssetCALC ID: 8026072

Uniformat Code: D3060
Recommendation: **Replace in 2024**

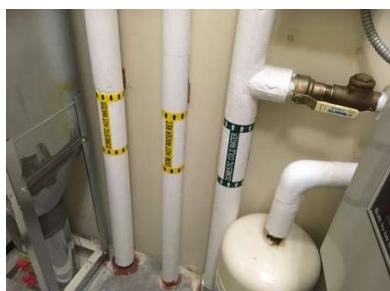
Plumbing System

any type, Repairs per Man-Day Wells Station Elementary Classroom Annex

Ongoing water hammer issue is prevalent throughout the school. - AssetCALC ID: 8046248

Uniformat Code: D2010
Recommendation: **Repair in 2024**

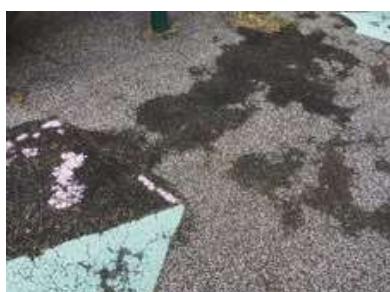
Playfield Surfaces in Poor condition.

Artificial Play Turf Wells Station Elementary Site

Multiple holes, tears and over-worn areas. - AssetCALC ID: 8026144

Uniformat Code: G2050
Recommendation: **Replace in 2025**

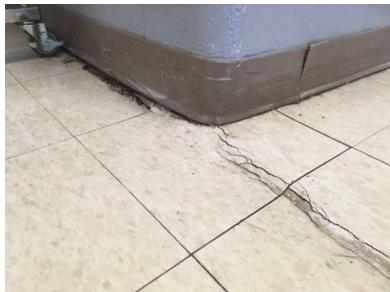
Recommended Follow-up Study: Structural, Superstructure

Structural, Superstructure
Wells Station Elementary Hallways & Common Areas

Widespread building settlement, flooring and wall cracks, building envelope gaps, wall leaks - AssetCALC ID: 8026142

Uniformat Code: P2030
Recommendation: **Evaluate/Report in 2024**

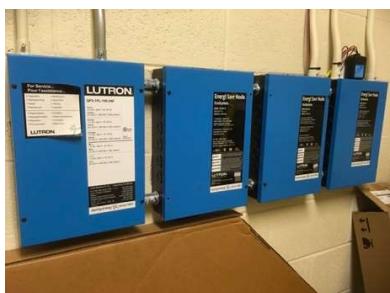
Lighting Controls in Failed condition.

Dimming Panel, Digital Time Control Clock & Photosensor
Wells Station Elementary Classroom Addition

Damaged and non functional - AssetCALC ID: 8026155

Uniformat Code: D5040
Recommendation: **Replace in 2024**

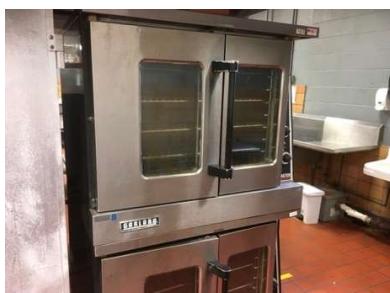
Foodservice Equipment in Failed condition.

Convection Oven, Double
Wells Station Elementary Kitchen

Not currently functioning - AssetCALC ID: 8026146

Uniformat Code: E1030
Recommendation: **Replace in 2024**

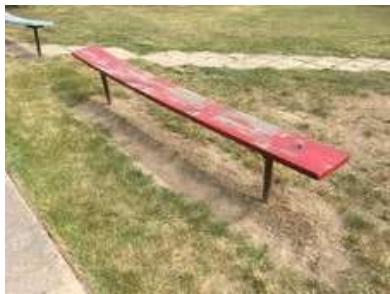
Park Bench in Poor condition.

Wood/Composite/Fiberglass
Wells Station Elementary Site

Bent, abused and poorly constructed - AssetCALC ID: 8026055

Uniformat Code: G2060
Recommendation: **Replace in 2024**

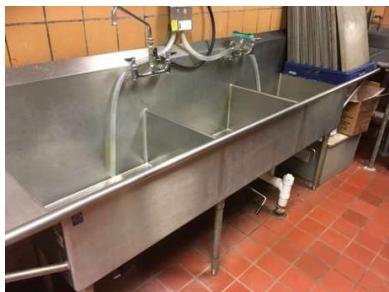
Sink/Lavatory in Failed condition.

Commercial Kitchen, 3-Bowl
Wells Station Elementary Kitchen

Leaking - AssetCALC ID: 8026110

Uniformat Code: E1030
Recommendation: **Replace in 2025**

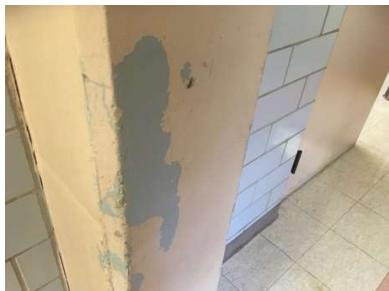
Wall Finishes in Poor condition.

any surface
Wells Station Elementary Throughout Building

Many areas of missing paint - AssetCALC ID: 8026159

Uniformat Code: C2010
Recommendation: **Prep & Paint in 2025**

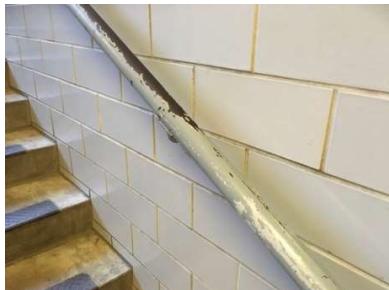
Stair/Ramp Rails in Poor condition.

Metal
Wells Station Elementary Stairwells

Well worn and missing finish - AssetCALC ID: 8026076

Uniformat Code: B1080
Recommendation: **Refinish in 2025**
