FACILITY CONDITION ASSESSMENT

Westside Elementary School
3347 Dawn Drive
Memphis, Tennessee 38127

163745.23R000-052.354

April 19, 2024

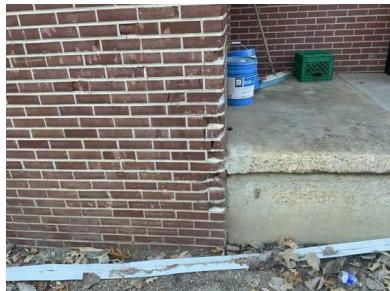
Exterior Walls in Poor condition.

Brick
Main Building Westside Elementary School
Building exterior

Isolated areas of missing mortar - AssetCALC ID: 7162496

Uniformat Code: B2010
Recommendation: **Repair in 2023**

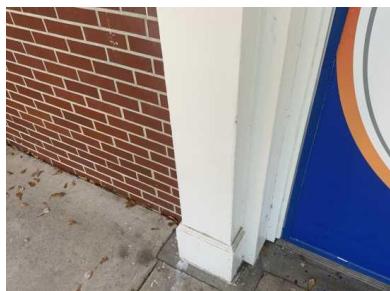
Exterior Walls in Poor condition.

Wood Siding
Main Building Westside Elementary School
Building Exterior

Isolated areas of rot and deterioration observed - AssetCALC ID: 7162511

Uniformat Code: B2010
Recommendation: **Replace in 2025**

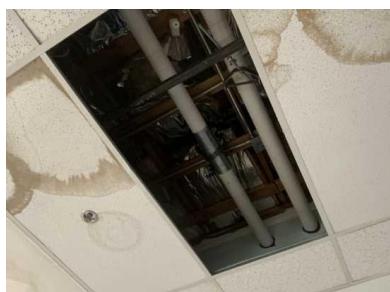
Roofing in Failed condition.

any type, Repairs per Man-Day
Annex Westside Elementary School Annex
classroom 109

Reports of leaking in classroom 109 - AssetCALC ID: 7170300

Uniformat Code: B3010
Recommendation: **Repair in 2023**

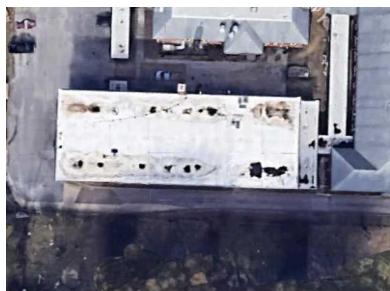
Roofing in Poor condition.

Single-Ply Membrane, TPO/PVC
Main Building Westside Elementary School
Roof - 2 story wing

Widespread evidence of ponding water - AssetCALC ID: 7177800

Uniformat Code: B3010
Recommendation: **Replace in 2025**

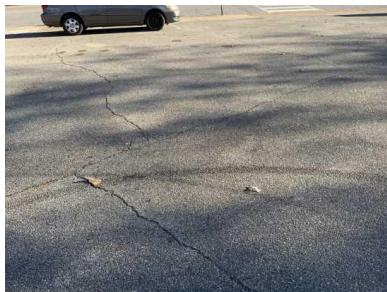
Parking Lots in Poor condition.

Pavement, Asphalt
Main Building Westside Elementary School Site

Large areas of severe alligator cracking - AssetCALC ID: 7162484

Uniformat Code: G2020
Recommendation: **Cut and Patch in 2023**

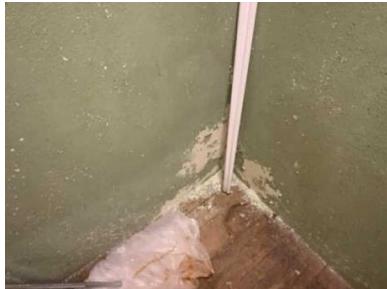
Interior Wall in Poor condition.

Gypsum Board/Plaster
Main Building Westside Elementary School
Electrical room

Flaking paint on walls of Electrical Room - AssetCALC ID: 7166673

Uniformat Code: C1010
Recommendation: **Repair in 2023**

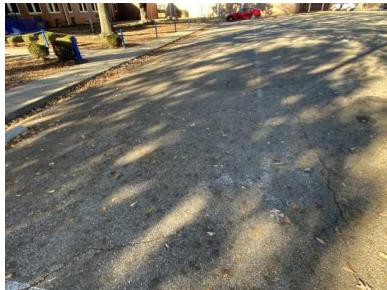
Parking Lots in Poor condition.

Pavement, Asphalt
Main Building Westside Elementary School Site

Large areas of faded striping - AssetCALC ID: 7162503

Uniformat Code: G2020
Recommendation: **Seal and Stripe in 2024**

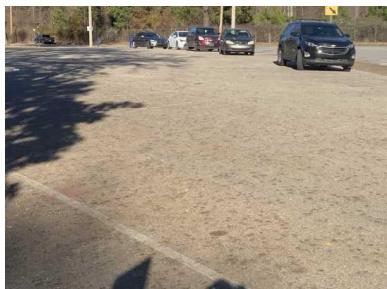
Parking Lots in Poor condition.

Pavement, Asphalt
Main Building Westside Elementary School Site

Large areas of surface degradation - AssetCALC ID: 7162492

Uniformat Code: G2020
Recommendation: **Mill and Overlay in 2025**

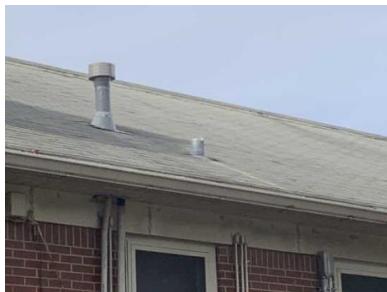
Plumbing System in Poor condition.

Supply and Sanitary, Medium Density (excludes fixtures)
Main Building Westside Elementary School
Throughout building

POC reports frequent clogging and backups of plumbing lines - AssetCALC ID: 7166708

Uniformat Code: D2010
Recommendation: **Replace in 2025**

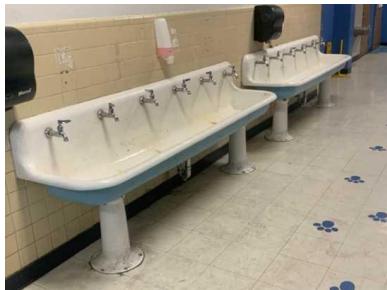
Sink/Lavatory in Poor condition.

Pedestal, Vitreous China
Main Building Westside Elementary School
Common Hall

Leaking faucets - AssetCALC ID: 7166690

Uniformat Code: D2010
Recommendation: **Replace in 2023**

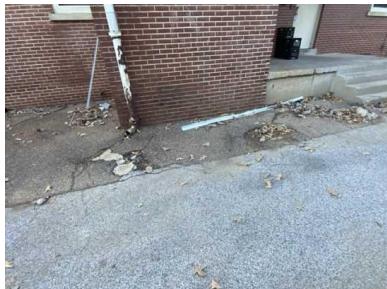
Site Earthwork in Poor condition.

Slopes and Contours, Reshaping/Regrading
Main Building Westside Elementary School
South side

Grade is flat or sloping into building. Gutters and downspouts have no splash blocks or not connected to subsurface drainage system - AssetCALC ID: 7162471

Uniformat Code: G1070
Recommendation: **Repair in 2023**

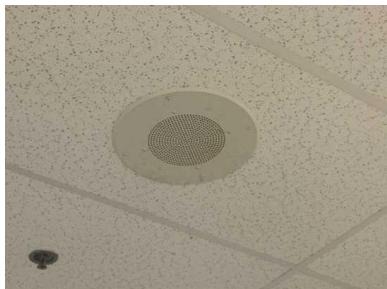
Intercom/PA System in Poor condition.

Public Address Upgrade, Facility-Wide
Annex Westside Elementary School
Throughout building

POC states that PA system needs replacement - AssetCALC ID: 7170316

Uniformat Code: D6060
Recommendation: **Replace in 2025**
