# FACILITY CONDITION ASSESSMENT

**Shelby County Board of Education**  
160 South Hollywood Street  
Memphis, Tennessee 38112-4892  
Michelle Stuart

White Station Middle School  
5465 Mason Road  
Memphis Tennessee 38120

October 24, 2024

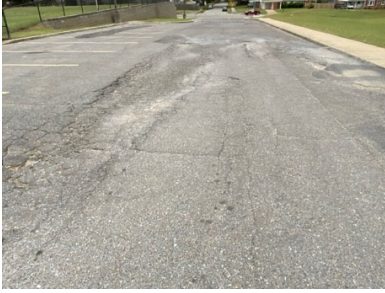
### Parking Lots in Poor condition.

Pavement, Asphalt  
White Station Middle School Site

Parking lots have significant wear including cracking, potholes and areas of repair that are also failing. - AssetCALC ID: 8454410

Uniformat Code: G2020  
Recommendation: **Mill and Overlay in 2025**

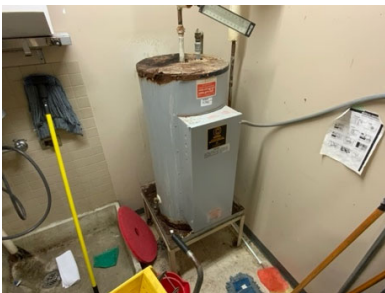
### Water Heater in Poor condition.

Electric, Commercial ( 12 kW), 30 to 80 GAL  
White Station Middle School Utility  
Rooms/Areas B119

Unit has significant corrosion and leaking at multiple locations. Power is off. - AssetCALC ID: 8454419

Uniformat Code: D2010  
Recommendation: **Replace in 2024**

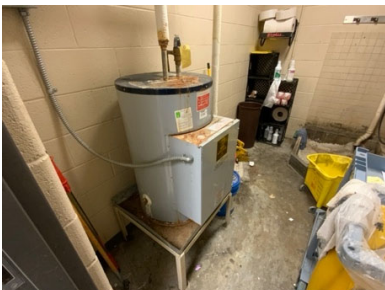
### Water Heater in Poor condition.

Electric, Commercial (12 kW), 30 to 80 GAL  
White Station Middle School Utility  
Rooms/Areas

Unit is not functional, significant leaking. Power is off. - AssetCALC ID: 8454334

Uniformat Code: D2010  
Recommendation: **Replace in 2024**

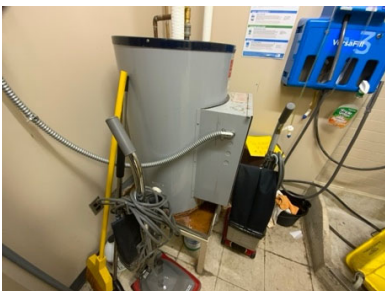
### Water Heater in Poor condition.

Electric, Commercial (12 kW), 30 to 80 GAL  
White Station Middle School Utility  
Rooms/Areas A122

Unit has significant corrosion and leaking at base. - AssetCALC ID: 8454329

Uniformat Code: D2010  
Recommendation: **Replace in 2025**

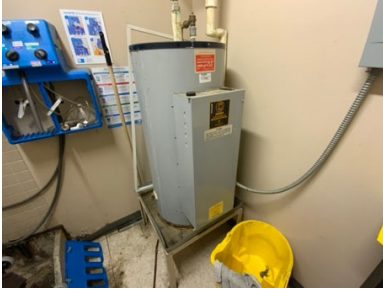
### Water Heater in Poor condition.

Electric, Commercial (12 kW)  
White Station Middle School Utility  
Rooms/Areas G210

Unit has significant corrosion and leaking at base. - AssetCALC ID: 8456844

Uniformat Code: D2010  
Recommendation: **Replace in 2025**

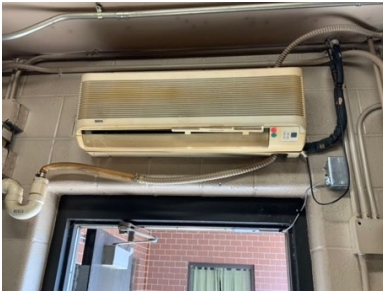
### Packaged Terminal Air Conditioner in Poor condition.

PTAC, 18001 to 24000 BTUH  
White Station Middle School Mechanical Room  
E112

Unit reported as not functioning. Power is off. - AssetCALC ID: 8454345

Uniformat Code: D3030  
Recommendation: **Replace in 2024**

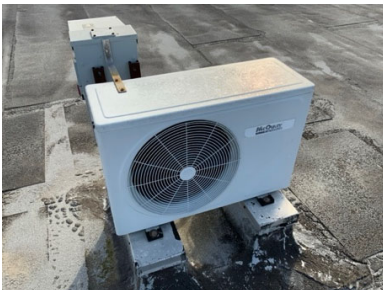
### Split System in Poor condition.

Condensing Unit/Heat Pump  
White Station Middle School Roof

Unit not functioning, power is off. Disconnect has wasp infestation. - AssetCALC ID: 8456837

Uniformat Code: D3030  
Recommendation: **Replace in 2024**

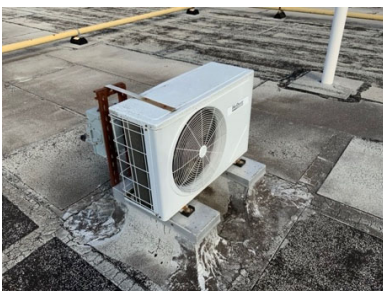
### Split System in Poor condition.

Condensing Unit/Heat Pump  
White Station Middle School Roof

Uniformat Code: D3030  
Recommendation: **Replace in 2024**
