# FACILITY CONDITION ASSESSMENT

**Shelby County Board of Education**  
160 South Hollywood Street  
Memphis, Tennessee 38112-4892  
Michelle Stuart

Whitehaven Elementary  
4783 Elvis Presley Boulevard  
Memphis, Tennessee 38116

October 1, 2024

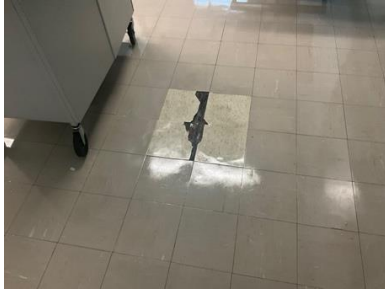
**Interior Construction in Poor condition.**

any type, Repairs per Man-Day  
Whitehaven Elementary Throughout Building

Cost allowance for tile repairs throughout the facility - AssetCALC ID: 8040316

Uniformat Code: C1010  
Recommendation: **Repair in 2024**

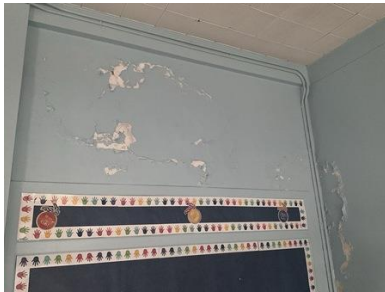
The interior wall paint is in poor condition. The interior walls in various classrooms have blistering paint. Which is a sign of potential moisture. An architect must be retained to analyze the existing condition, provide recommendations and, if necessary, estimate the scope and cost of any required repairs. Due to the ambiguity of the required repair scope at the time of this assessment, the cost for any possible subsequent repairs is not included.

**Recommended Follow-up Study: Building Envelope, Façade**

The paint peeling on the walls is signs of potential moisture issue - AssetCALC ID: 8040344

Uniformat Code: P2030  
Recommendation: **Evaluate/Report in 2024**

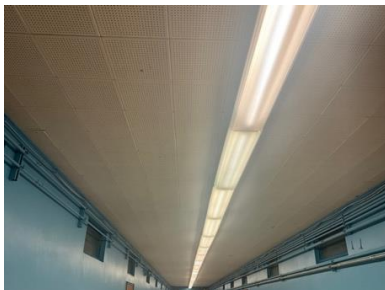
The acoustical ceiling tiles is in poor condition. The acoustical ceiling tiles along the hallway potentially has asbestos. A professional consultant must be retained to analyze the existing condition, provide recommendations and, if necessary, estimate the scope and cost of any required repairs. The cost of this study is included in the cost tables. A budgetary cost allowance to replace the asbestos ceiling tiles is also included

**Recommended Follow-up Study: Environmental, Asbestos (ACM) and Lead Base Paint (LBP)**

A study is recommend for potential asbestos ceiling tiles - AssetCALC ID: 8045857

Uniformat Code: P2030  
Recommendation: **Evaluate/Report in 2024**

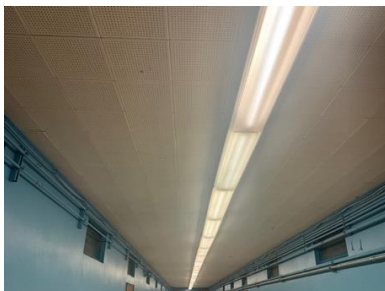
**Suspended Ceilings in Poor condition.**

Hard Tile, ACM Abatement and Replacement  
with ACT  
Whitehaven Elementary Throughout Building

Uniformat Code: C1070  
Recommendation: **Replace in 2024**
