FACILITY CONDITION ASSESSMENT

Shelby County Board of Education
160 South Hollywood Street
Memphis, Tennessee 38112-4892
Michelle Stuart

Whitehaven Stadium
4851 Elvis Presley Boulevard
Memphis, Tennessee 38116

October 1, 2024

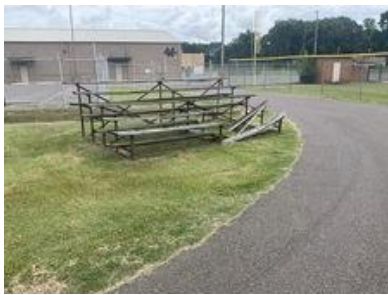
Sports Apparatus in Poor condition.

Player/Dugout Benches, 12' Length
Stadium Whitehaven Stadium Site

Uniformat Code: G2050
Recommendation: **Replace in 2025**

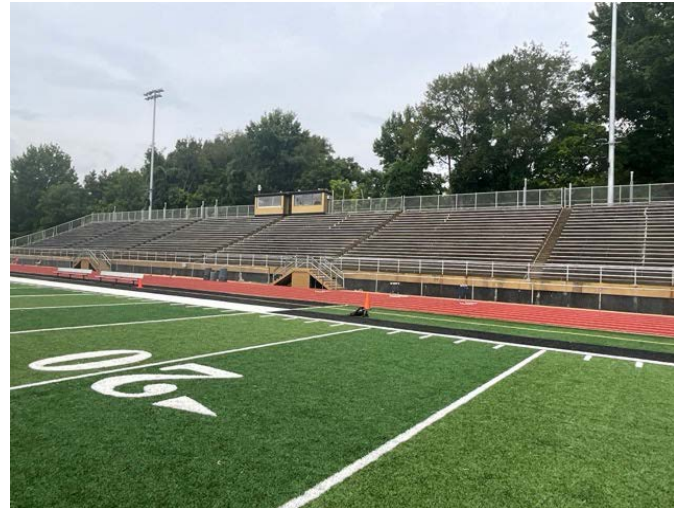
8 - BLEACHERS

The outdoor wood bleachers are dry rotted and broken - AssetCALC ID: 8025390

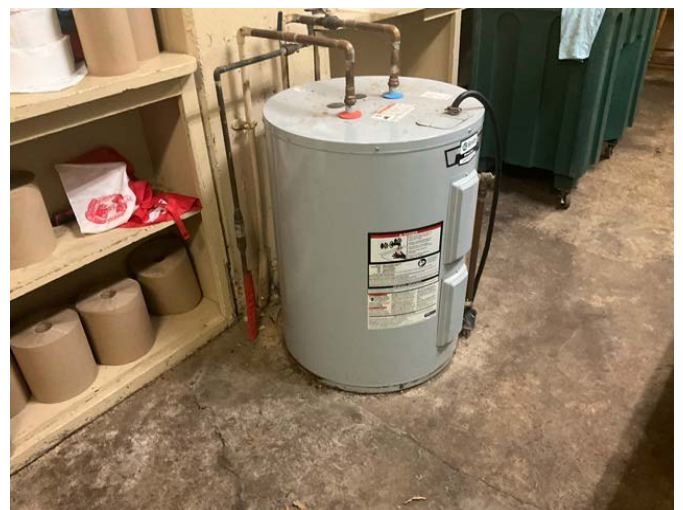
12 - WATER HEATER

In general, the plumbing system is reportedly adequate to serve the facilities, with equipment and fixtures updated as needed. The water heater located in the concession area was replaced in the recent years.
