FACILITY CONDITION ASSESSMENT

Whitney Elementary School
1219 Whitney Avenue
Memphis, Tennessee 38127

163745.23R000-049.354

April 19, 2024

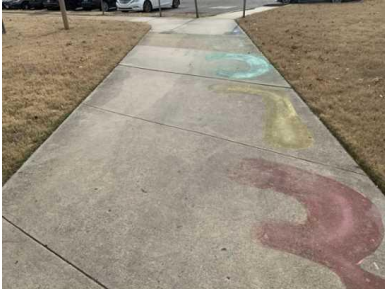
Sidewalk in Failed condition.

Concrete, Large Areas
Whitney Elementary School Site

Widespread surface degradation and isolated areas of cracking - AssetCALC ID: 7170233

Uniformat Code: G2030
Recommendation: **Replace in 2025**

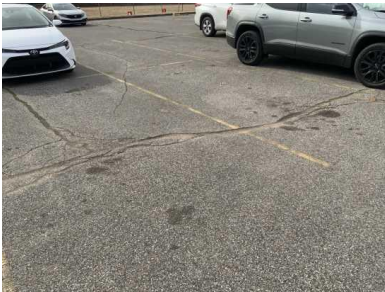
Parking Lots in Failed condition.

Pavement, Asphalt
Whitney Elementary School Site

Striping is worn out - AssetCALC ID: 7170224

Uniformat Code: G2020
Recommendation: **Seal and Stripe in 2023**

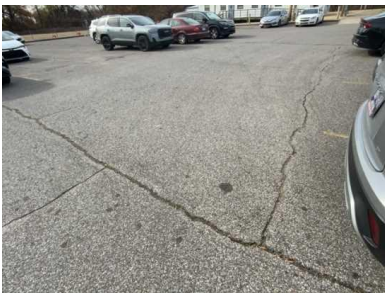
Parking Lots in Failed condition.

Pavement, Asphalt
Whitney Elementary School Site

Widespread cracking is evident - AssetCALC ID: 7170277

Uniformat Code: G2020
Recommendation: **Cut and Patch in 2023**

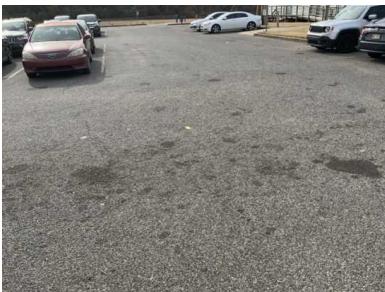
Parking Lots in Poor condition.

Pavement, Asphalt
Whitney Elementary School Site

Widespread surface degradation - AssetCALC ID: 7170251

Uniformat Code: G2020
Recommendation: **Mill and Overlay in 2025**

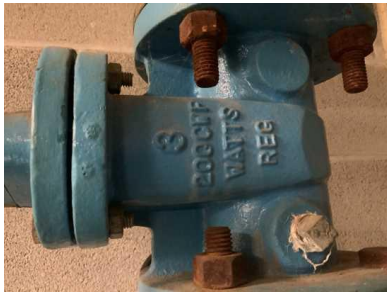
Backflow Preventer in Poor condition.

Domestic Water
Whitney Elementary School Rear wing boiler room

Fluctuating water pressure. Leaking pressure relief valve - AssetCALC ID: 7170225

Uniformat Code: D2010
Recommendation: **Replace in 2025**

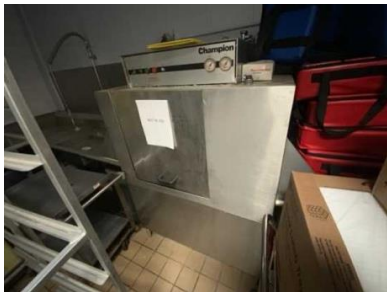
Foodservice Equipment in Failed condition.

Dishwasher Commercial
Whitney Elementary School Kitchen

Uniformat Code: E1030
Recommendation: **Replace in 2023**

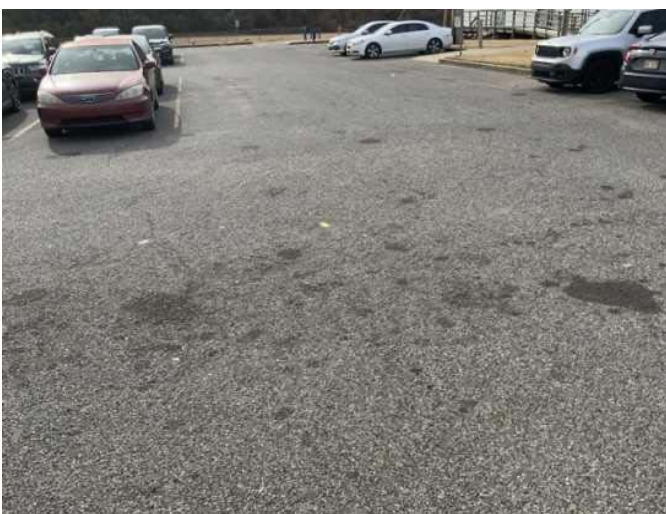
29 - PARKING LOT

The parking lot paving has been replaced around 2000 after the original construction but is currently showing signs of wear and weathering including widespread areas of alligator cracking. Near term lifecycle replacement is recommended. Concrete sidewalk pavement shows signs of widespread surface degradation and is due for near term lifecycle replacement. There are no playground structures on the school property, however, there is a playground in the neighboring public park. Temporary classroom buildings on the school property are vacant and scheduled for demolition and removal.
