# FACILITY CONDITION ASSESSMENT

**Shelby County Board of Education**  
160 South Hollywood Street  
Memphis, Tennessee 38112-4892  
Michelle Stuart

Brewster Elementary  
2605 Sam Cooper Boulevard  
Memphis, Tennessee 38112

*September 30, 2024*

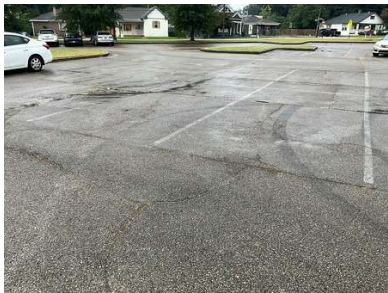
**Parking Lots in Poor condition.**

Pavement, Asphalt  
Brewster Elementary Site

Large cracks, ponding observed - AssetCALC ID: 8026477

Uniformat Code: G2020  
Recommendation: **Mill & Overlay in 2025**

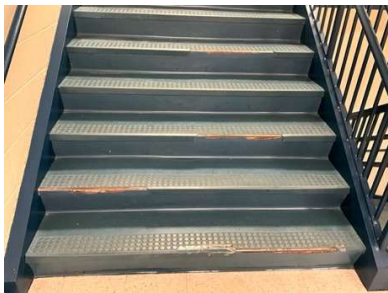
**Stair Treads in Poor condition.**

Raised Rubber Tile  
Brewster Elementary Stairwells

Deteriorated - AssetCALC ID: 8026454

Uniformat Code: B1080  
Recommendation: **Replace in 2025**

| Unit/Item Code | Location Description | ID | Cost Description | Lifespan (EUL) | EAge | RUL | Quantity | Unit | Unit Cost * | Subtotal 2024 | 2025 | 2026 | 2027 | 2028 | 2029 | 2030 | 2031 | 2032 | 2033 | 2034 | 2035 | 2036 | 2037 | 2038 | 2039 | 2040 | 2041 | 2042 | 2043 | 2044 | Deficiency Repair Estimate |
|---|---|---|---|---|---|---|---|---|---|---|---|---|---|---|---|---|---|---|---|---|---|---|---|---|---|---|---|---|---|---|---|
| B1080 | Stairwells | 8026454 | Stair Treads, Raised Rubber Tile, Replace | 18 | 17 | 1 | 260 | SF | \$10.00 | \$2,600 | | \$2,600 | | | | | | | | | | | | | | | | | \$2,600 | | \$5,200 |

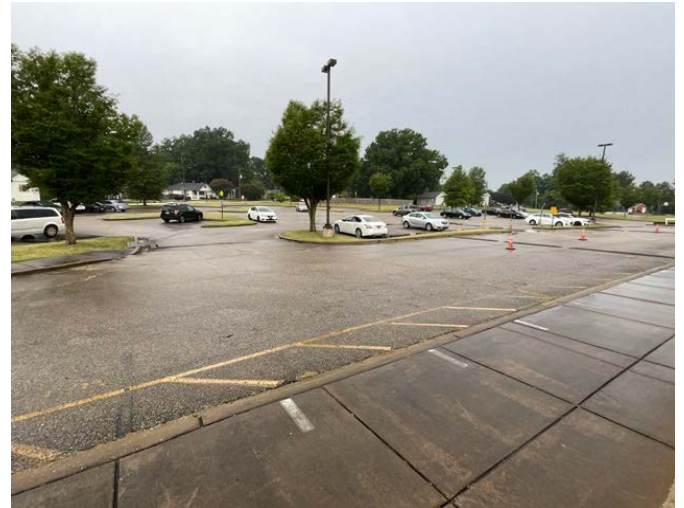
32 - MAIN PARKING AREA

Site maintenance appears to be in fair condition. However, the sidewalks are pocked and uneven. The asphalt parking lot is in poor condition, with large cracks, and signs of ponding and alligator cracking.
