FACILITY CONDITION ASSESSMENT

Shelby County Board of Education
160 South Hollywood Street
Memphis, Tennessee 38112-4892
Michelle Stuart

Winchester Elementary School
3587 Boeingshire Drive
Memphis, Tennessee 38116

January 15, 2024

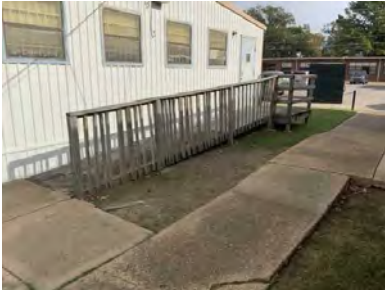
Exterior Ramp in Poor condition.

Wood
Portable A Winchester Elementary Site

Missing parts, uneven surface - AssetCALC ID: 7132382

Unifomat Code: B1010
Recommendation: **Replace in 2025**

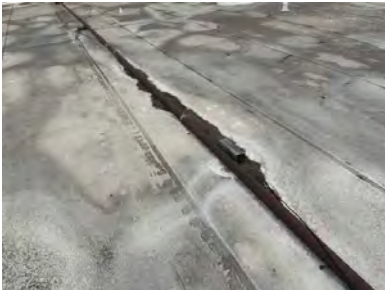
Gas line in Poor condition.

rusted
Winchester Elementary School Winchester
Elementary Roof

Gasline off blocks, needs paint - AssetCALC ID: 7132147

Unifomat Code: D3010
Recommendation: **n/a in 2024**

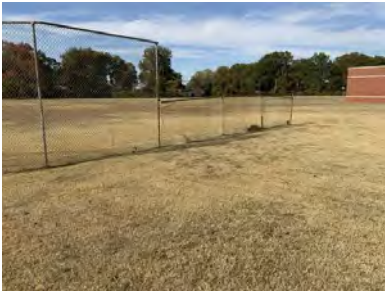
Sports Apparatus in Poor condition.

Baseball, Backstop Chain-Link
Winchester Elementary School Winchester
Elementary Site

Third base side missing, holes in fence - AssetCALC ID: 7132052

Unifomat Code: G2050
Recommendation: **Replace in 2025**

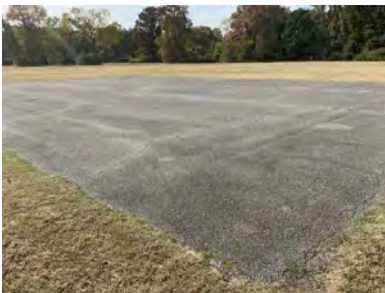
Athletic Surfaces and Courts in Poor condition.

Basketball/General, Asphalt Pavement
Winchester Elementary School Winchester
Elementary Site

Cracking, worn over - AssetCALC ID: 7132128

Unifomat Code: G2050
Recommendation: **Mill and Overlay in 2025**

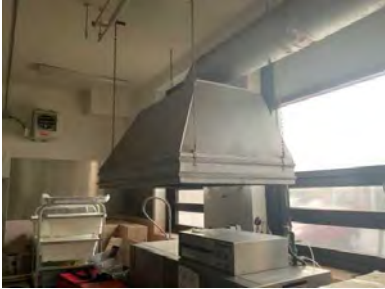
Foodservice Equipment in Poor condition.

Exhaust Hood, 3 to 6 LF
Winchester Elementary School Winchester Elementary Kitchen

Out of service - AssetCALC ID: 7132112

Uniformat Code: E1030
Recommendation: **Replace in 2023**

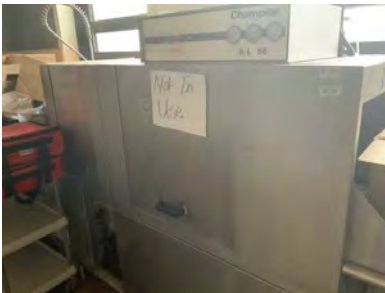
Foodservice Equipment in Poor condition.

Dishwasher Commercial
Winchester Elementary School Winchester Elementary Kitchen

Out of service - AssetCALC ID: 7132156

Uniformat Code: E1030
Recommendation: **Replace in 2024**

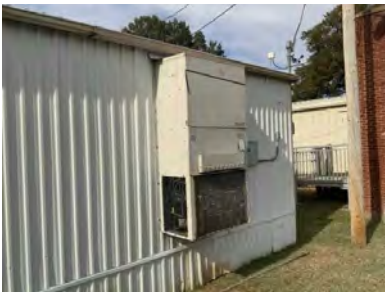
Packaged Terminal Air Conditioner in Poor condition.

PTAC
Portable A Winchester Elementary Building exterior

Equipment out of service 3 years - AssetCALC ID: 7132386

Uniformat Code: D3030
Recommendation: **Replace in 2025**

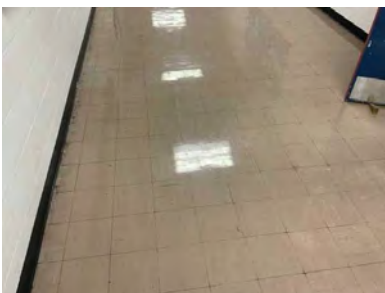
Flooring in Poor condition.

Vinyl Tile (VCT), with Asbestos Abatement
Winchester Elementary School Winchester Elementary Hallway

Asbestos tile, broken in some rooms Included all square footage not knowing if asbestos mastic was addressed - AssetCALC ID: 7132142

Uniformat Code: C2030
Recommendation: **Replace in 2025**

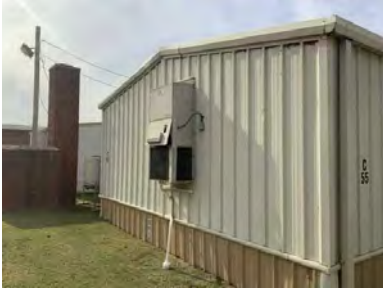
Packaged Terminal Air Conditioner in Poor condition.

PTAC
Portable C55 Winchester Elementary Building exterior

Out of service 3 years - AssetCALC ID: 7132416

Uniformat Code: D3030
Recommendation: **Replace in 2025**

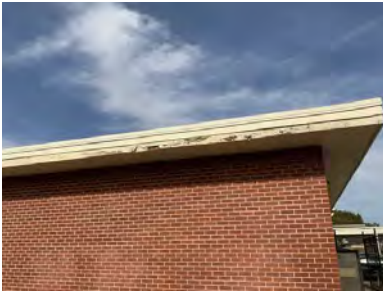
Soffit in Poor condition.

Wood
Winchester Elementary School Winchester Elementary Roof

Rot does not hold paint - AssetCALC ID: 7132180

Uniformat Code: B3080
Recommendation: **Replace in 2025**

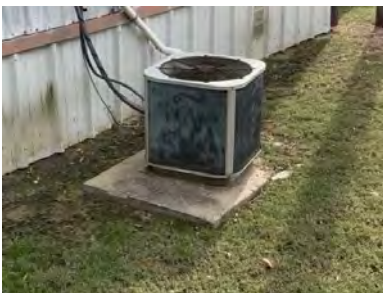
Split System in Poor condition.

Condensing Unit/Heat Pump
Portable C26 Winchester Elementary Site

Out of service 3 years Not on pad - AssetCALC ID: 7132608

Uniformat Code: D3030
Recommendation: **Replace in 2025**

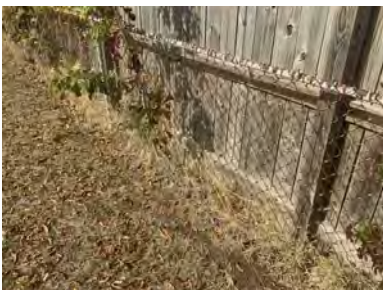
Fences and Gates in Poor condition.

Fence, Chain Link 4'
Winchester Elementary School Winchester Elementary Site

Rusting, damaged areas, - AssetCALC ID: 7132224

Uniformat Code: G2060
Recommendation: **Replace in 2025**

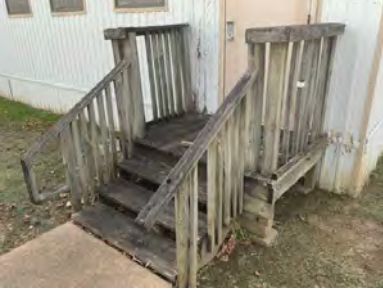
**Stairs in Poor condition.**

Wood, Exterior
Portable A Winchester Elementary Site

Worn, missing parts - AssetCALC ID: 7132387

Uniformat Code: B1080
Recommendation: **Replace in 2025**

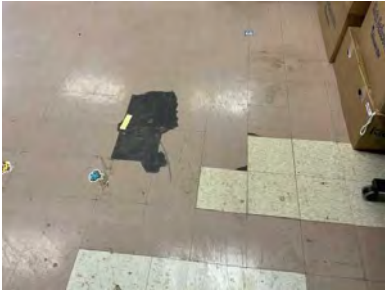
**Recommended Follow-up Study:
Environmental, Asbestos (ACM)
and Lead Base Paint (LBP)**

Environmental, Asbestos (ACM) and Lead
Base Paint (LBP)
Winchester Elementary School Winchester
Elementary

Uniformat Code: P2030
Recommendation: **Evaluate/Report in 2023**
