FACILITY CONDITION ASSESSMENT

*Bureau Veritas
6021 University Boulevard, Suite 200
Ellicott City, Maryland 21043
www.us.bureauveritas.com*

May 16, 2024

Woodstock Middle School
5885 Woodstock Cuba Road
Memphis, Tennessee 38127

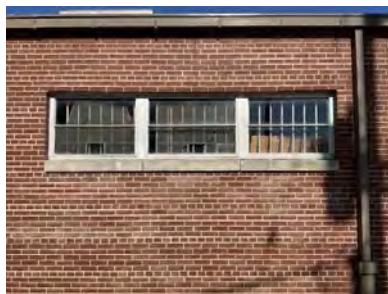
Window in Poor condition.

Aluminum Double-Glazed, 28-40 SF
Woodstock Middle School Building Exterior

Replace all single pane windows - AssetCALC ID: 7381716

Uniformat Code: B2020
Recommendation: **Replace in 2026**

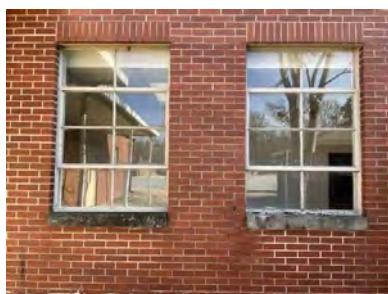
Window in Poor condition.

Steel, 28-40 SF
Woodstock Middle School Building Exterior

Replace all single pane steel windows - AssetCALC ID: 7381751

Uniformat Code: B2020
Recommendation: **Replace in 2026**

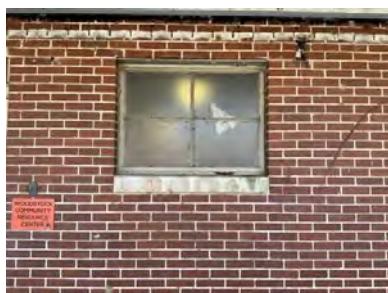
Window in Poor condition.

Steel, 16-25 SF
Woodstock Middle School Building Exterior

Replace all single pane steel windows - AssetCALC ID: 7381738

Uniformat Code: B2020
Recommendation: **Replace in 2026**

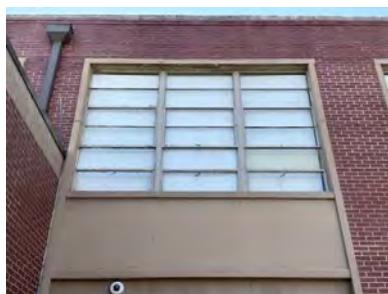
Window in Poor condition.

Steel, 28-40 SF
Woodstock Middle School Building Exterior

Replace all single pane steel windows - AssetCALC ID: 7381726

Uniformat Code: B2020
Recommendation: **Replace in 2026**

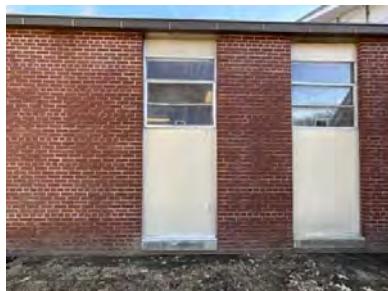
Window in Poor condition.

Steel, 16-25 SF
Woodstock Middle School Gymnasium

Replace all single pane steel windows - AssetCALC ID: 7381750

Uniformat Code: B2020
Recommendation: **Replace in 2026**

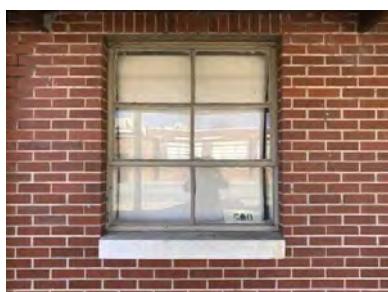
Window in Poor condition.

Steel, 16-25 SF
Woodstock Middle School Building Exterior

Replace all single pane steel windows - AssetCALC ID: 7381717

Uniformat Code: B2020
Recommendation: **Replace in 2026**

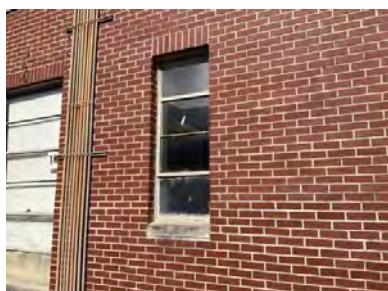
Window in Poor condition.

Steel, 16-25 SF
Woodstock Middle School Building Exterior

Replace all single pane steel windows - AssetCALC ID: 7381727

Uniformat Code: B2020
Recommendation: **Replace in 2026**

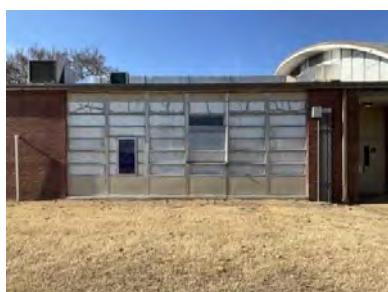
Window in Poor condition.

Aluminum Double-Glazed, 28-40 SF
Woodstock Middle School Building Exterior

Replace all single pane steel windows - AssetCALC ID: 7381688

Uniformat Code: B2020
Recommendation: **Replace in 2026**

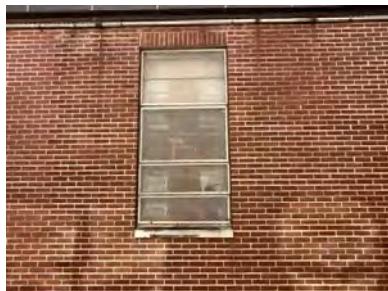
Window in Poor condition.

Steel, 28-40 SF
Woodstock Middle School Building Exterior

Replace, single pane steel windows - AssetCALC ID: 7381702

Uniformat Code: B2020
Recommendation: **Replace in 2026**

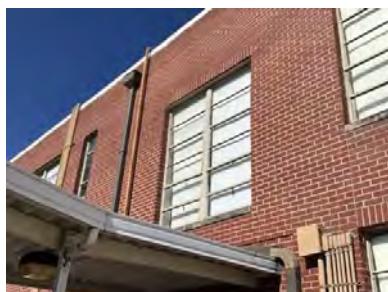
Window in Poor condition.

Steel, 28-40 SF
Woodstock Middle School Building Exterior

Replace all single pane steel windows - AssetCALC ID: 7381722

Uniformat Code: B2020
Recommendation: **Replace in 2026**

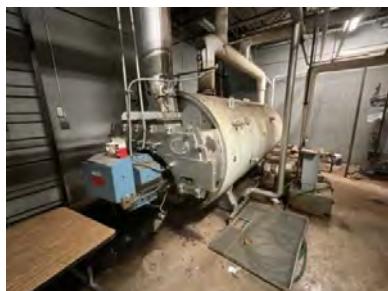
Boiler in Failed condition.

Gas, HVAC
Woodstock Middle School Gym Boiler Room

Decommissioned - AssetCALC ID: 7378084

Uniformat Code: D3020
Recommendation: **Replace in 2024**

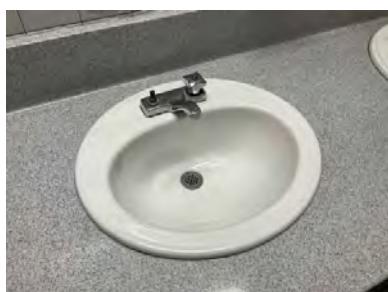
Sink/Lavatory in Poor condition.

Vanity Top, Solid Surface or Vitreous China
Woodstock Middle School Restrooms

Damaged, aged, and missing hardware - AssetCALC ID: 7424547

Uniformat Code: D2010
Recommendation: **Replace in 2026**

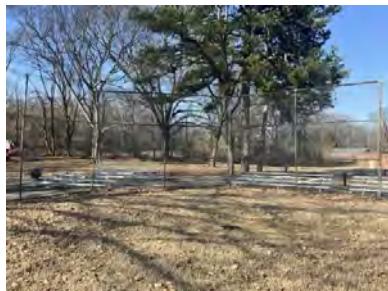
Sports Apparatus in Failed condition.

Baseball, Backstop Chain-Link
Woodstock Middle School Site

Chain link has rusted as well as torn away from supports. Large openings in the fencing. - AssetCALC ID: 7378109

Recommendation: **Replace in 2024**

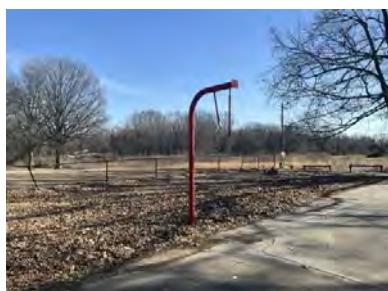
Sports Apparatus in Poor condition.

Basketball, Backboard/Rim/Pole
Woodstock Middle School Site

Worn and weakened from age and use. 1 of 4 has failed - AssetCALC ID: 7378128

Recommendation: **Replace in 2026**

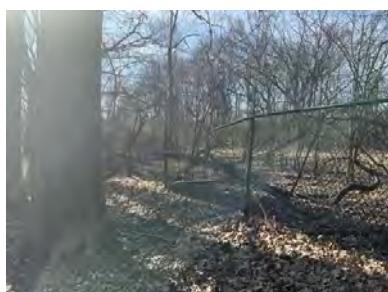
Fences and Gates in Failed condition.

Fence, Chain Link 6'
Woodstock Middle School Site

Fallen trees have damaged sections of fencing - AssetCALC ID: 7378082

Recommendation: **Replace in 2024**

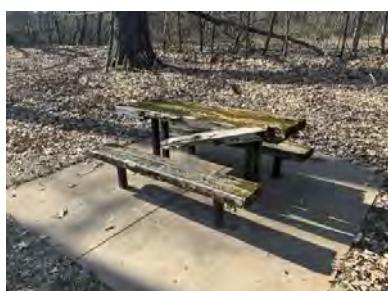
Picnic Table in Failed condition.

Wood/Composite/Fiberglass
Woodstock Middle School Site

Wood rot, moss growth, broken seating plane - AssetCALC ID: 7378116

Recommendation: **Replace in 2024**

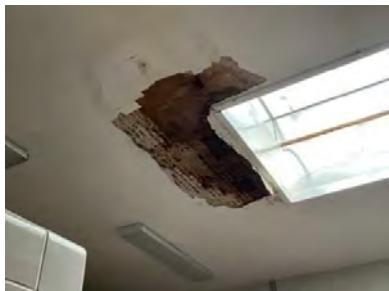
Ceiling Finishes in Poor condition.

Gypsum Board/Plaster
Woodstock Middle School Gymnasium

Girls shower room, Water damage - AssetCALC ID: 7381755

Uniformat Code: C2050
Recommendation: **Replace in 2025**

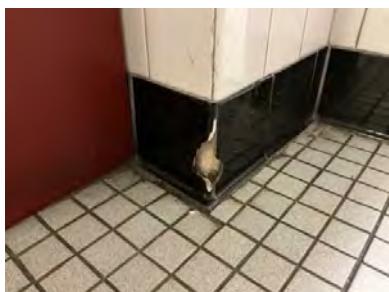
Flooring in Poor condition.

Ceramic Tile
Woodstock Middle School Restrooms

Deteriorating tile - AssetCALC ID: 7381693

Uniformat Code: C2030
Recommendation: **Replace in 2026**

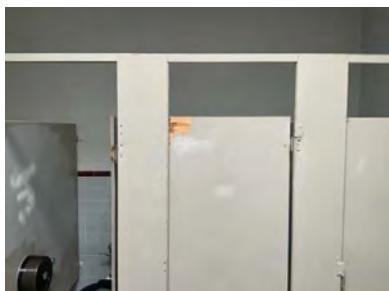
Toilet Partitions in Poor condition.

Wood
Woodstock Middle School Throughout building

Damaged and worn from use. Replace with plastic partitions - AssetCALC ID: 7424553

Uniformat Code: C1090
Recommendation: **Replace in 2026**

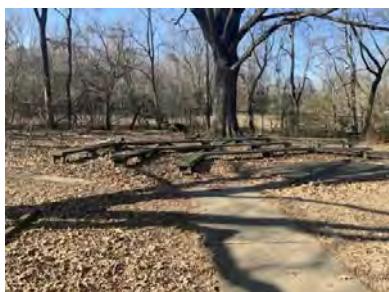
Outdoor Spectator Seating in Poor condition.

Amphitheater, Timber
Woodstock Middle School Site

Broken seating planes - AssetCALC ID: 7378105

Uniformat Code: G2060
Recommendation: **Replace in 2026**

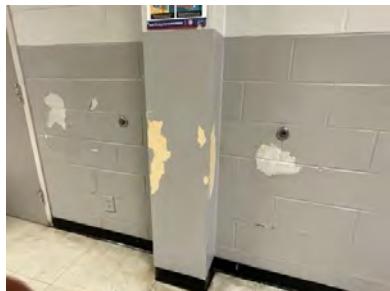
Wall Finishes in Poor condition.

any surface
Woodstock Middle School Restrooms

peeling/deteriorating paint - AssetCALC ID: 7381733

Uniformat Code: C2010
Recommendation: **Prep and Paint in 2026**

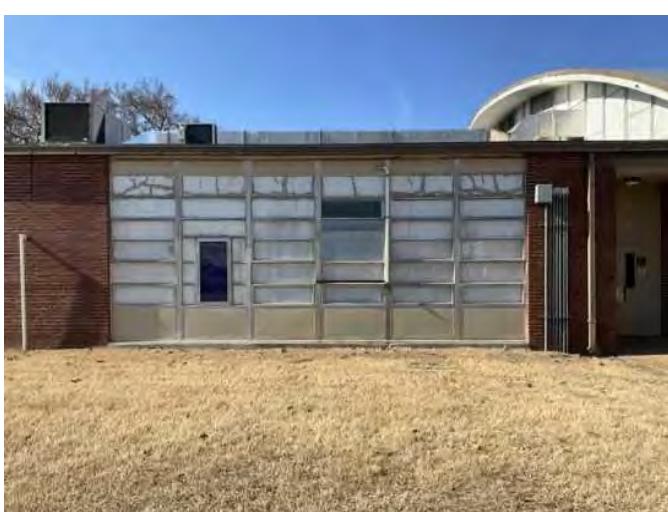
5 - SINGLE PANE STEEL FRAME WINDOWS

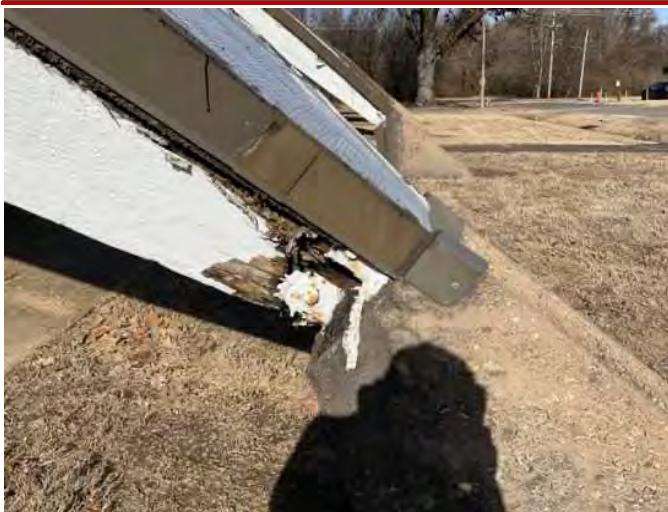
7 - WOOD ROT AT ROOF STRUCTURE (GYMNASIUM)
