# FACILITY CONDITION ASSESSMENT

**Shelby County Board of Education**  
160 South Hollywood Street  
Memphis, Tennessee 38112-4892  
Michelle Stuart

Georgian Hills Elementary School  
3930 Leweir Street  
Memphis, TN 38127

April 19, 2024

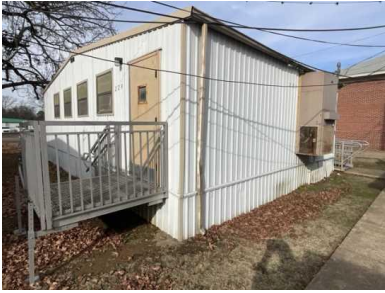
### Ancillary Building in Poor condition.

Classroom/Office Module, Basic/Portable  
Georgian Hills Elementary School Portables

Portables are no longer in use, only for storage - AssetCALC ID: 7185462

Uniformat Code: F1020  
Recommendation: **Replace in 2024**

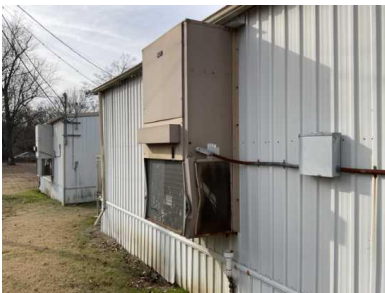
### Heat Pump in Poor condition.

Packaged and Wall-Mounted  
Georgian Hills Elementary School Portables

Portables are no longer in use, only for storage - AssetCALC ID: 7185449

Uniformat Code: D3030  
Recommendation: **Replace in 2024**

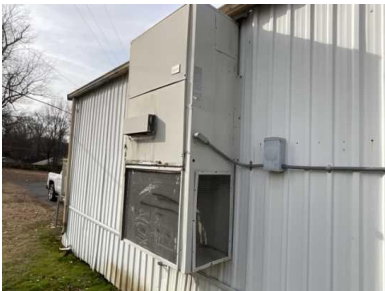
### Heat Pump in Poor condition.

Packaged and Wall-Mounted  
Georgian Hills Elementary School Portables

Portables are no longer in use, only for storage - AssetCALC ID: 7185444

Uniformat Code: D3030  
Recommendation: **Replace in 2024**

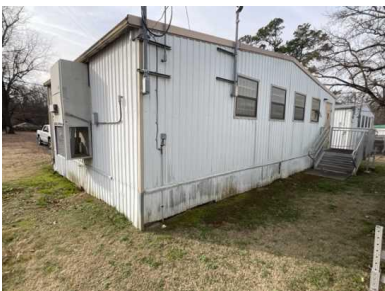
### Ancillary Building in Poor condition.

Classroom/Office Module, Basic/Portable  
Georgian Hills Elementary School Portables

Portables are no longer in use, only for storage - AssetCALC ID: 7185445

Uniformat Code: F1020  
Recommendation: **Replace in 2024**

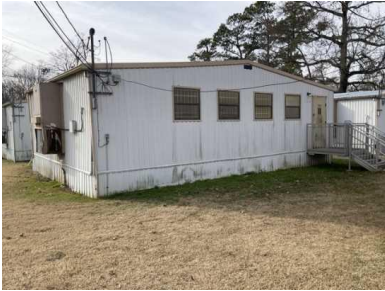
### Ancillary Building in Poor condition.

Classroom/Office Module, Basic/Portable  
Georgian Hills Elementary School Portables

Portables are no longer in use, only for storage - AssetCALC ID: 7185436

Uniformat Code: F1020  
Recommendation: **Replace in 2024**

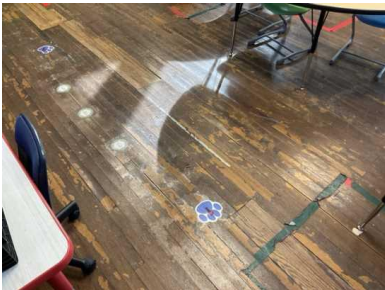
### Flooring in Poor condition.

Wood, Strip  
Georgian Hills Elementary School Classrooms

Excessive wear of wood surfaces observed - AssetCALC ID: 7185448

Uniformat Code: C2030  
Recommendation: **Refinish in 2023**

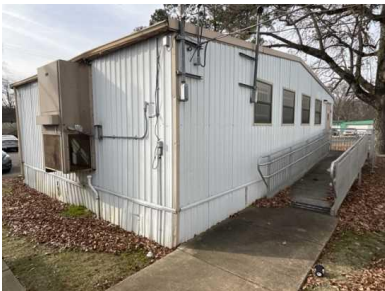
### Ancillary Building in Poor condition.

Classroom/Office Module, Basic/Portable  
Georgian Hills Elementary School Portables

Portables are no longer in use, only for storage - AssetCALC ID: 7185502

Uniformat Code: F1020  
Recommendation: **Replace in 2024**

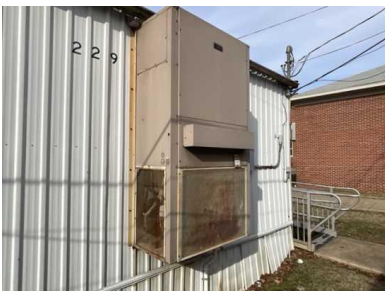
### Heat Pump in Poor condition.

Packaged and Wall-Mounted  
Georgian Hills Elementary School Portables

Portables are no longer in use, only for storage - AssetCALC ID: 7185447

Uniformat Code: D3030  
Recommendation: **Replace in 2024**

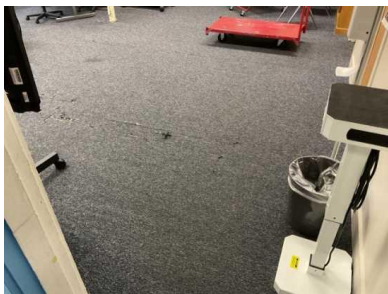
Flooring in Poor condition.

Carpet, Commercial Standard  
Georgian Hills Elementary School Classrooms

Ripped areas of carpet and excessive wear - AssetCALC ID: 7185458

Uniformat Code: C2030  
Recommendation: **Replace in 2023**

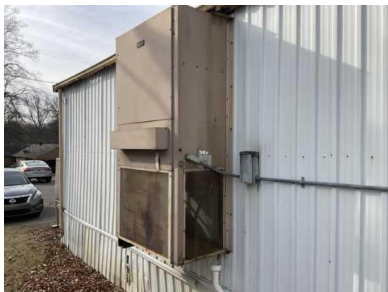
Heat Pump in Poor condition.

Packaged and Wall-Mounted  
Georgian Hills Elementary School Portables

Uniformat Code: D3030  
Recommendation: **Replace in 2024**

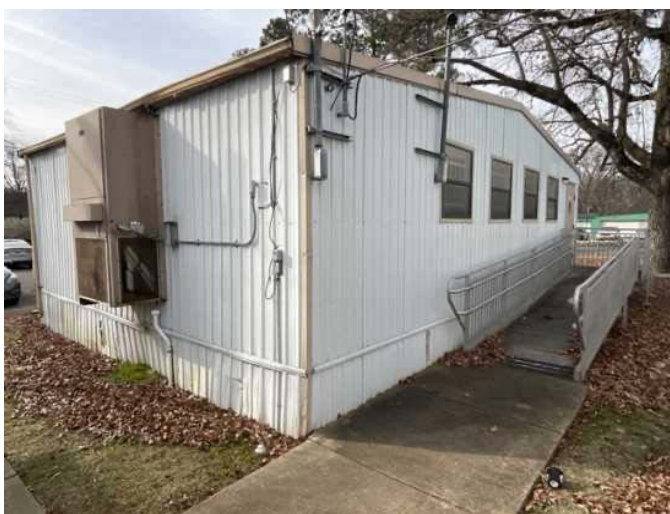
29 - PORTABLE CLASSROOMS

<b>Ancillary Structures</b>	Portable classroom buildings	Poor
<b>Accessibility</b>	Presently it does not appear an accessibility study is needed for this property. See Appendix D.	
<b>Key Issues and Findings</b>	Portables are no longer in use, only for storage, ripped areas of carpet and excessive wear
