# FACILITY CONDITION ASSESSMENT

**Shelby County Board of Education**  
160 South Hollywood Street  
Memphis, Tennessee 38112-4892  
Mary Taylor

Grahamwood Elementary  
School 3950 Summer Avenue  
Memphis, Tennessee 38122

*September 30, 2024*

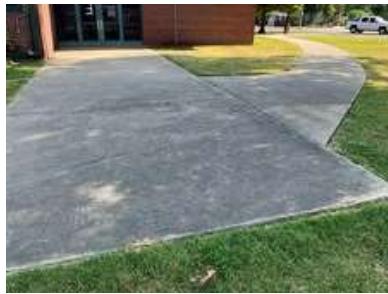
### Sidewalk in Poor condition.

Concrete, Large Areas  
Grahamwood Elementary School Site

Large cracks observed, as well as severe parking on surface and a little bit of up - AssetCALC ID: 8003524

Recommendation: **Replace in 2026**

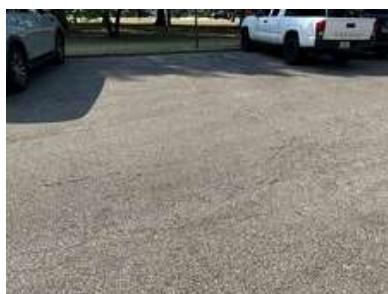
### Parking Lots in Poor condition.

Pavement, Asphalt  
Grahamwood Elementary School Site

Barely visible - AssetCALC ID: 8003526

Recommendation: **Seal & Stripe in 2025**

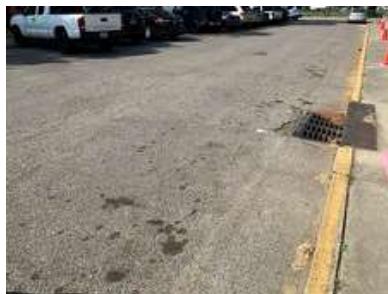
### Parking Lots in Poor condition.

Pavement, Asphalt  
Grahamwood Elementary School Site

Cracking and welling observed - AssetCALC ID: 8003547

Recommendation: **Mill & Overlay in 2026**

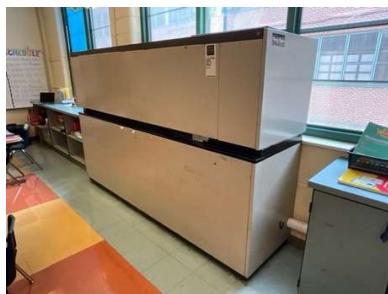
### Unit Ventilator in Poor condition.

approx/nominal 2 Ton  
Grahamwood Elementary School Classroom  
245

Down unit - AssetCALC ID: 8029470

Recommendation: **Replace in 2024**

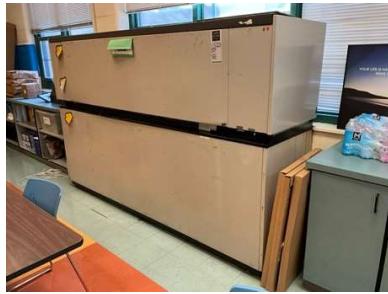
## Unit Ventilator in Poor condition.

approx/nominal 2 Ton  
Grahamwood Elementary School Classroom 236

Down unit - AssetCALC ID: 8029482

Uniformat Code: D3030  
Recommendation: **Replace in 2024**

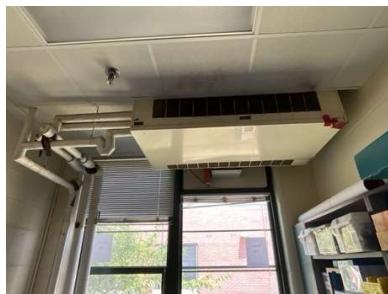
## Unit Ventilator in Poor condition.

approx/nominal 2 Ton  
Grahamwood Elementary School Room 246

Down unit - AssetCALC ID: 8029469

Uniformat Code: D3030  
Recommendation: **Replace in 2024**

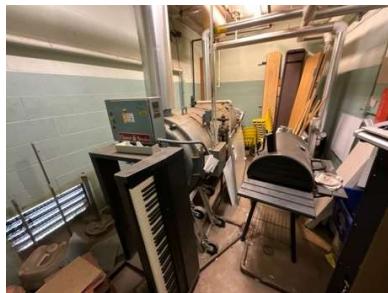
## Boiler

Gas, HVAC  
Grahamwood Elementary School Boiler Room

Uniformat Code: D3020  
Recommendation: **Replace in 2024**
