# FACILITY CONDITION ASSESSMENT

**Shelby County Board of Education**  
160 South Hollywood Street  
Memphis, Tennessee 38112-4892  
Michelle Stuart

Grandview Heights Middle School  
2342 Clifton Avenue  
Memphis, Tennessee 38127

*January 15, 2024*

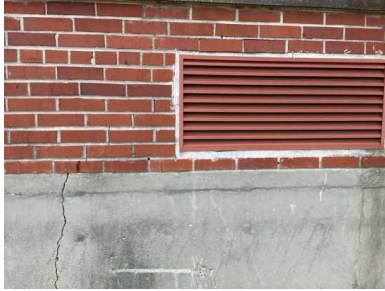
**Exterior Walls in Poor condition.**

Brick  
Grandview Heights Middle School Building  
Exterior

Some areas of brick needs repointing - AssetCALC ID: 7168543

| ID | Location | Location Description | UF Code | Description | Condition | Plan Type | Cost |
|---|---|---|---|---|---|---|---|
| 7168543 | Grandview Heights Middle School | Building Exterior | B2010 | Exterior Walls, Brick, Repair/Repoint | Poor | Performance/Integrity | \$16,500 |

Uniformat Code: B2010  
Recommendation: **Repair/Repoint in 2023**

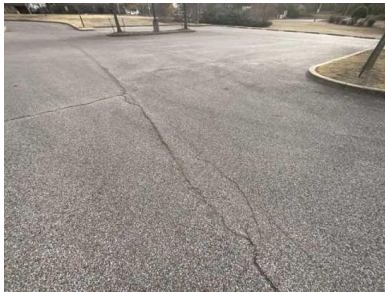
**Parking Lots in Poor condition.**

Pavement, Asphalt  
Grandview Heights Middle School Site

Asphalt weathered and cracked, markings worn - AssetCALC ID: 7168574

Uniformat Code: G2020  
Recommendation: **Mill and Overlay in 2025**

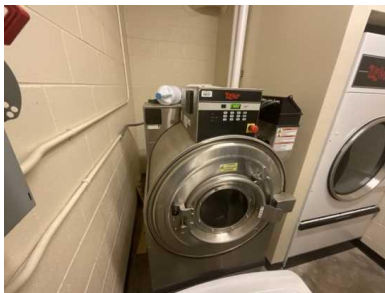
**Laundry Equipment in Failed condition.**

Washer, Commercial  
Grandview Heights Middle School Gymnasium

Not operating - AssetCALC ID: 7168501

| ID | Location | Location Description | UF Code | Description | Condition | Plan Type | Cost |
|---|---|---|---|---|---|---|---|
| 7168501 | Grandview Heights Middle School | Gymnasium | E1030 | Laundry Equipment, Washer, Commercial, Replace | Failed | Performance/Integrity | \$9,700 |

Uniformat Code: E1030  
Recommendation: **Replace in 2023**

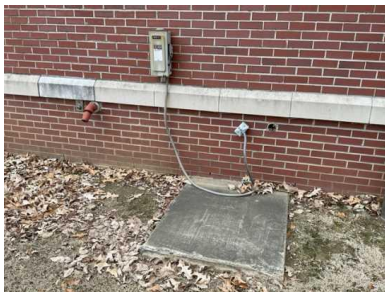
**Split System in Failed condition.**

Condensing Unit/Heat Pump  
Grandview Heights Middle School Site

Condensing Unit is missing - AssetCALC ID: 7168477

| ID | Location | Location Description | UF Code | Description | Condition | Plan Type | Cost |
|---|---|---|---|---|---|---|---|
| 7168477 | Grandview Heights Middle School | Site | D3030 | Split System, Condensing Unit/Heat Pump, Replace | Failed | Performance/Integrity | \$7,100 |

Uniformat Code: D3030  
Recommendation: **Replace in 2023**
