# FACILITY CONDITION ASSESSMENT

**Shelby County Board of Education**  
160 South Hollywood Street  
Memphis, Tennessee 38112-4892  
Michelle Stuart

JP Freeman Stadium  
5250 Tulane Road  
Memphis, Tennessee 38109

*September 30, 2024*

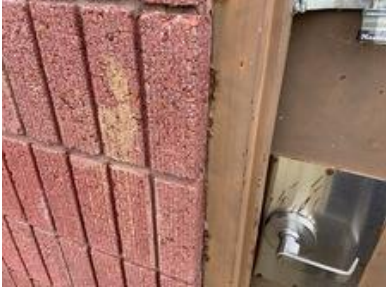
### Caulking in Poor condition.

Window Edge/Trim, per 24 SF Window (or 20 LF)  
JP Freeman Stadium Concession Stand

Failed joints - AssetCALC ID: 8086099

Uniformat Code: B2010  
Recommendation: **Replace in 2024**
