FACILITY CONDITION ASSESSMENT

Manassas High School
1111 North Manassas Street
Memphis, Tennessee, 38107

163745.23R000-137.354

September 6, 2024

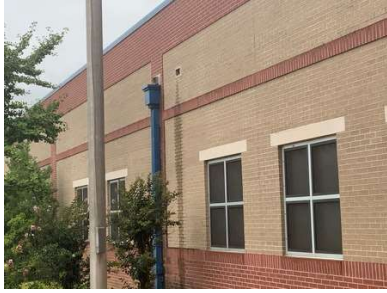
any type, Repairs per Man-Day
Manassas High School Front downspouts

Roofing in Poor condition.

Clogged downspouts. Overflowing during rains - AssetCALC ID: 7869588

Uniformat Code: B3010
Recommendation: **Repair in 2025**

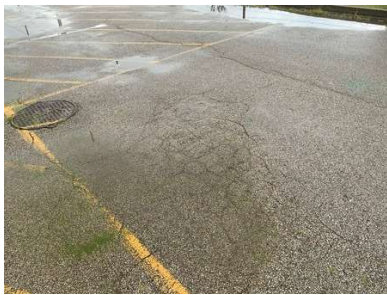
Pavement, Asphalt
Manassas High School Site

Parking Lots in Failed condition.

Transverse and longitudinal cracks throughout parking lot - AssetCALC ID: 7869433

Uniformat Code: G2020
Recommendation: **Cut & Patch in 2024**

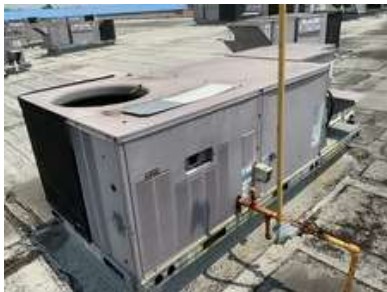
RTU, Pad or Roof-Mounted
Manassas High School Roof

Packaged Unit in Failed condition.

Unit is disabled - AssetCALC ID: 7869517

Uniformat Code: D3050
Recommendation: **Replace in 2024**

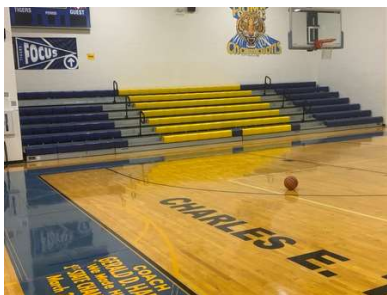
Telescoping Power-Operated, up to 15 Tier
(per Seat)
Manassas High School Gymnasium

Bleachers in Failed condition.

POC reports that bleachers are broken and no longer operable - AssetCALC ID: 7869563

Uniformat Code: E2010
Recommendation: **Replace in 2025**

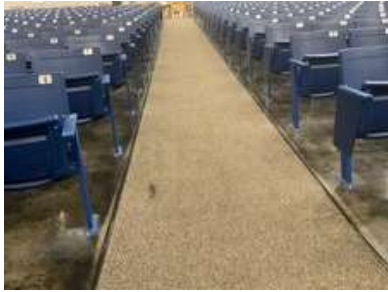
Carpet, Commercial Standard
Manassas High School Auditorium

Flooring in Poor condition.

Carpet is torn and stained - AssetCALC ID: 7869500

Uniformat Code: C2030
Recommendation: **Replace in 2025**

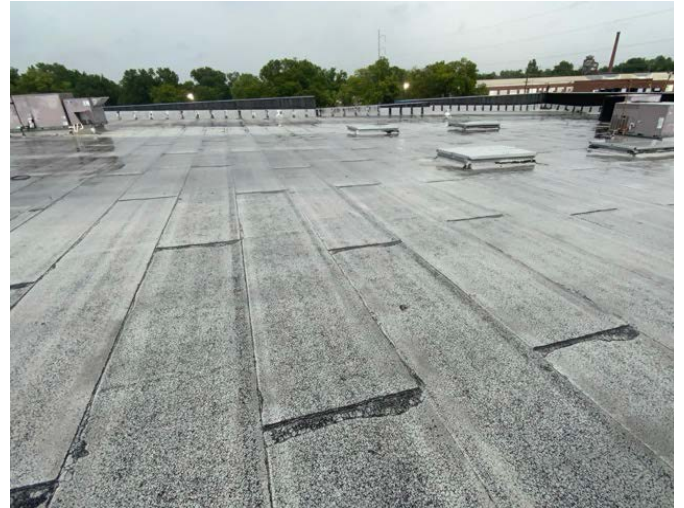
8 - MODIFIED BITUMINOUS ROOFING

Most building envelope components appear to be original and in fair condition. The modified bitumen roof covering is estimated to be installed in 2006 and appears in poor condition due to numerous large areas of cracking and reports of leaks in several areas such as gymnasium and auditorium. The existing sloped metal roof over the main hallway appears to be in fair condition. The interior finishes such as vinyl tile flooring, ceramic tile, acoustic tile ceiling appear to be original. Only typical lifecycle interior finish, exterior finish, and roof membrane replacements are budgeted and anticipated.

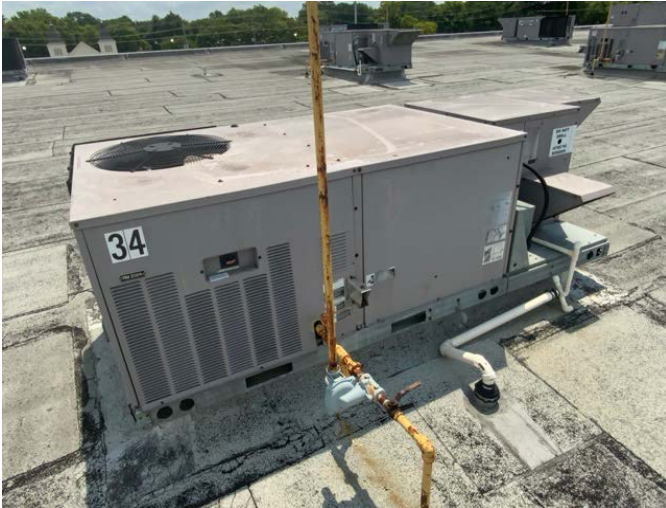
31 - ROOFTOP PACKAGE UNIT

The HVAC system for this facility consists of numerous packaged rooftop units and a few ductless split systems. POC reports that several areas, including some classrooms, have inadequate heating and cooling. Auxiliary heating and cooling provided by ductless split systems around the building. One RTU was found to be currently decommissioned. Rooftop units are served by four 800MBH gas boilers. Near term lifecycle replacement of the packaged units is anticipated.

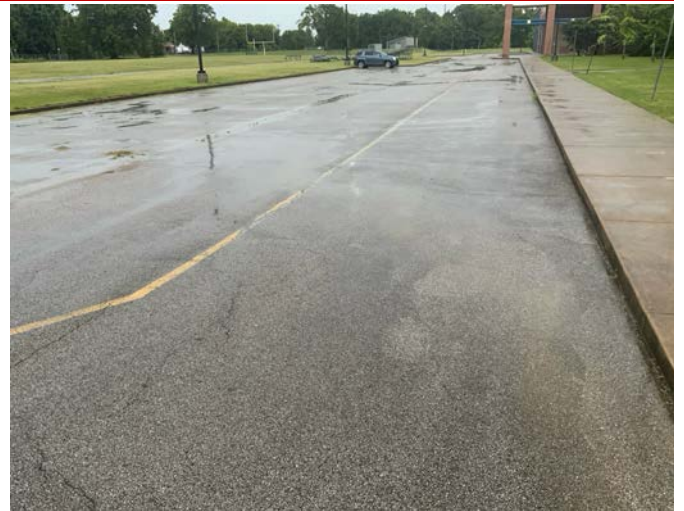
44 - PARKING LOTS

The parking lots and sidewalks appear to be original and are currently showing signs of wear and weathering including widespread areas of longitudinal and alligator cracking in the asphalt paving. Pavement striping has been worn out in all areas. Site lighting has been upgraded to LED recently.

Key Issues and Findings	Severe alligator cracking and potholes.
