# FACILITY CONDITION ASSESSMENT

Mitchell High School  
658 West Mitchell Road  
Memphis, Tennessee 38109

*October 17, 2024*

*September 13, 2024*

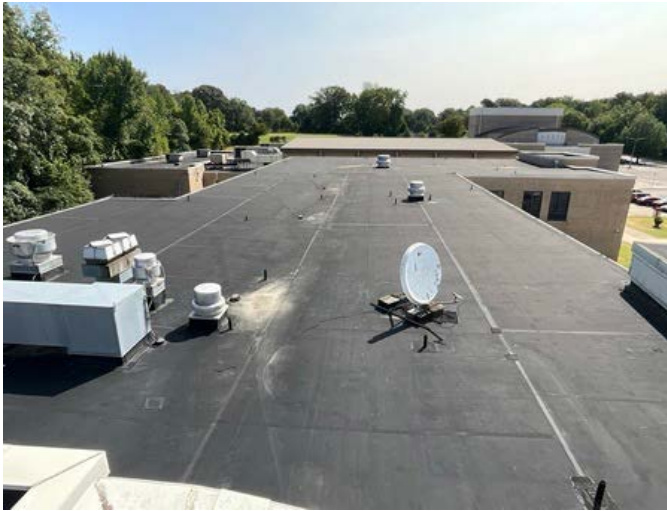
25 – ROOF OVERVIEW

The two-story brick school was constructed in 1957. The windows are aluminum and are well maintained. The roofs are a mixture of metal roofing and membrane. The membrane roofs show signs of wear and requires replacement. The metal roofing is aged, but functional. The interior finishes have been updated throughout the years, but no large-scale projects have taken place.
