FACILITY CONDITION ASSESSMENT

Shelby County Board of Education
160 South Hollywood Street
Memphis, Tennessee 38112-4892
Michelle Stuart

Balmoral Elementary
5905 Grosvenor Avenue
Memphis, Tennessee 38119

September 30, 2024

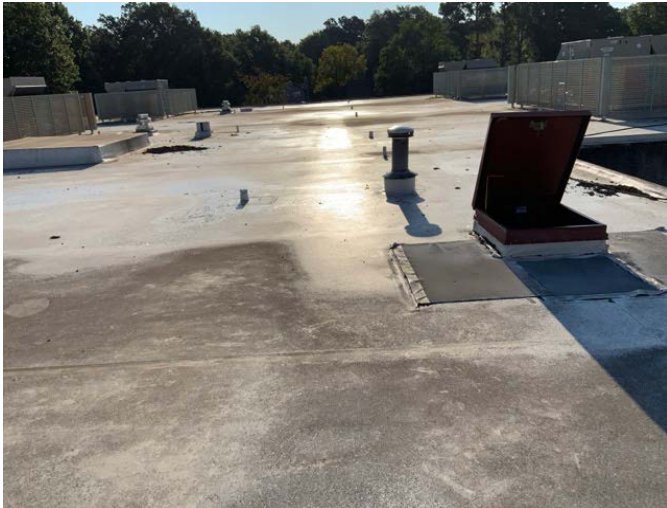
7 - PRIMARY ROOF OVERVIEW

The primary roof is finished using single-ply PVC/TPO membrane and was installed in 2000. The TPO looks to be in good condition. Minor dirt and debris have accumulated on the roof in the corners and near the roof drains. Maintenance should continue inspect the roofs periodically and discard wind-blown debris. No recent deficiencies were reported or observed. No staining or mold was observed. The exterior walls are concrete tilt-up with steel window frames. The interior flooring is mainly VCT. Typical lifecycle interior and exterior finish replacements are budgeted and anticipated.

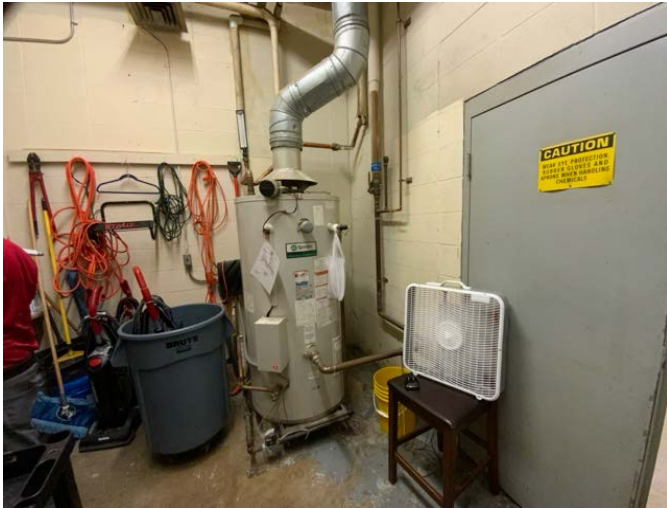
13 - MECHANICAL ROOM - PLUMBING

The domestic water service within the building is well maintained, with no evidence of leaks observed. Domestic hot water is supplied by a commercial gas water heater installed in 2014, which is within ten years of its expected useful life. The plumbing fixtures in the restrooms show very little wear.

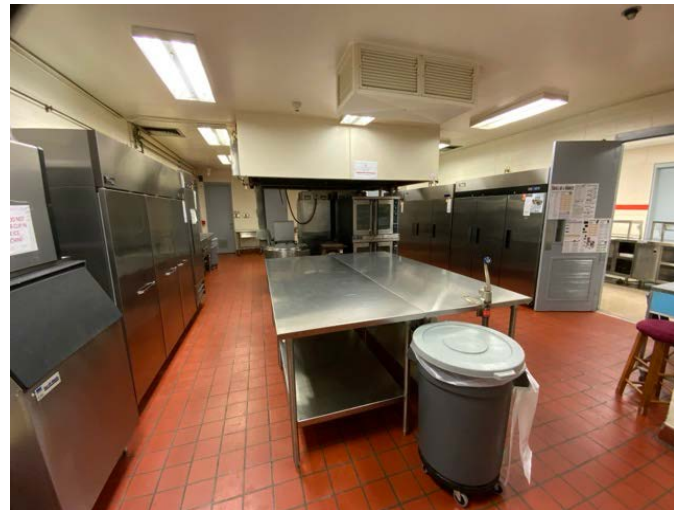
22 - COMMERCIAL KITCHEN

The commercial kitchen contains a variety of foodservice equipment with no deficiencies observed. Future lifecycle replacements are anticipated and appear in the cost tables.

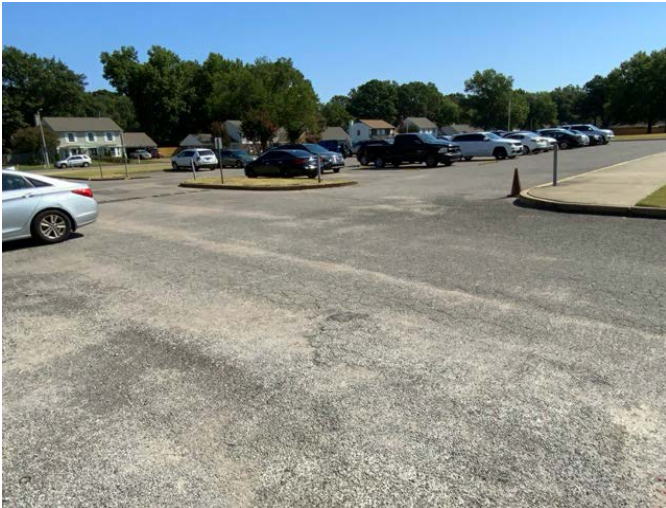
25 - MAIN PARKING AREA

Driveways and parking areas have degraded to the point that they are predominantly potholes and gravel. - AssetCALC ID: 8086705

Recommendation: **Overlay in 2026**
