FACILITY CONDITION ASSESSMENT

Shelby County Board of Education

Barret's Chapel (K-8)
10280 Godwin Road
Arlington, Tennessee 38002

September 30, 2024

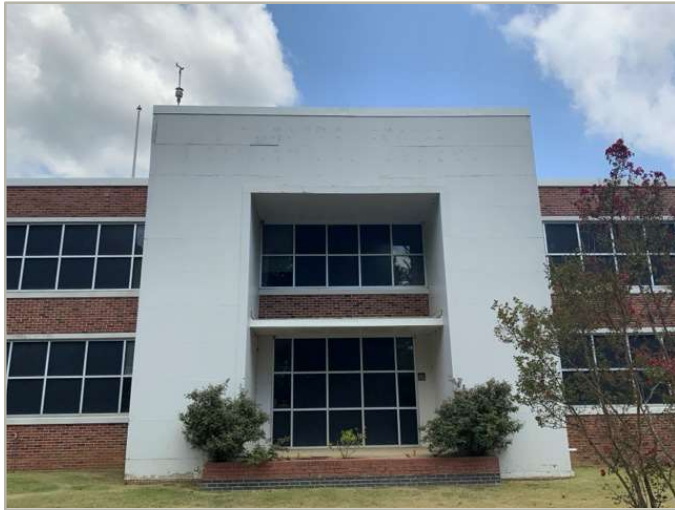
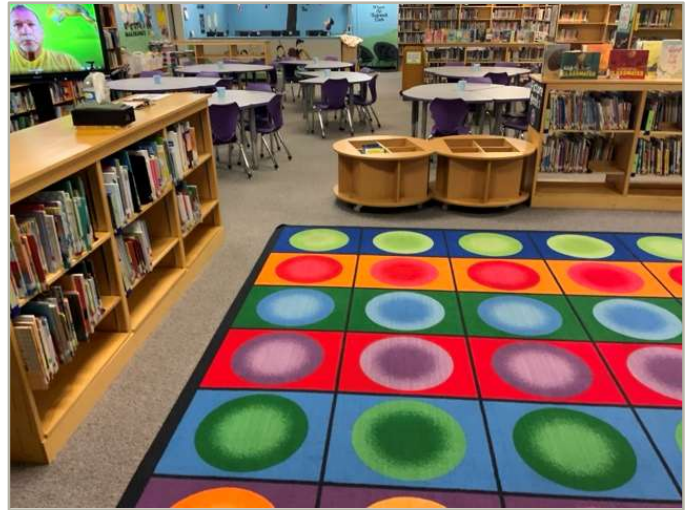
2. Classroom Building

| Classroom Building: Systems Summary | | |
|---|--|---|
| Key Issues and Findings | Exterior windows boarded up, emergency shower missing showerhead, leaking and rusted domestic water expansion tank. missing exterior wall caulking, out of service rooftop equipment | |

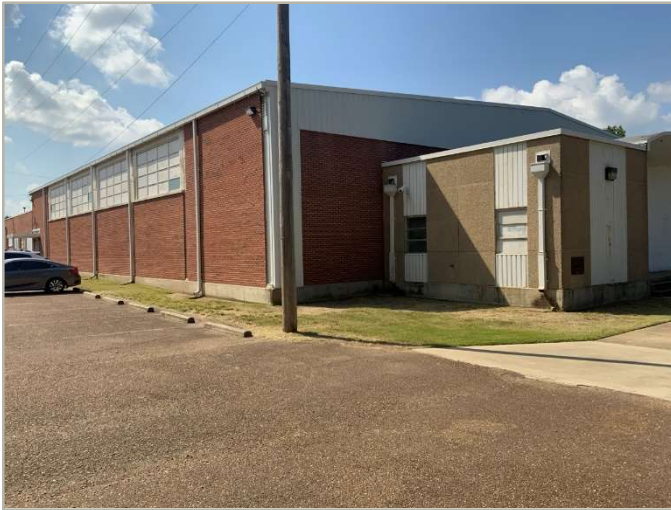
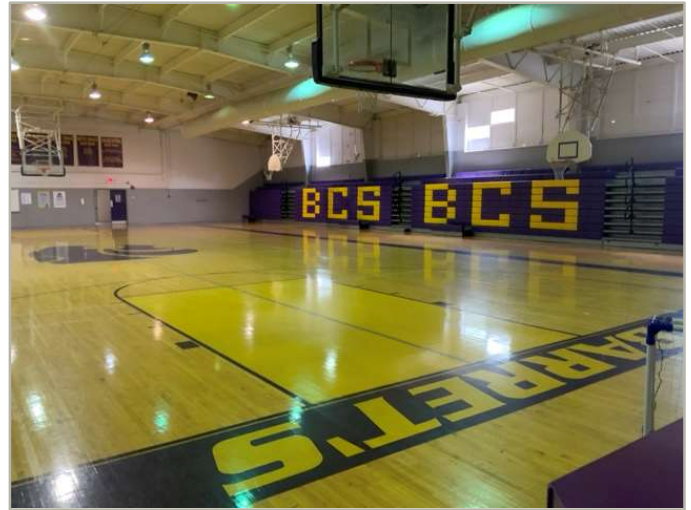
3. Gymnasium

| Key Issues and Findings | Exterior Steel doors and frames rusting out, holes visible., Aluminum windows have broken panes and are not energy efficient., VRV system not working. | |

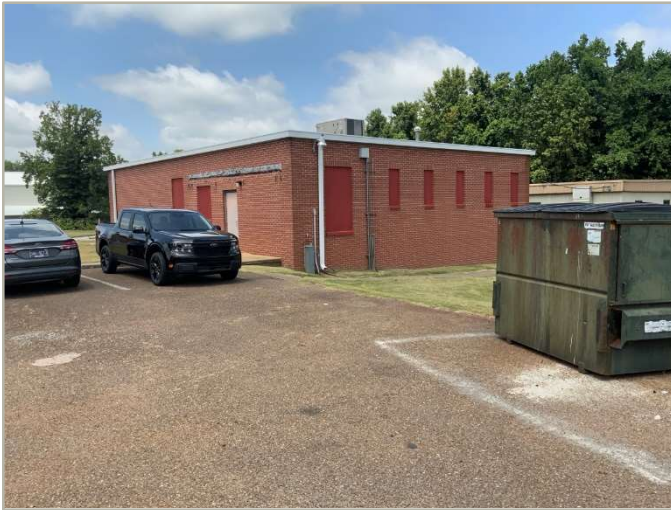
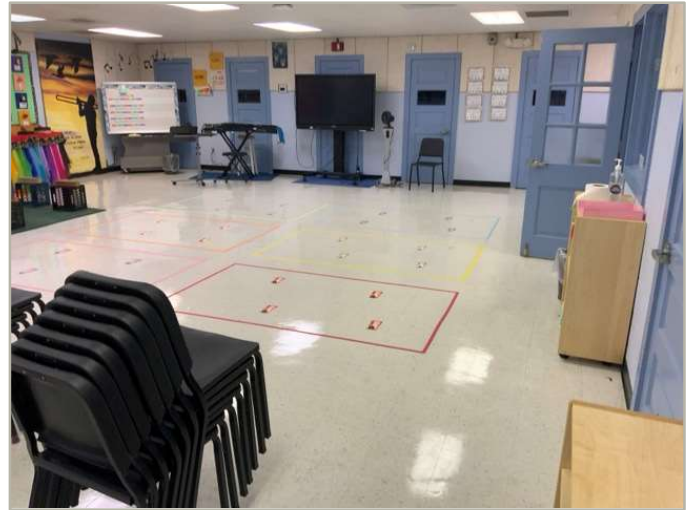
4. Music Building

| Key Issues and Findings | Boarded over windows, Worn out carpet in office | |

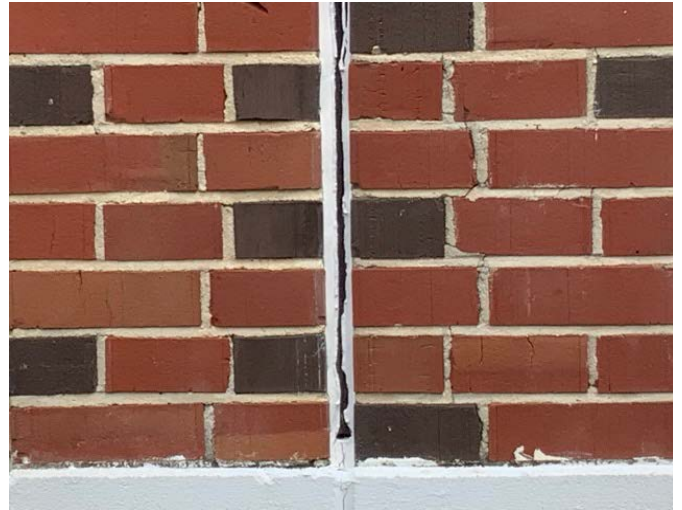
16 - CAULKING

The expansion joints in the walls should be re-caulked. The roof of the classroom building is nearing the end of life and replacement should be planned. The windows in all the buildings are at or near the end of life. Music Building are all boarded over. The Gymnasium has some broken and some boarded over. The classroom building has some with broken seals between the panes and are near the end of life. Generally, the finishes will need to be refreshed before long. There are broken ceramic tiles on the floor expansion joints. The carpets are either worn out or nearing that and should be replaced. The rubber tiles in the stairs are worn and will require replacement in the near future. In some of the rooms the paint is peeling off the substrate.

Caulking in Failed condition.

Uniformat Code: B2010
Recommendation: **Replace in 2024**

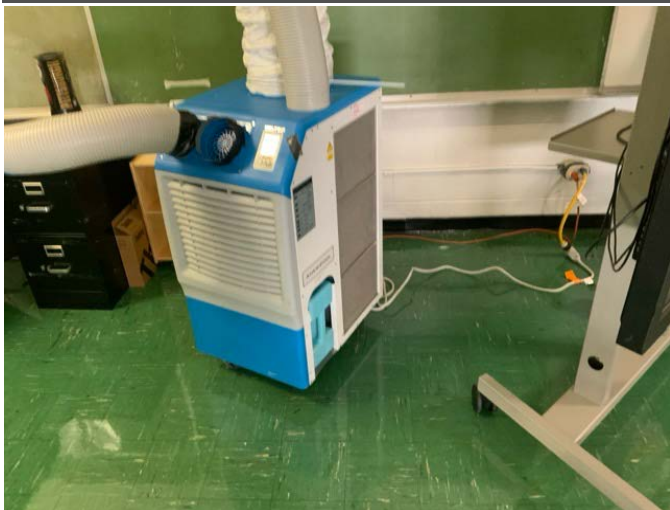
37 - TEMPORARY AIR CONDITIONER IN GYMNASIUM

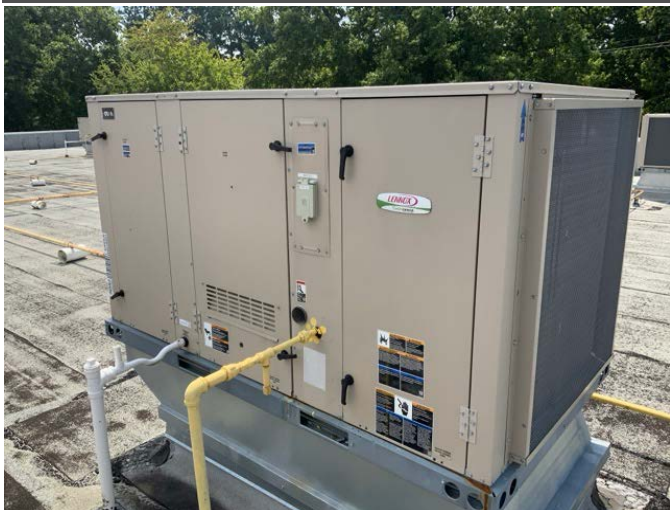
43 - ROOFTOP PACKAGED UNIT

| UF L3 Code | Location | Condition | Asset/Component/Repair | Quantity | RUL | ID |
|---|---|---|--|---|---|---|
| D3050 | Roof | Failed | Packaged Unit, RTU, Pad or Roof-Mounted | 1 | 0 | 8040888 |

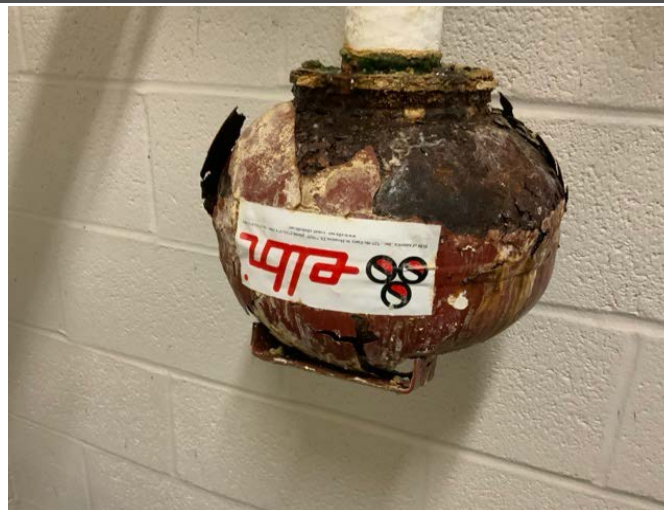
44 - EXPANSION TANK

| UF L3 Code | Location | Condition | Asset/Component/Repair | Quantity | RUL | ID |
|---|---|---|--|---|---|---|
| D3020 | Utility Rooms/Areas | Failed | Boiler Supplemental Components, Expansion Tank | 1 | 0 | 8040971 |
