FACILITY CONDITION ASSESSMENT

Bellevue Middle School
575 South Bellevue Boulevard
Memphis, Tennessee 38104

163745.23R000-005.354

April 19, 2024

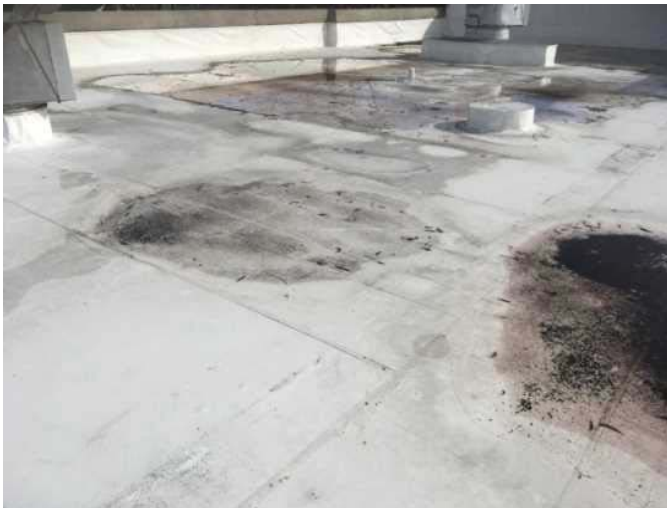
9 - ROOFING, SINGLE-PLY MEMBRANE

Roofing in Failed condition.

Excessive ponding, roof leaks - AssetCALC ID: 7359245

Uniformat Code: B3010
Recommendation: **Evaluate/Report in 2024**

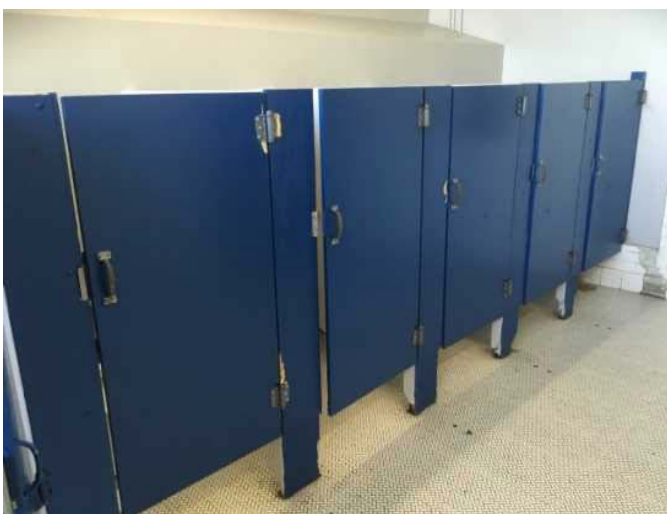
11 - TOILET PARTITIONS

Toilet Partitions in Poor condition.

Rusted or rotted, rickety, inadequate height, hardware worn - AssetCALC ID: 7359350

Uniformat Code: C1090
Recommendation: **Replace in 2024**

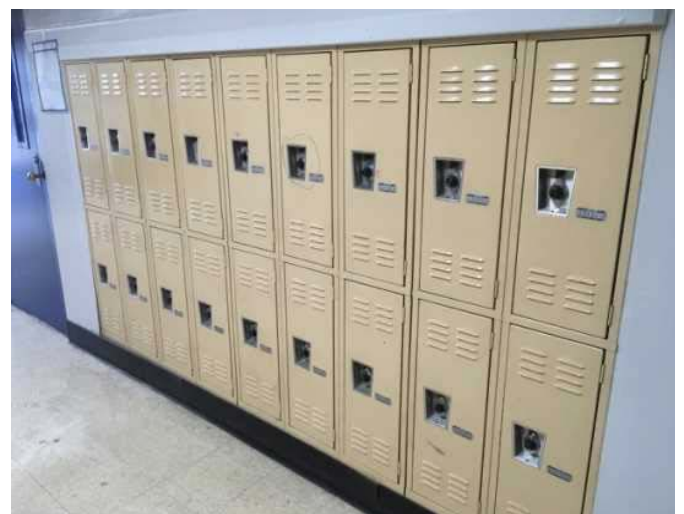
12 - LOCKERS

Lockers in Poor condition.

Many failed locks, unusable - AssetCALC ID: 7359269

Uniformat Code: C1090
Recommendation: **Replace in 2024**

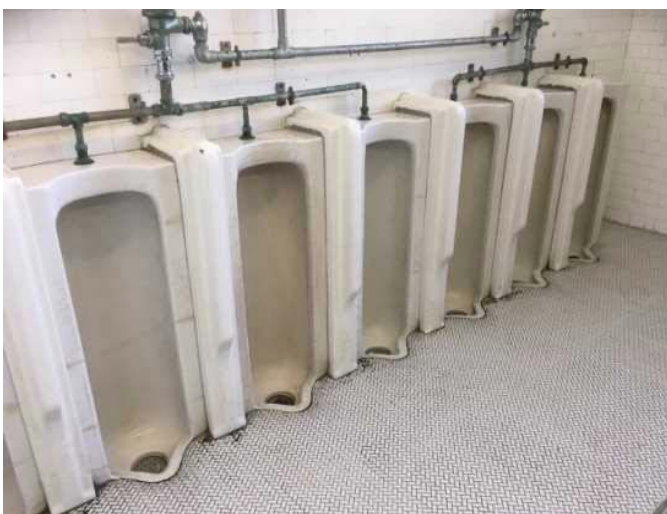
17 - URINAL, STANDARD

Urinal in Poor condition.

Obvious wear, marginal reliability, unnecessary quantity - AssetCALC ID: 7359375

Uniformat Code: D2010
Recommendation: **Replace in 2024**
