# FACILITY CONDITION ASSESSMENT

**Shelby County Board of Education**  
160 South Hollywood Street  
Memphis, Tennessee 38112-4892  
Michelle Stuart

Booker T. Washington High School Stadium  
715 South Lauderdale Street  
Memphis, Tennessee 38126

April 22, 2024

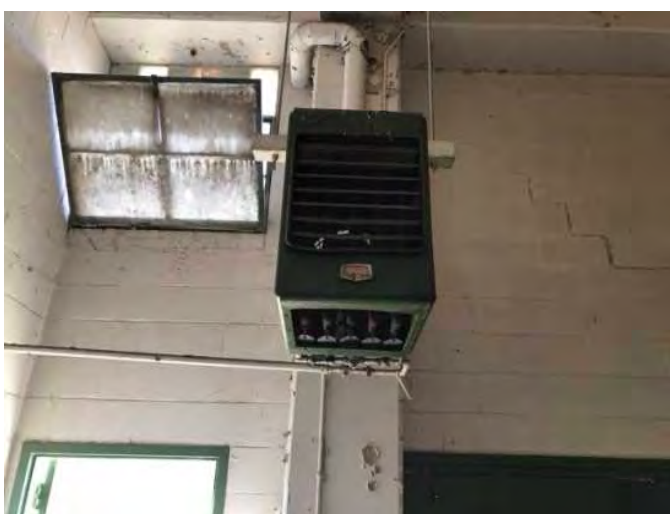
The unit heaters for the different areas are all end of life equipment. The locker rooms have poor temperature control. The electrical distribution is likely original and should be upgraded. It is possible that the electrical service is undersized. The distribution to the various buildings and within should be updated. The lighting on both interior and exterior should be upgraded to LED and fixtures should include lenses. Most of the plumbing was not accessible. What was available is in fair condition for the limited use it is subjected to. Fire protection is limited to portable fire extinguishers that have been removed. There is an AED in the locker room.

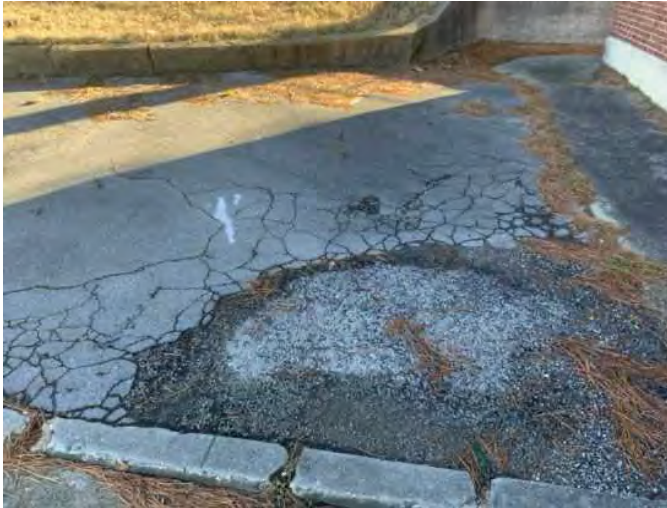
19 - SIDEWALK - ASPHALT

The asphalt walks are deteriorating and require replacement. There are fence supports with broken concrete. The railings are rusting with peeling paint. The shorter field lighting may or may not be functional.

Large cracks, depressions and potholes - AssetCALC ID: 7381096

Uniformat Code: G2030  
Recommendation: **Replace in 2026**
