# FACILITY CONDITION ASSESSMENT

**Shelby County Board of Education**  
160 South Hollywood Street  
Memphis, Tennessee 38112-4892  
Michelle Stuart

Chimneyrock Elementary  
8601 Chimneyrock Boulevard  
Cordova, Tennessee 38016

*November 21, 2024*

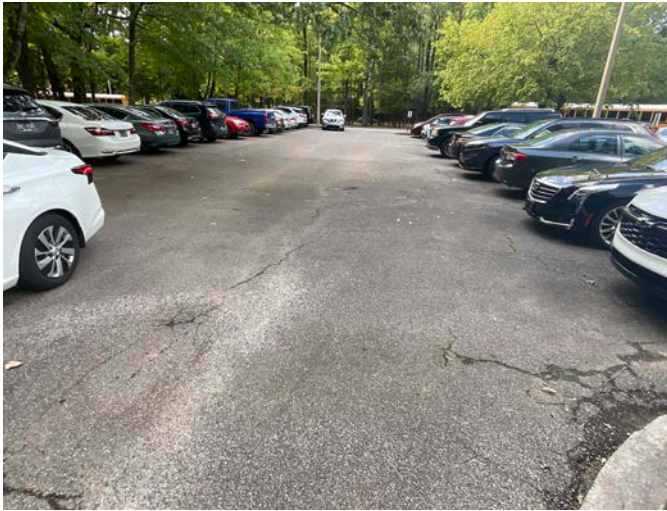
7 - PARKING LOT

Parking lot shows signs of heavy wear. Cracking and small holes found in asphalt. - AssetCALC ID: 8513492

Uniformat Code: G2020  
Recommendation: **Cut and Patch in 2024**

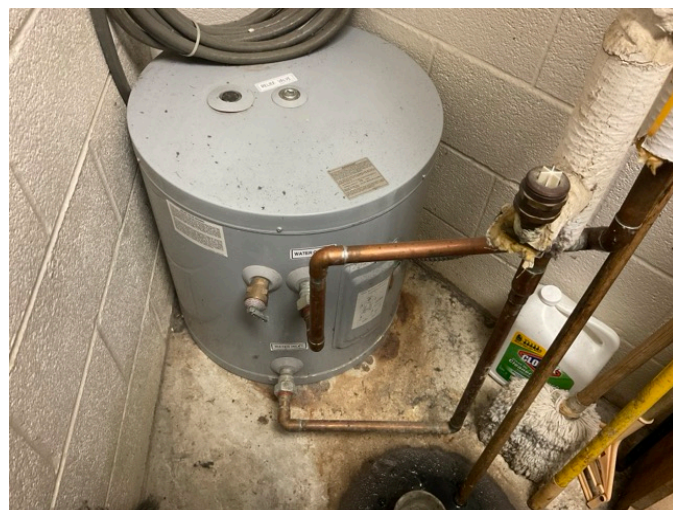
12 - WATER HEATER

Old unit. Top and Lower level of unit is rusted. - AssetCALC ID: 8513493

Uniformat Code: D2010  
Recommendation: **Replace in 2026**

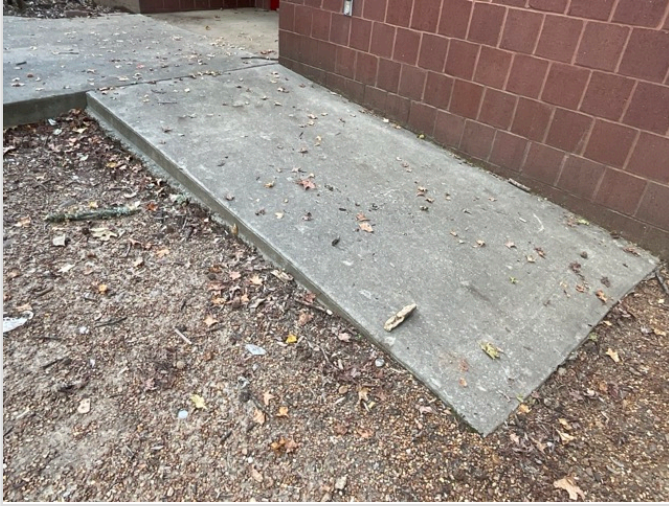
ACCESSIBLE ROUTE TO PLAYGROUND

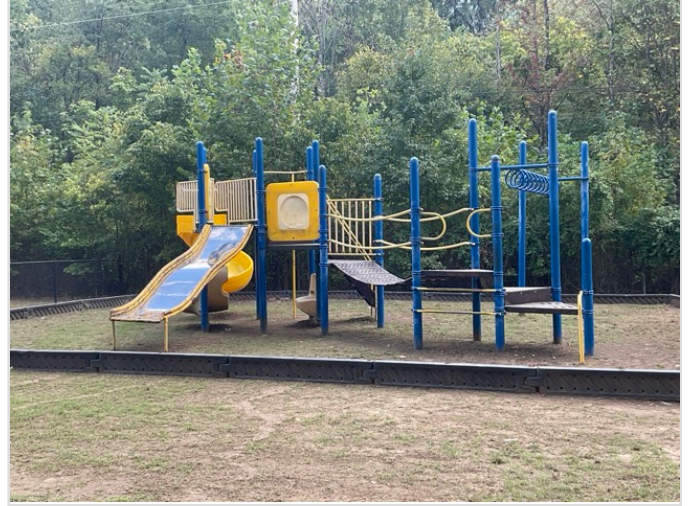
OVERVIEW OF PLAYGROUND
