FACILITY CONDITION ASSESSMENT

prepared for

September 30, 2024

Cordova Elementary
750 North Sanga Road
Cordova, Tennessee 38018

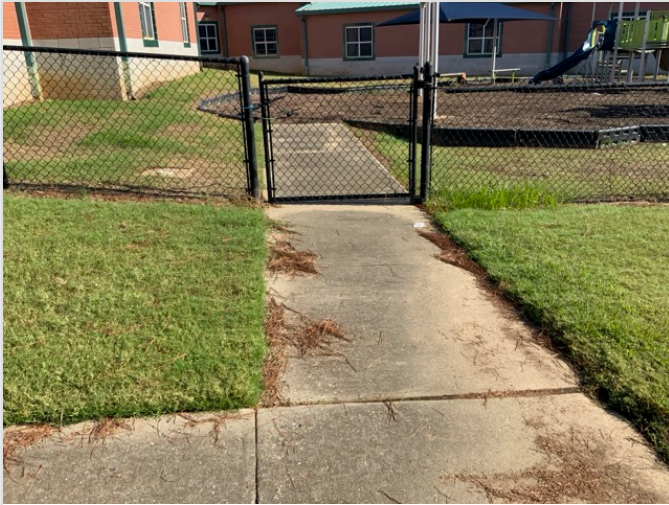
ACCESSIBLE ROUTE TO PLAYGROUND

Category	Major Issues (ADA study recommended)	Moderate Issues (ADA study recommended)	Minor Issues	None*
Parking				✗
Exterior Accessible Route				✗
Building Entrances				✗
Interior Accessible Route				✗
Elevators				✗
Public Restrooms				✗
Kitchens/Kitchenettes	NA			
Playgrounds and Swimming Pools			Play surface is not suitable for ADA access.	
Other	NA
