FACILITY CONDITION ASSESSMENT

Shelby County Board of Education
160 South Hollywood Street
Memphis, Tennessee 38112-4892
Michelle Stuart

Cummings Elementary School
1037 Cummings Street
Memphis, Tennessee 38106

October 7, 2024

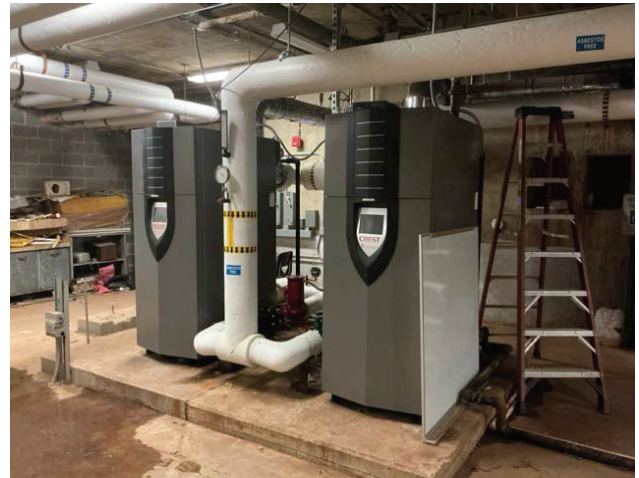
16 - BOILERS

Plumbing systems generally consist of copper supply piping and cast-iron waste pipe. There are two boilers that are present in the main building basement and were replaced in 2022 as evidenced by the installation date written on the unit. Leaks were observed in the main building boiler room and westside of the building. No other major issues were observed or reported.

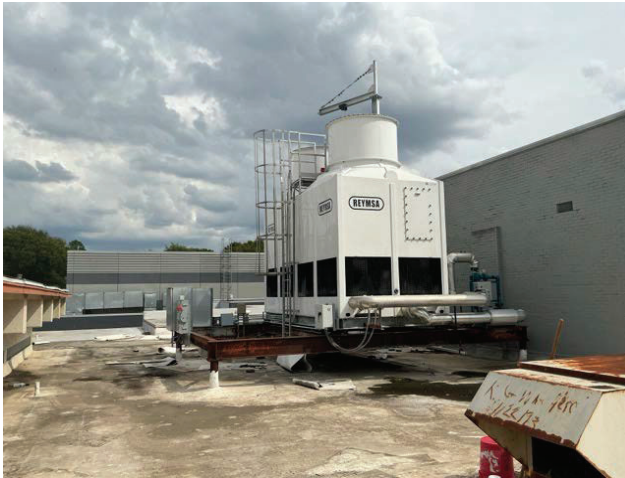
19 - COOLING TOWER

The HVAC systems consist of a boiler, chiller, 4-pipe hydronic piping, and ventilators, with auxiliary systems that include condensing units and a unit heater. The main building is supported by a cooling tower which is located roof. There is a new chiller dated 2022 located in the Basement. Typical lifecycle replacements are budgeted and anticipated.

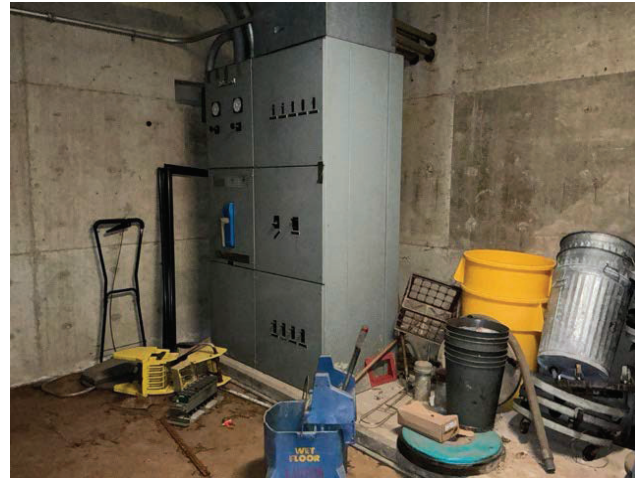
20 - MAIN ELECTRICAL ROOM

The electrical system in the older building still has some original components and newer ones as evidenced by manufacture dates on the components. The annex building/gym has a backup generator in the rear of the building dated around 2022. The building's electrical systems appeared to be overall in fair condition.

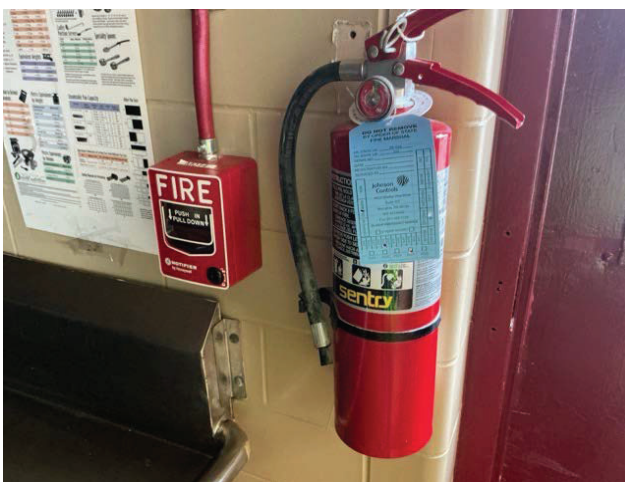
23 - FIRE EXTINGUISHER AND ALARM DEVICE

The fire alarm and suppression systems appear to be in fair condition. The inspection tags are current. Typical lifecycle replacements and ongoing maintenance will be required.

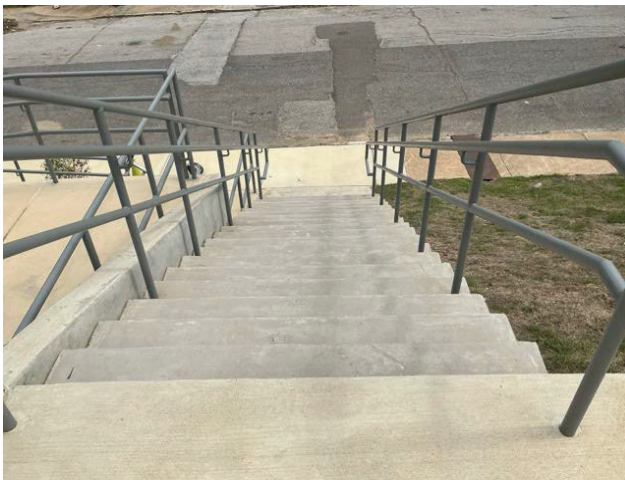
27 - EASTSIDE STAIRS

Stairs in Poor condition.

Exterior stairs and slightly cracked - AssetCALC ID: 8310898

Uniformat Code: B1080
Recommendation: **Repair in 2024**

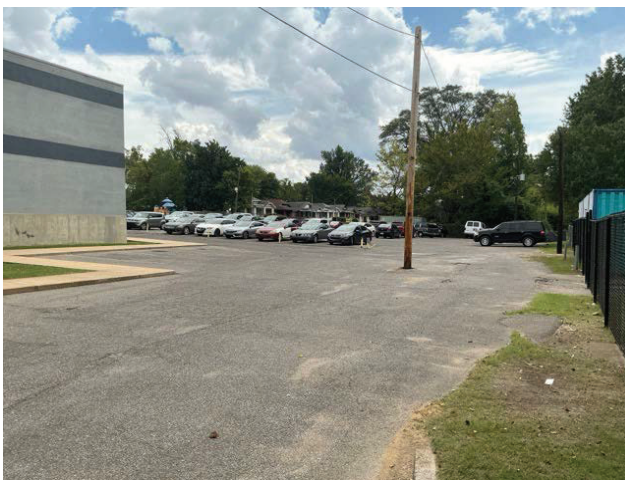
29 - MAIN PARKING AREA

Site maintenance appear to be average, and site improvements and landscaping are generally in good condition. Sidewalks are fine. The curb cut out and asphalt pavement located near the parking lot are heavily worn with cracking throughout, and replacement is recommended.

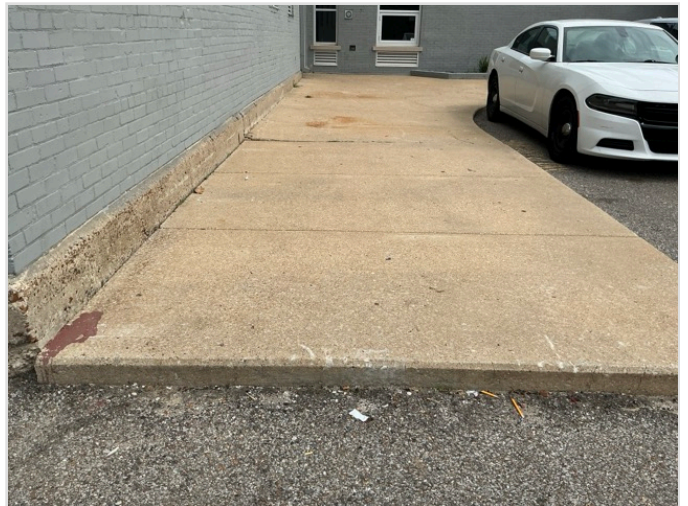
CURB CUT

Category	Major Issues (ADA study recommended)	Moderate Issues (ADA study recommended)	Minor Issues	None*
Parking				X
Exterior Accessible Route			Curb is damaged and needs to be repaired	
Building Entrances				X
Interior Accessible Route				X
Elevators	NA			
Public Restrooms				X
Kitchens/Kitchenettes				X
Playgrounds and Swimming Pools				X
Other	NA
